COLORADO DIVISION OF RECLAMATION, MINING AND SAFETY
MINERALS PROGRAM INSPECTION REPORT
PHONE: (303) 866-3567

MINE NAME: Bunn Ranch Pit	MINE/PROSPECTING ID#: M-1980-131	MINERAL: Sand and gravel	COUNTY: Moffat
INSPECTION TYPE: Monitoring	INSPECTOR(S): Dustin M. Czapla	INSP. DATE: March 28, 2012	INSP. TIME: 09:00
OPERATOR: Elam Construction, Inc.	OPERATOR REPRESENTATIVE: Gayle Lyman	TYPE OF OPERATION: 112c - Construction Regular Operation

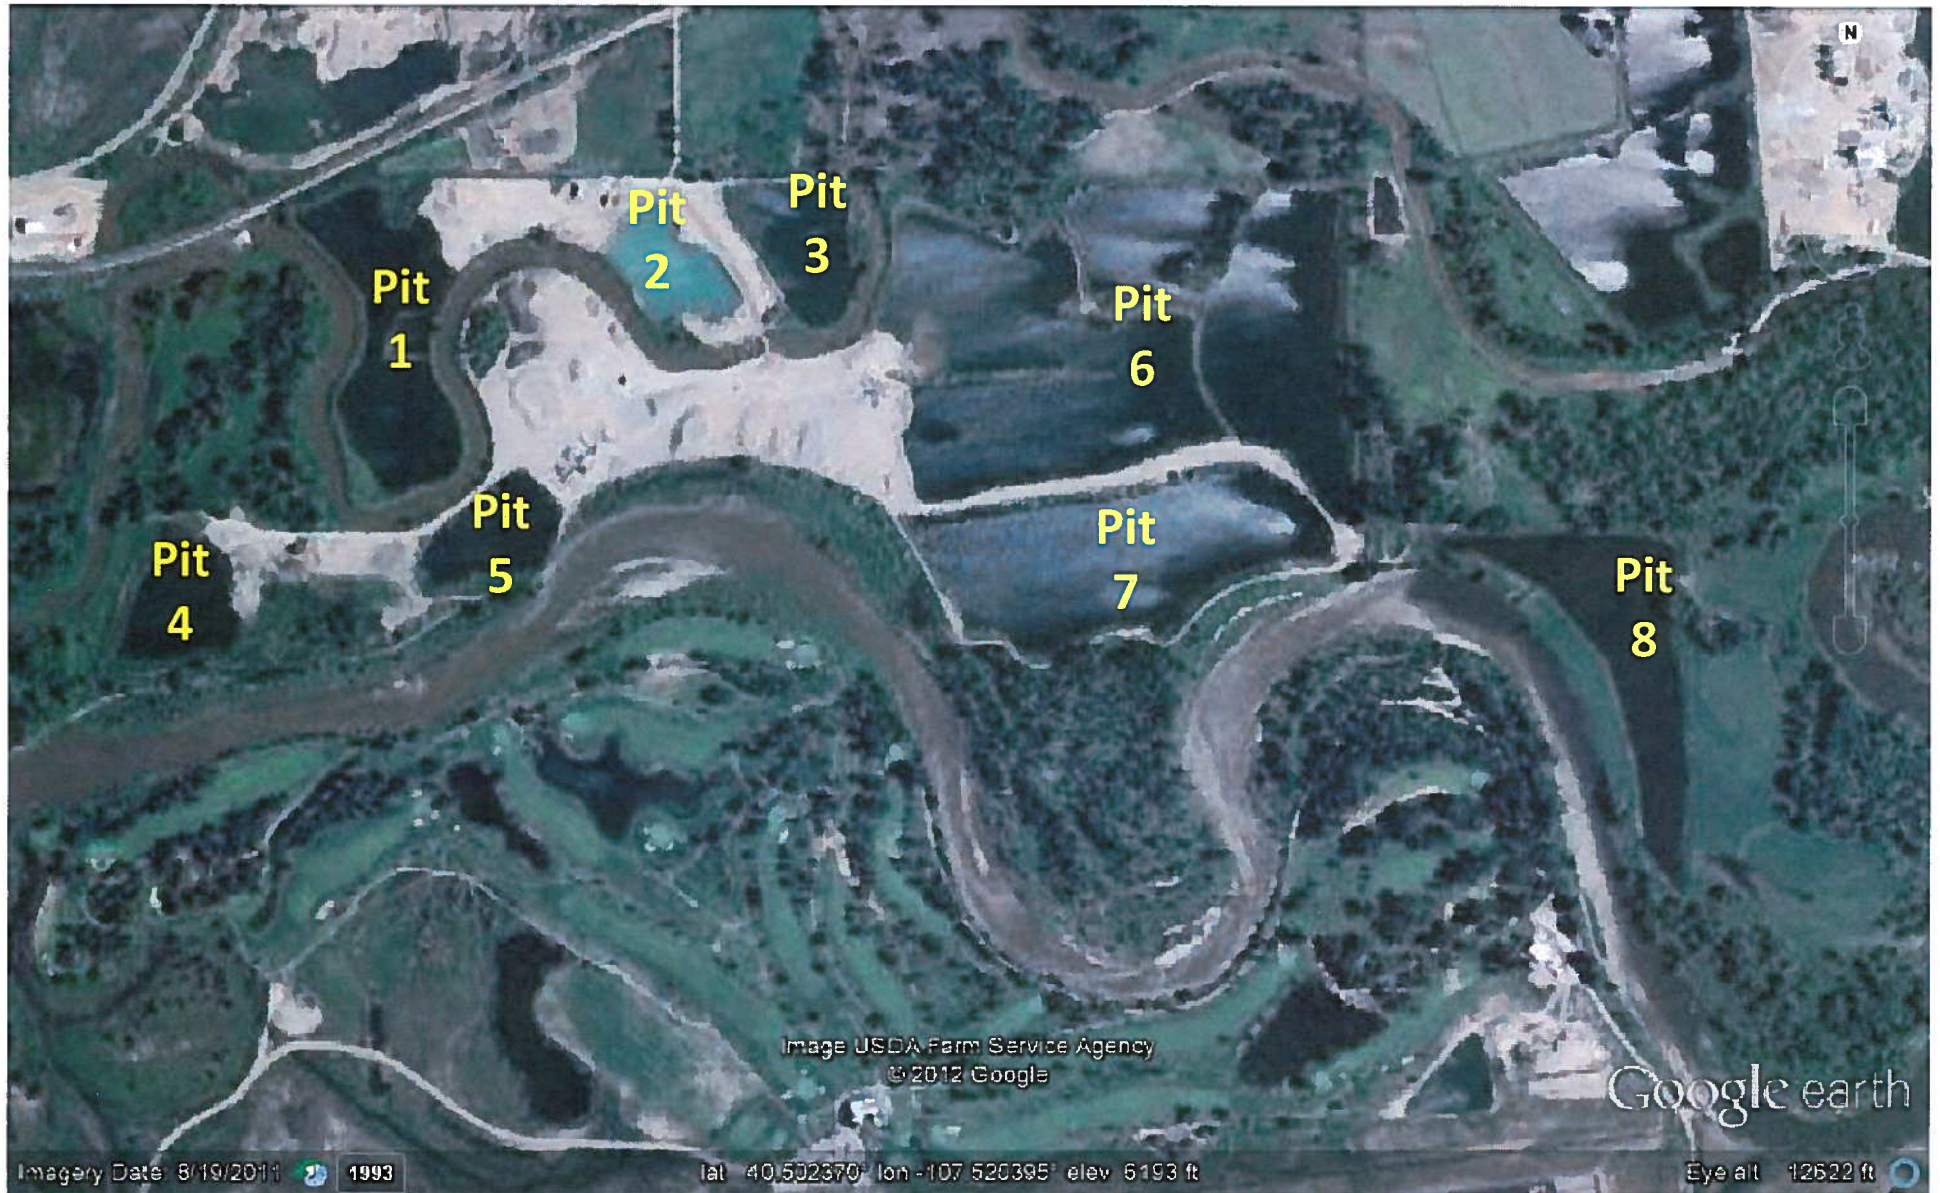
Mining at the site has created eight distinct pits. Figure 1 shows the pits labeled as they will be referred to in this report.
