COLORADO DIVISION OF RECLAMATION, MINING, AND SAFETY
MINERALS PROGRAM INSPECTION REPORT
PHONE: (303) 866-3567

MINE NAME: Arnold Gulch	MINE/PROSPECTING ID#: M-1998-091	MINERAL: Sand and gravel	COUNTY: Chaffee
INSPECTION TYPE: Monitoring	INSPECTOR(S): G. Russell Means	INSP. DATE: April 10, 2012	INSP. TIME: 13:00
OPERATOR: BBL COGAN LLC	OPERATOR REPRESENTATIVE: Joe Cogan	TYPE OF OPERATION: 110c - Construction Limited Impact

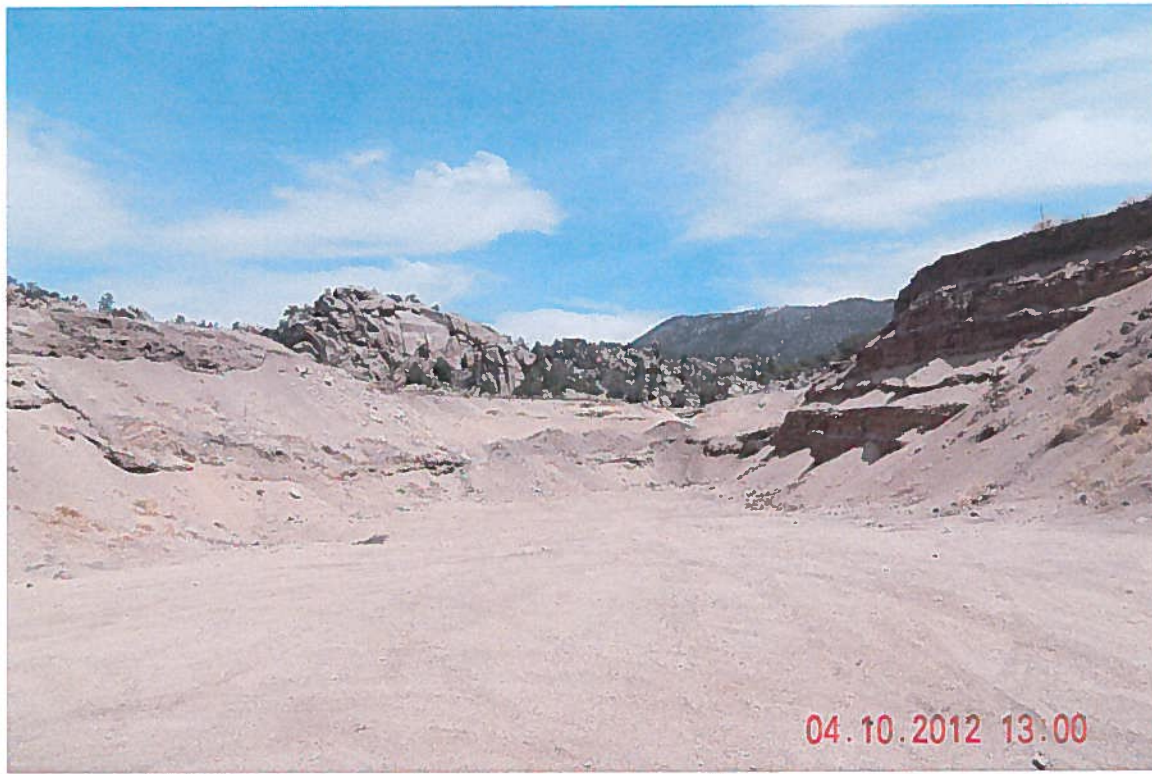
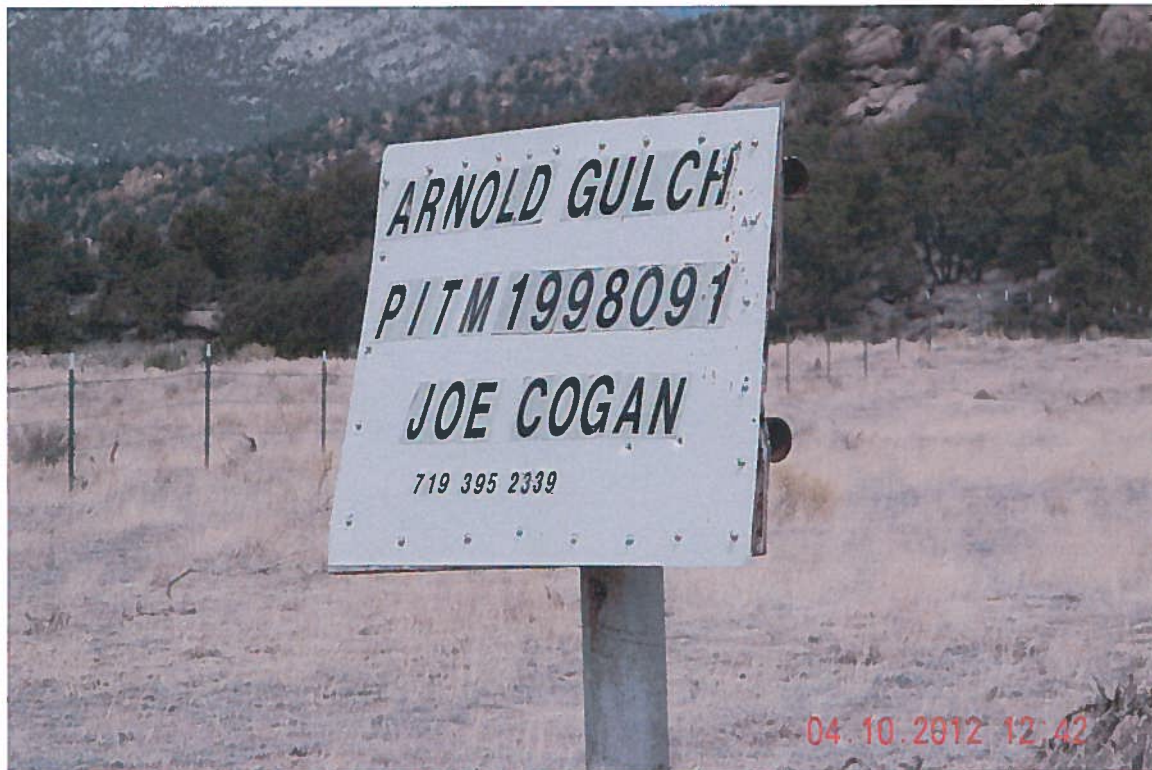
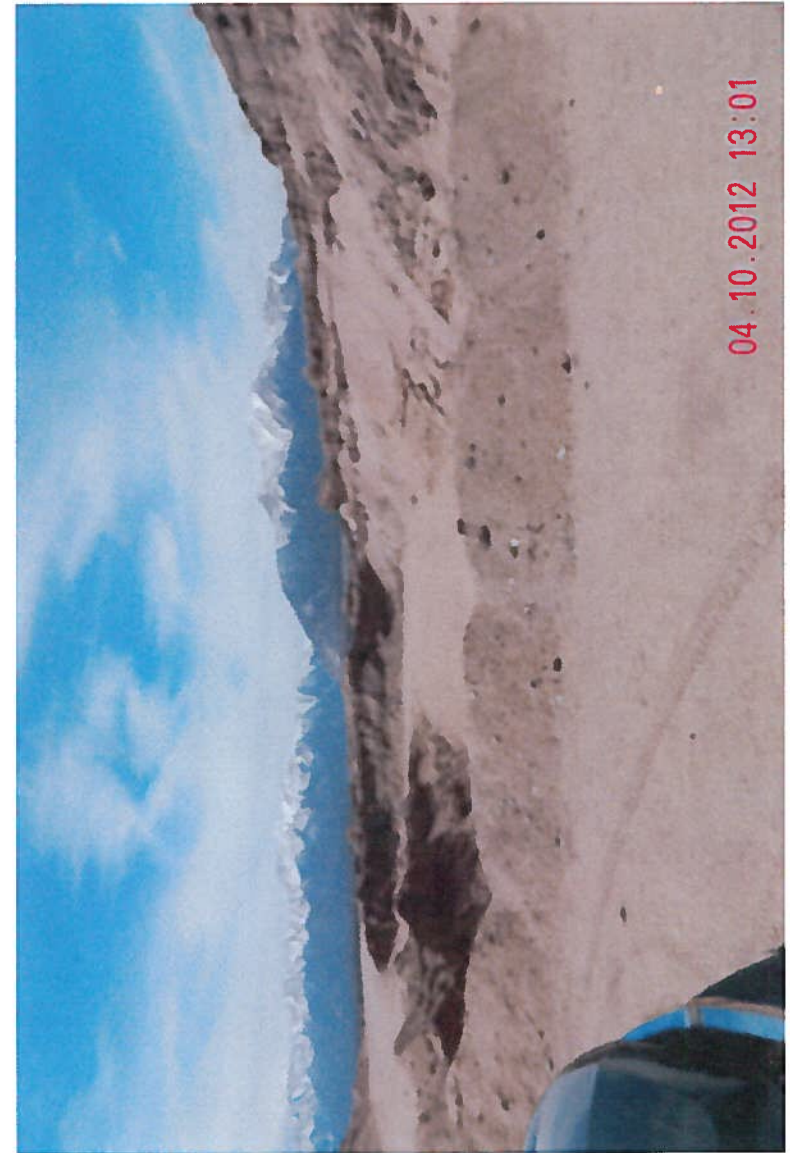
The Annual Report submitted in February 2012 reflects current conditions. Approximately 1.5 acres are disturbed which consist of cell # 8 and part of #7. While no equipment was on site evidence of mining activities since the last inspection in 2006 were obvious. Highwalls in the excavation area are approximately 10 to 15 feet in height. The nature of the sandy materials keeps the natural angle of repose at approximately 1.5 to 1. No stability issues were observed.
