COLORADO DIVISION OF RECLAMATION, MINING AND SAFETY
MINERALS PROGRAM INSPECTION REPORT
PHONE: (303) 866-3567

MINE NAME: Whitewater Pit 500	MINE/PROSPECTING ID#: M-1977-129	MINERAL: Sand and gravel	COUNTY: Mesa
INSPECTION TYPE: Surety Release Inspection	INSPECTOR(S): Travis H. Marshall	INSP. DATE: April 10, 2012	INSP. TIME: 10:00
OPERATOR: Whitewater Building Materials	OPERATOR REPRESENTATIVE: Mark Gardner	TYPE OF OPERATION: 112c - Construction Regular Operation

REASON FOR INSPECTION: Surety Release Requested	BOND CALCULATION TYPE: None	BOND AMOUNT: \$287,500.00
DATE OF COMPLAINT: NA	POST INSP. CONTACTS: None	JOINT INSP. AGENCY: None
WEATHER: Clear	INSPECTOR'S SIGNATURE:

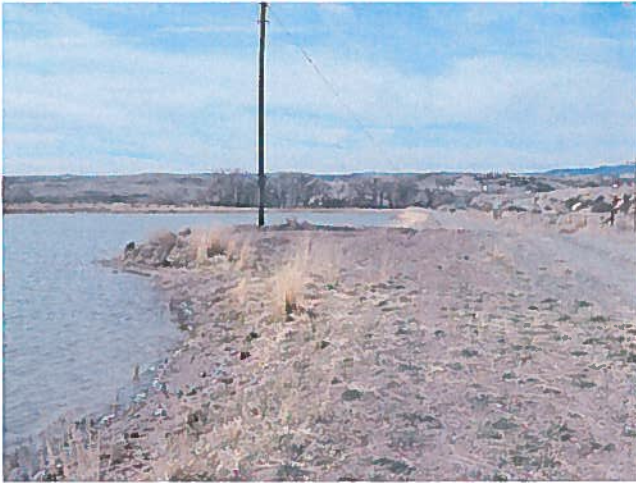
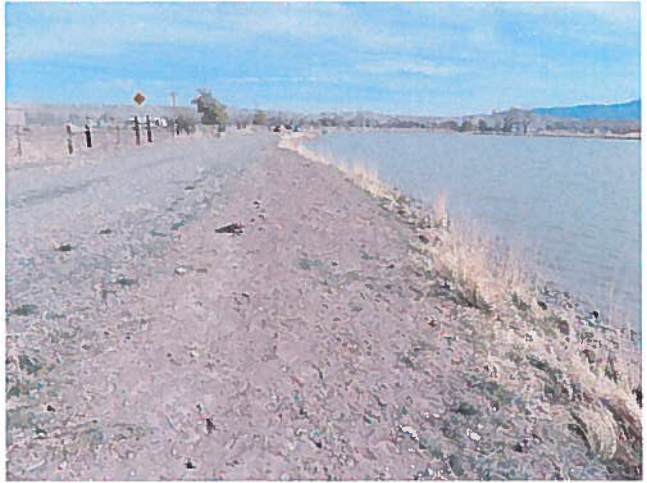
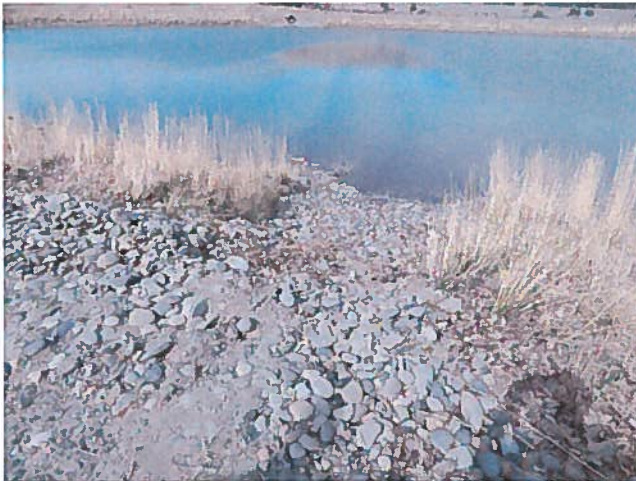
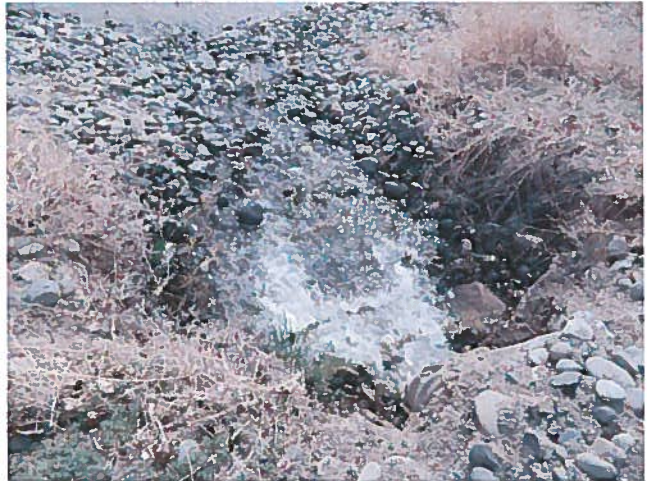
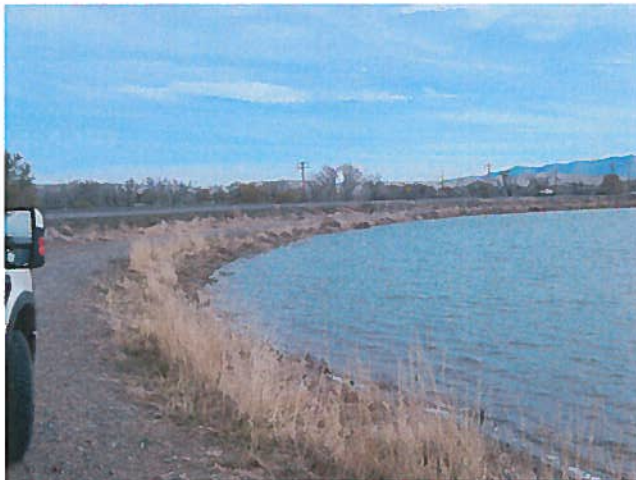
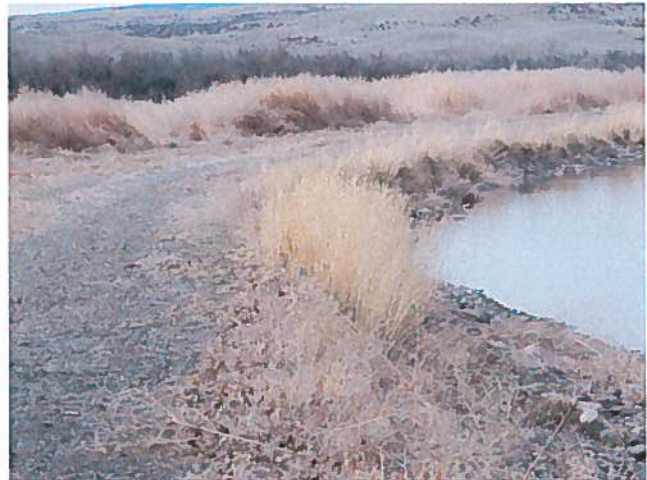
Conditions Observed in Stage 2 – Part B – This Portion of the permitted area is owned by James McCurter. All sloping appeared to be no steeper than the required 3H:1V. The majority of the area appeared to have adequate topsoil. The water inlet features that were considered an erosional issue during the previous inspection have been repaired and appear to be stable. A horse and a mule were observed within the permit area and appear to be compromising the success of revegetation. It appears that the animals grazing in the permitted area is delaying the reclamation success and negating the efforts for final reclamation put in by Whitewater. Please see photos of over grazed bare areas included with this report. Also, the area located between the eastern road and the Gunnison River appears to consist primarily of annual weeds and has very limited desirable perennial grass species established. The operator is required establish long term vegetation in the corridor between the Gunnison River and the road.

Due to the lack of adequate vegetation the release request cannot be approved at this time. The operator must restrict grazing of the permitted area until long term vegetation establishment is achieved.

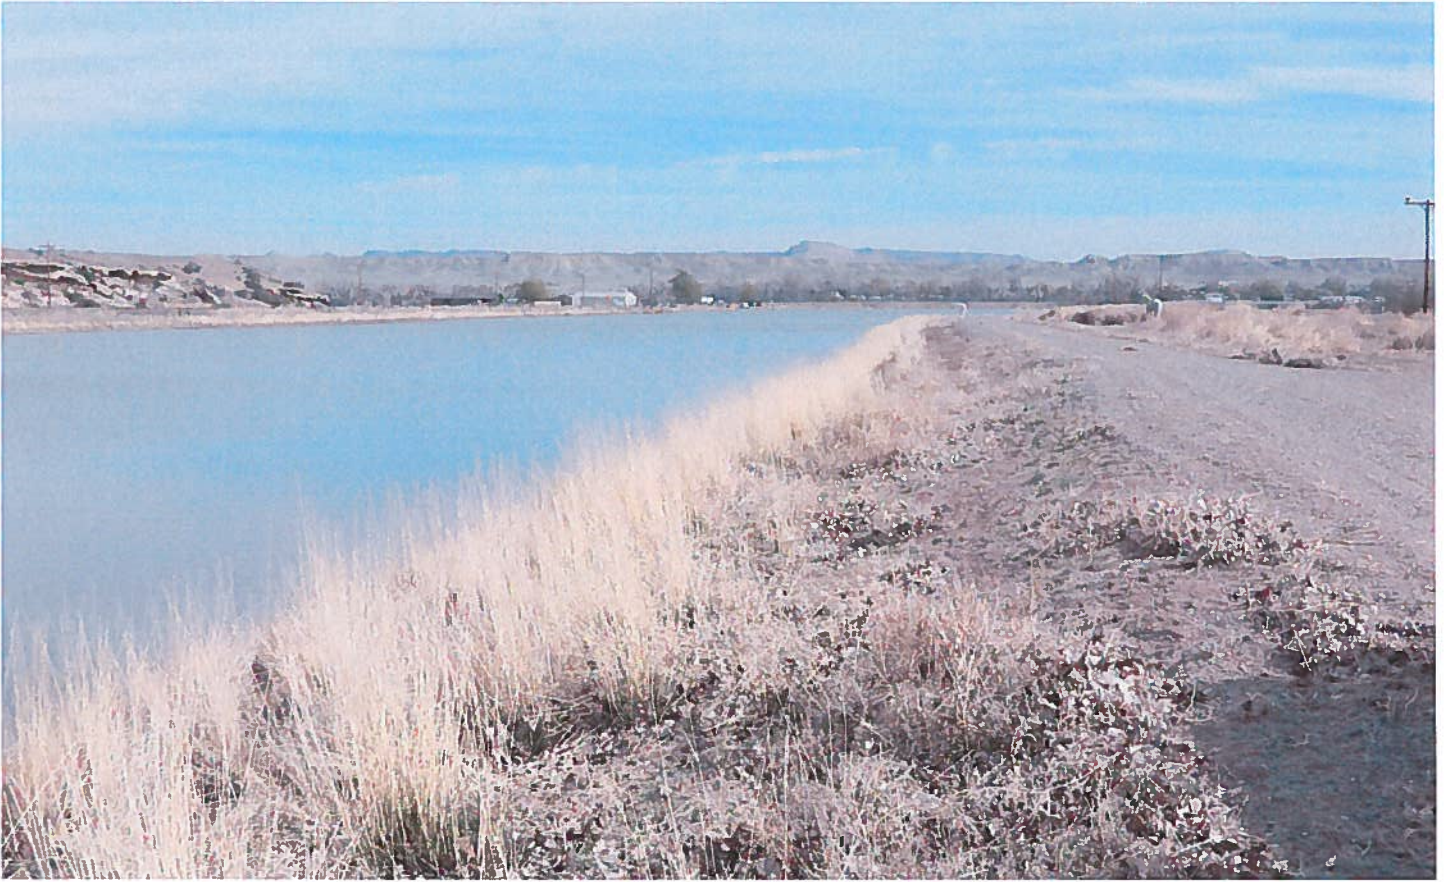
PROBLEM/POSSIBLE VIOLATION: Problem: Premature grazing by horses has significantly reduced the success of revegetation at the site.

Photo of horse and mule located in permit area

CORRECTIVE ACTIONS: Per Rule 3.1.10(4) the operator must restrict grazing during the initial establishment of vegetation. DRMS staff, in consultation with the landowner and the local soil conservation district, if any, shall determine when grazing may start. At this time grazing shall be restricted to allow for long term vegetation establishment at the property owned by Mr. McCurter. Documentation along with photographs that demonstrate the horses and mules have been restricted from the permitted site must be submitted to this office no later than May 14, 2012. Also the operator is advised to send the landowner documentation that states that grazing is not allowed inside the permit area at this time and copy this office of any such correspondence.
