COLORADO DIVISION OF RECLAMATION, MINING, AND SAFETY
MINERALS PROGRAM INSPECTION REPORT
PHONE: (303) 866-3567

MINE NAME: Weimer No. 2	MINE/PROSPECTING ID#: M-1996-031	MINERAL: Gravel	COUNTY: Montrose
INSPECTION TYPE: Surety-Related Inspection	INSPECTOR(S): G. Russell Means	INSP. DATE: April 24, 2012	INSP. TIME: 08:30
OPERATOR: Sutherland Brothers, Inc.	OPERATOR REPRESENTATIVE: None	TYPE OF OPERATION: 110c - Construction Limited Impact

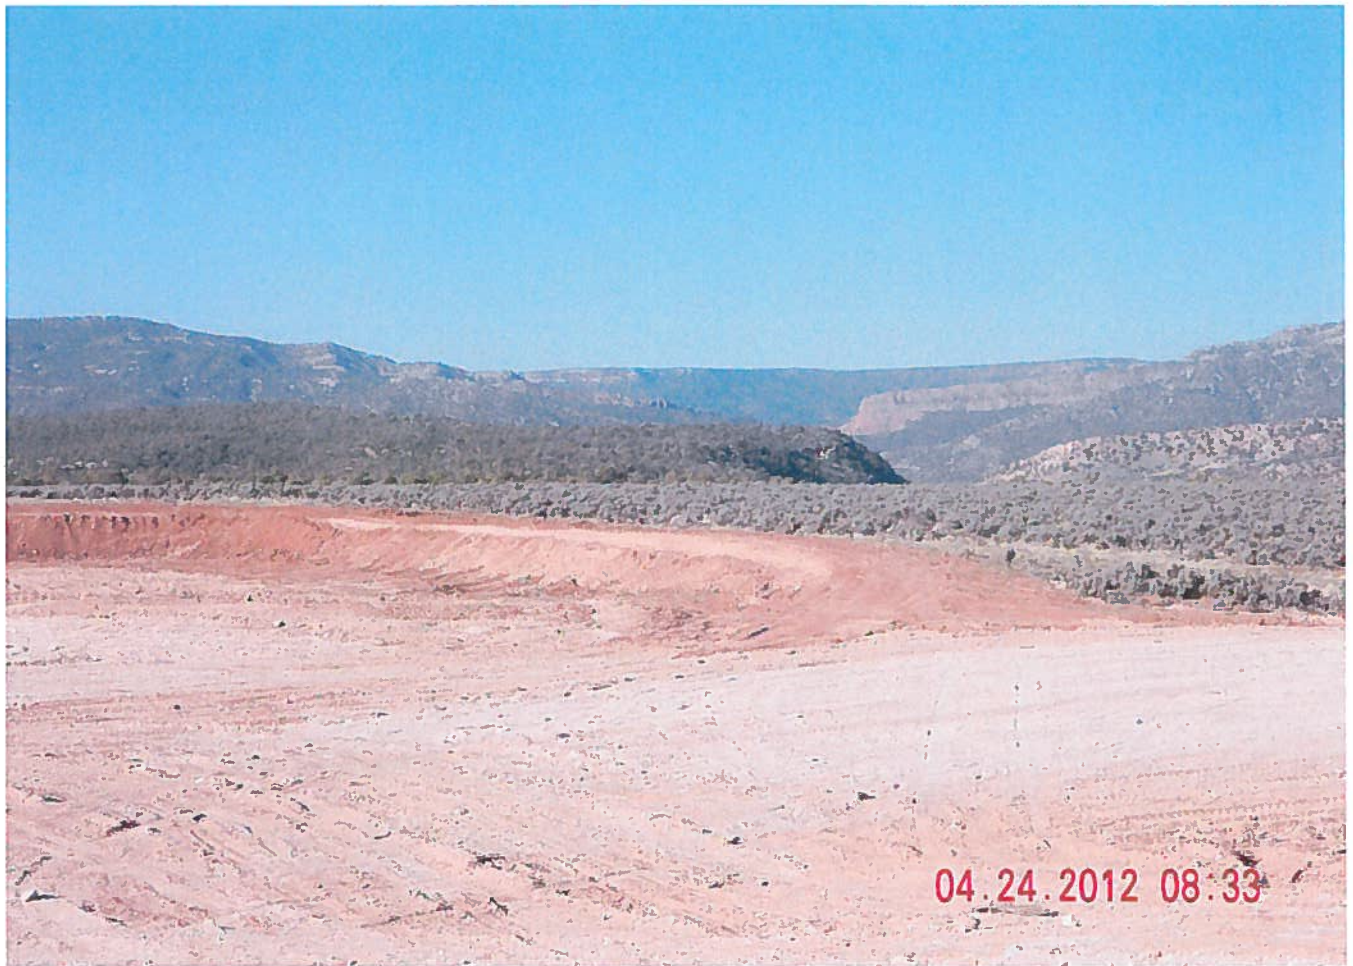
The slopes are now 2:1 or better and acceptable.

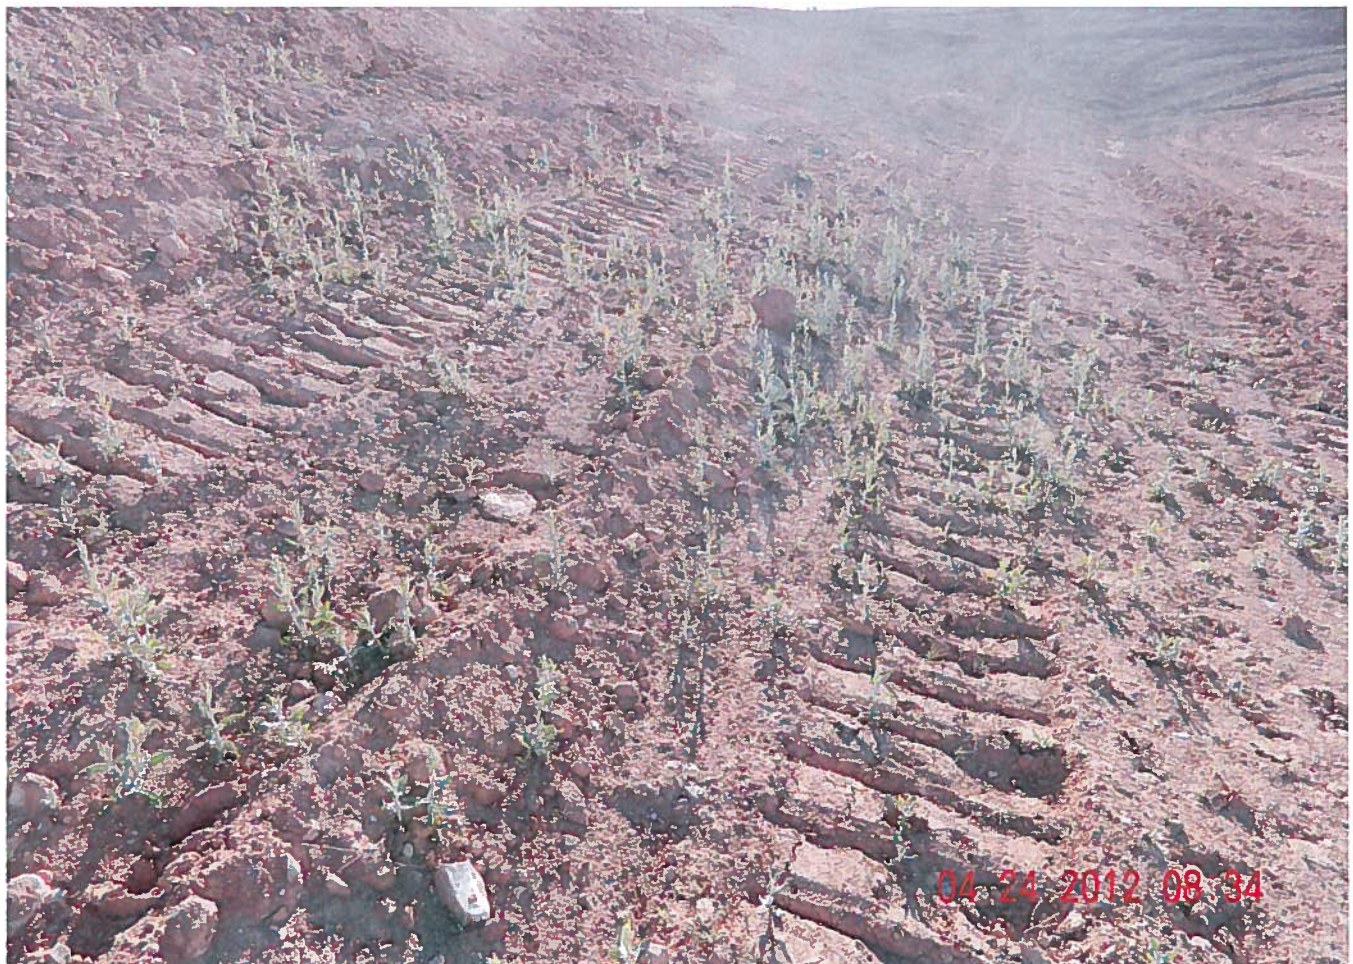
All mine related equipment and debris have been removed.
