ANNUAL FEE and REPORT REQUEST

PERMITTEE NAME:	Homestake Mining Company	RECEIVED
PERMIT NO .:	M-1977-004	
OPERATION NAME:	Pitch Project	APR 192012
ANNIVERSARY DATE:	April 19, 2012	Division of Reclamation,
ANNUAL FEE DUE:	\$\$1,150.00 (Due on or before your annive	Mining & Safety ersary date)
COUNTY:	Saguache

Notice of Intent to Continue Mining Operations 112 Hard Rock/Metal and DMO Annual Report

Permit	ttee Name:	Homestake Mining Company of California	
Permit	t No.:	M-77-004	
Operat	tion Name:	Pitch Project	
Anniv	ersary Date:	April 19, 2012	
Total:		\$1150.00 (enclosed)

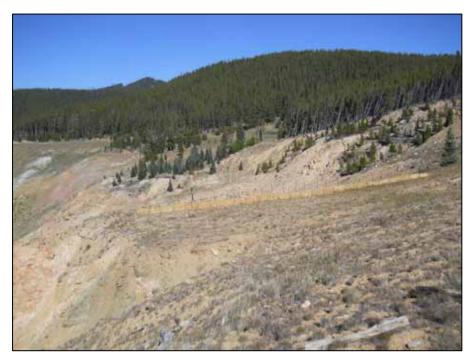
Photograph 1: Straw bale flow barrier at the crest of the east wall of the North Pit looking northwest.

As shown on photographs 1 & 2, straw bales were staked in place at the area above the pit crest late in the fall of 2010, to slow surface water velocities and reduce the impact of surface erosion. In 2011, the area was re-evaluated and it was determined that a small diversion ditch should be installed in 2012.

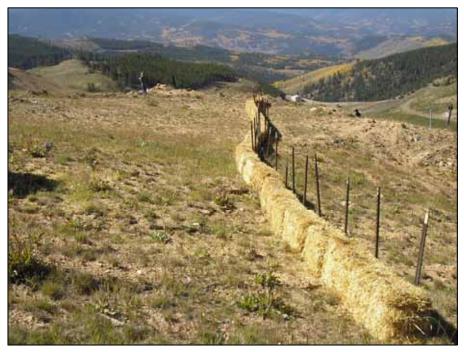
Visual inspection of the East Wall of the North Pit in 2011 indicated that continued maintenance will be required, as expected, in the two locations where an expression of the Chester Fault system, commonly referred to as the "smile crack" crosses the 10600 bench. The displacement creates "cracks" or "steps" in the 10,600 bench that require re-grading periodically. Also, depending on the level of snow pack and summer precipitation, every few years one or two small ponds form along the 10,600 bench. During

Photograph 2: East Wall of the North Pit erosion repairs.

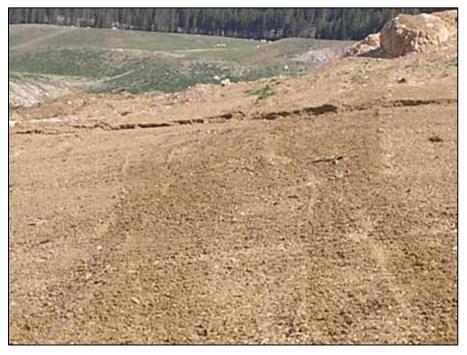
The photographs presented as number 3, 4, 5 & 6 shows the tension cracks associated with the slope displacement at the East Wall of the South Pit, as they appear on the upper bench. Slope displacement results in annual vertical displacement at these tension cracks, of about 1 ft or less. The tension cracks are graded annually to close the cracks and limit infiltration of surface water. During early October, the tension cracks were graded closed and a channel cut on the up-gradient side of the bench to facilitate diversion of surface water away from the tension cracks.

Photograph 3: Tension crack at north end of slope displacement before grading.

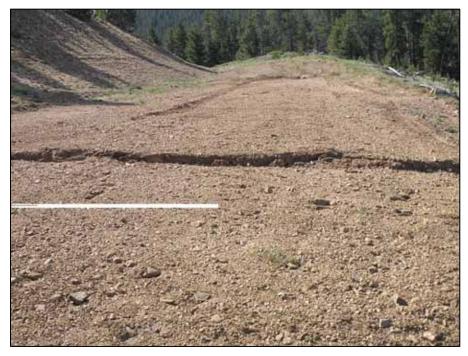
Photograph 4: Tension crack at south end of slope displacement before grading.

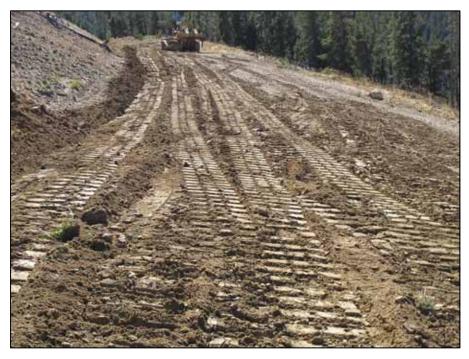
Photograph 5: Grading activities at the upper bench, looking south.

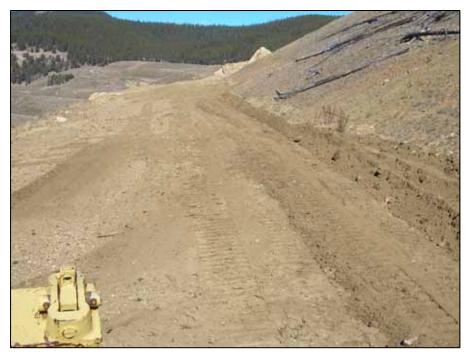
Photograph 6: Final grade and diversion ditch at upper bench, looking north.

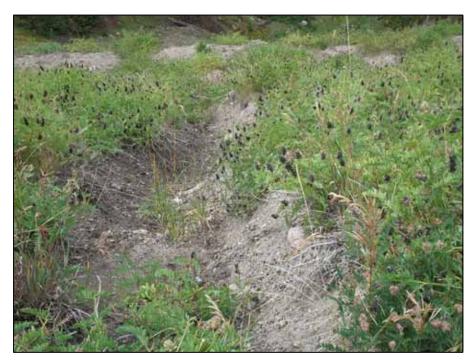
<u>Tie Camp Creek Rock Dump</u>: Photographs 7-11 show erosion on the face between the first and second drainage channels and repairs that were initiated in 2011.

Photograph 7: TCC second bench showing erosion caused by the bench channel filled with sediment.

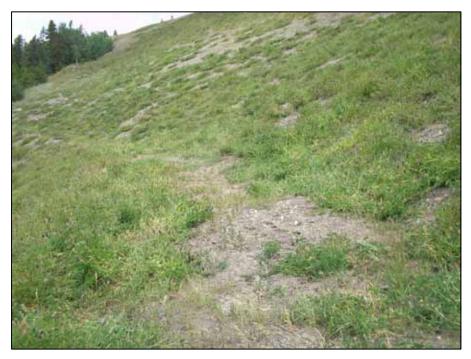
Photograph 8: TCC second bench down looking back to the North showing the drainage channel filled with sediment causing storm water and spring melt to run down the face causing erosion.

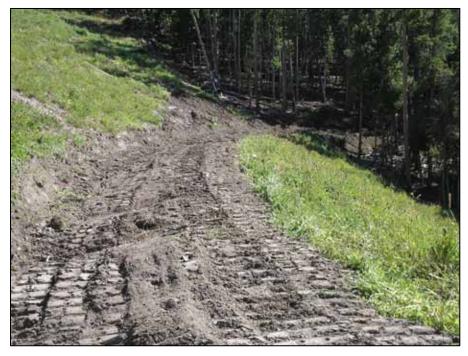
Photograph 9: TCC second bench looking south after widening and sloping back into the slope. This area was seeded, but will need to reseed again in 2012.

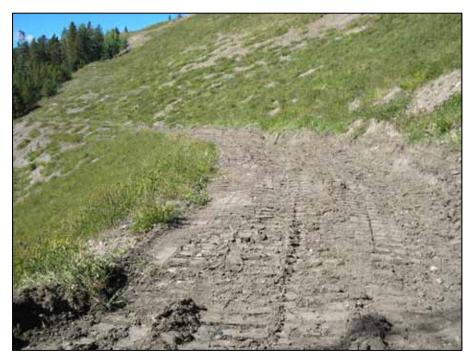
Photograph 10: TCC second bench after widening and sloping back in to the slope.

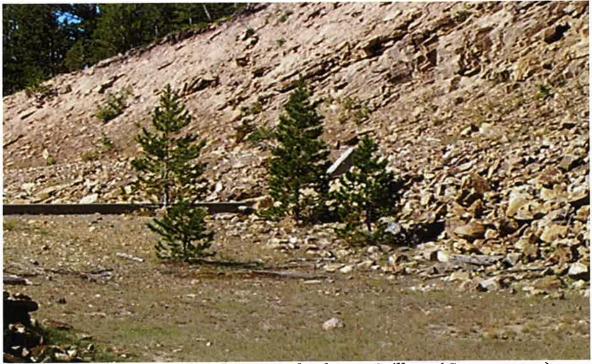
Pine trees growing on Pitch Sediment Embankment Spillway (Summer 2011)

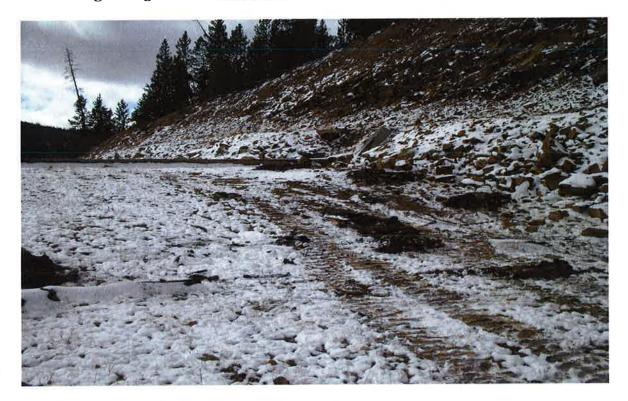
Pine trees and root balls removed. (Fall 2011)

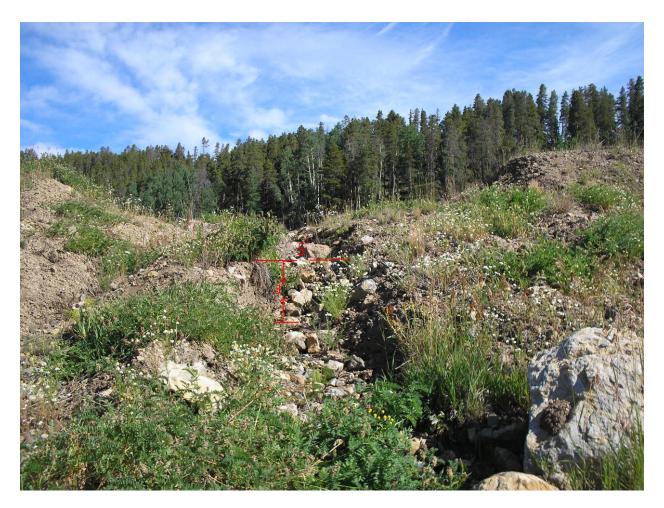
1. Existing erosion cut in channel. Looking N from toe of TCCDC up to crest of the drainage channel. Prior to initiation of channel repair work. Note dimension markers – erosion area is approximately 5 ft wide in some locations by 1-3 ft in depth.

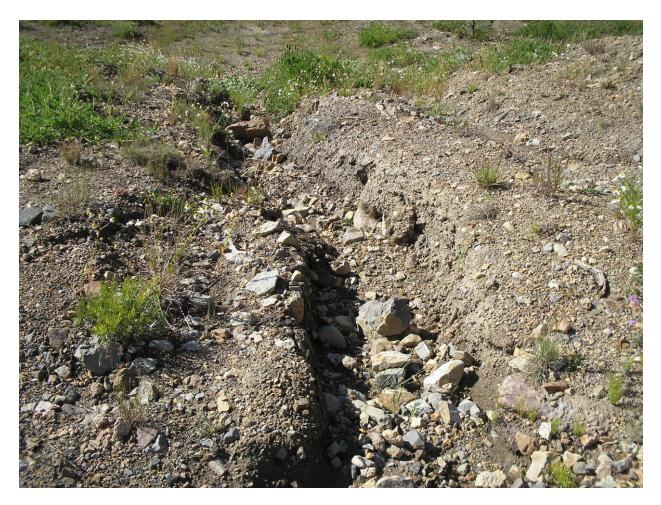
2. Existing erosion cut in channel. Opposite view from Photo 1. looking S from crest of the drainage channel to the toe of TCCDC. Prior to initiation of channel repair work.

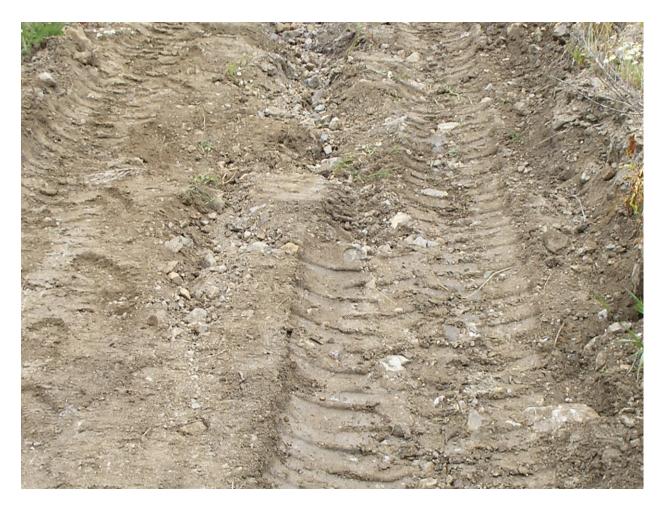
3. Initiation of wheel roll compacting of channel after excavation, and placement and shaping of clean soil cover material for the bedding portion of the channel.

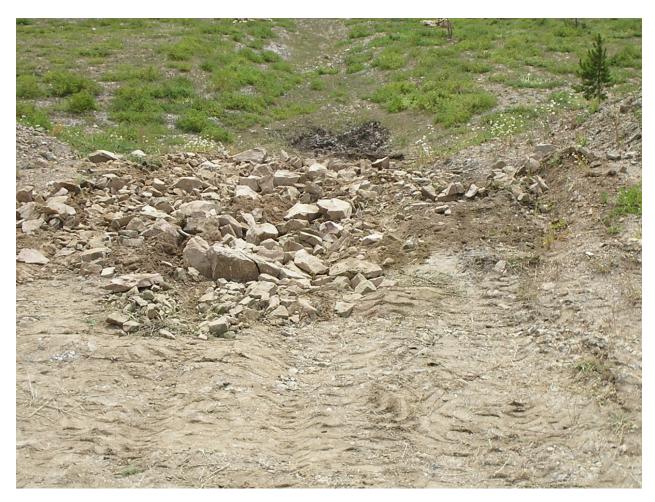
4. Initiation of rip-rap material placement over wheel compacted clean soil cover base material in the channel.

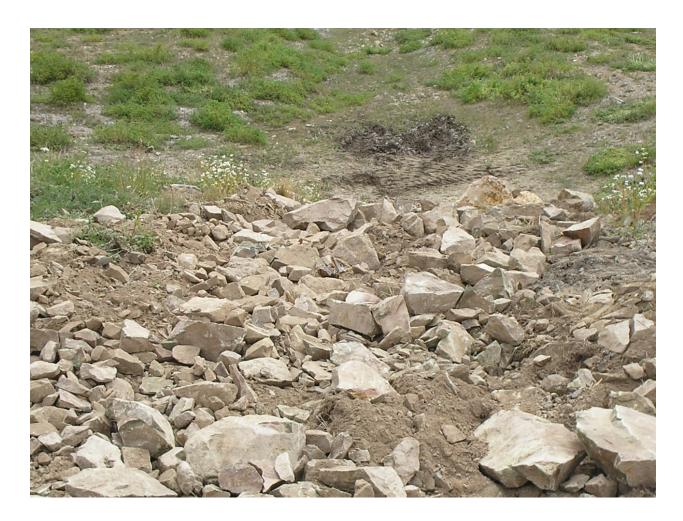
5. In-progress photo showing placement of rip-rap material.

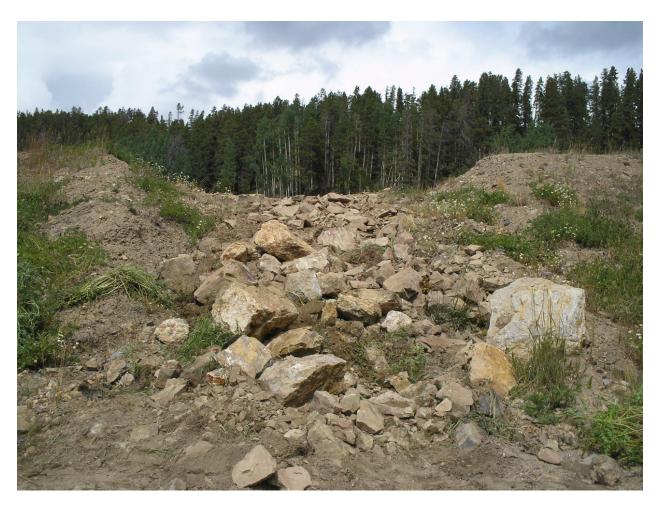
6. Rip-rap channel repair area; nearing completion of work. Area will be seeded and monitored in the short term following significant storm events and/or Spring meltoff to assure that the channel "beds" and is stable to prevent future erosion.
