Denison Mines (USA) Corp.
1050 17th Street, Suite 950
Denver, CO 80265
USA

April 30, 2012

Re: Comments on the Sunday Mine (M/1977/285) Bond Recalculation Estimate.

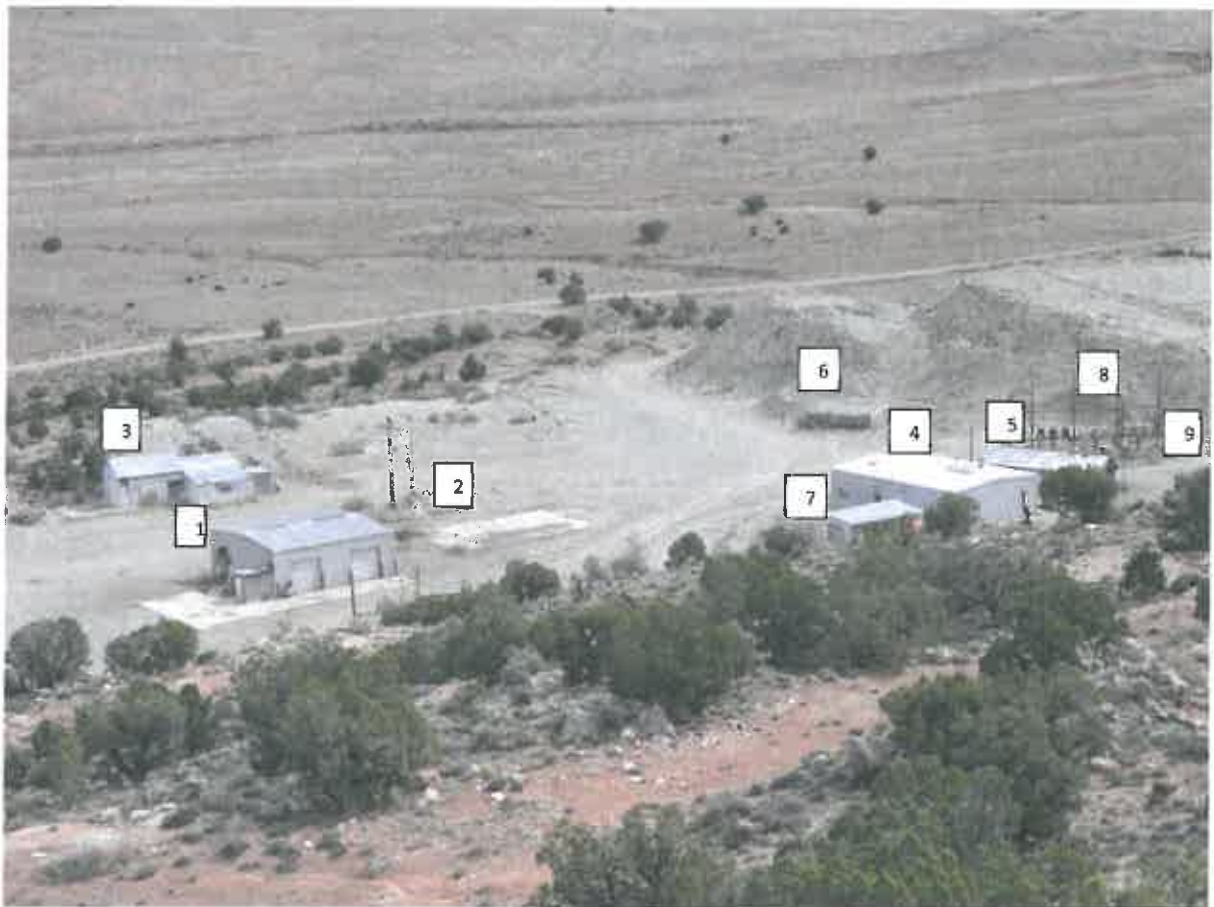
Photo 1.

Structures at Sunday Mine site, photo taken April 10, 2012

1. Sunday West Main shop and adjacent wash pad.
2. Location of Tire shop and Warehouse building that has been removed. Only slab remaining.
3. Ambulance Shed and Warehouse.
4. Sunday Main Dry Room.
5. Old Compressor shed.
6. Fuel Storage area with tanks removed.
7. Small Warehouse for drill supplies.
8. Transformer Station.
9. Compressor building removed – slab remaining.

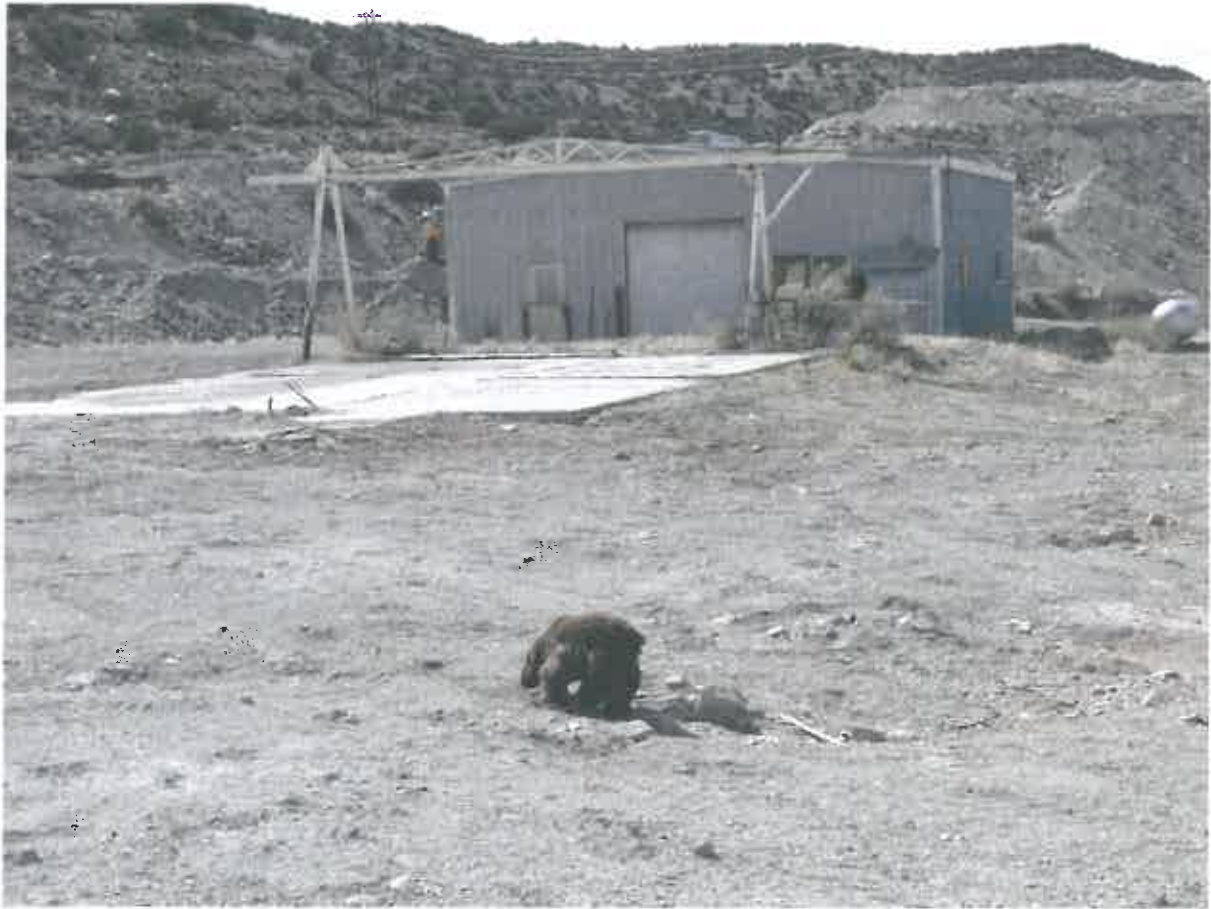
Photo2.

- East Shop has been demolished and debris removed. Slab remains - Photo 2.
- Attached storage (12x26x10) to East Shop has been removed.
- Attached Storage (12x12x10) has been removed.
- Small compressor building (20x16x12) removed. Slab remains – Photo 3.

Sunday Mine - Slab is all that is left of the old tire and machine shop and attached structures. View on east side of the main Sunday shop.

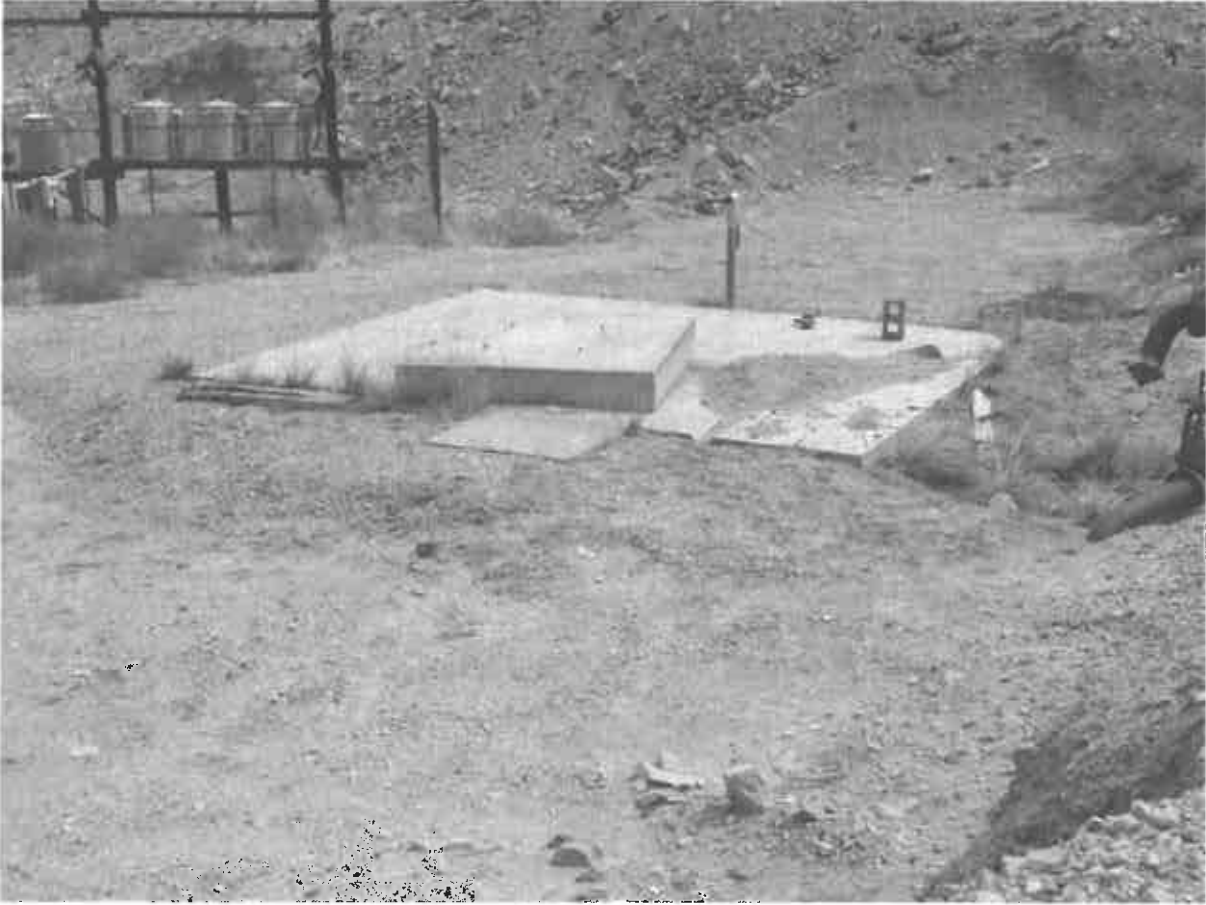
Photo 3.

Small compressor building slab (location number 9 in overview photo); building removed.

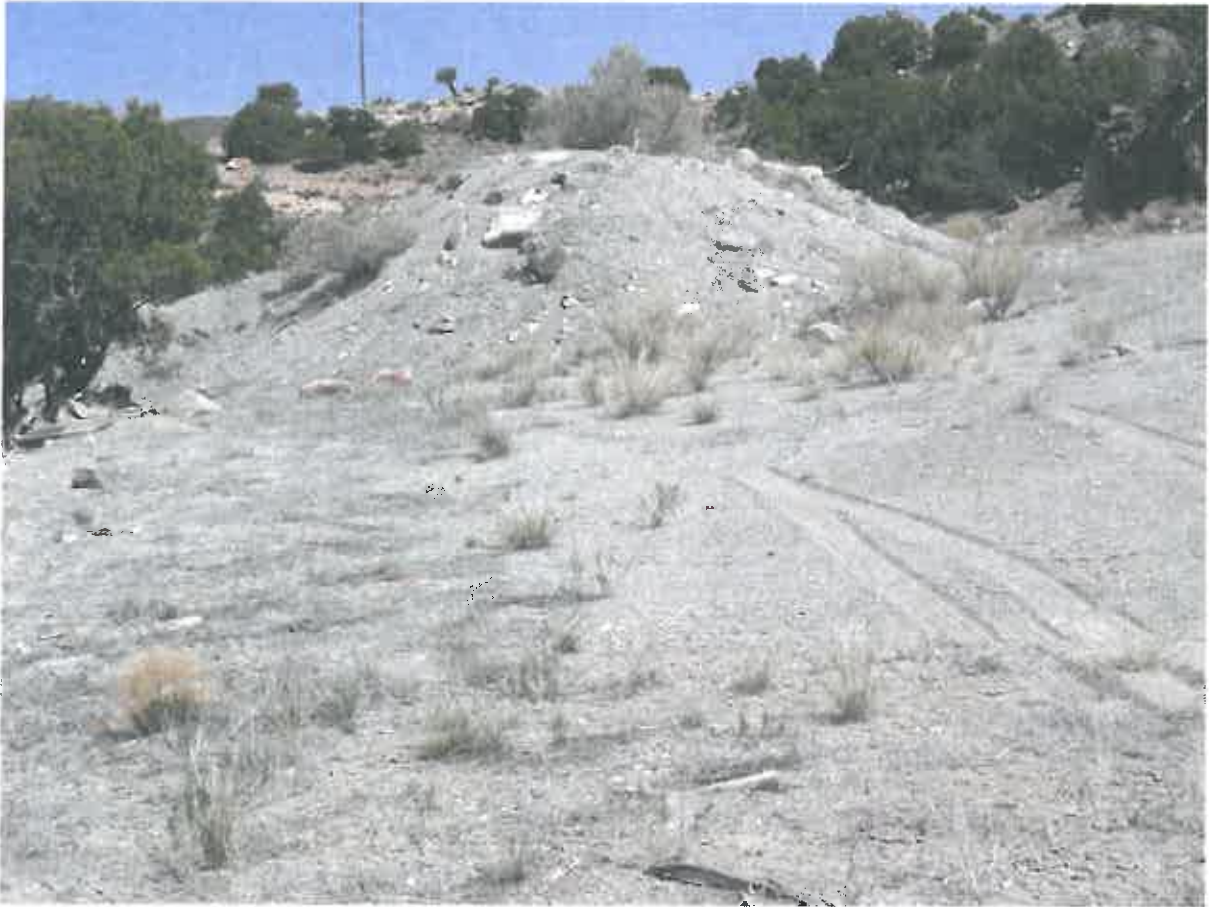
- Vent S-3 has been backfilled and has been stable for several years. Photo 4.

S-3 Vent. Backfilled and stable.
