**Re: Concurrent Reclamation and Cleanup at the Sunday Mines (M/1977-285 & COC53227)**

**Denison Mines (USA) Corp  
Sunday Mines Photographic Log  
Spring 2012**

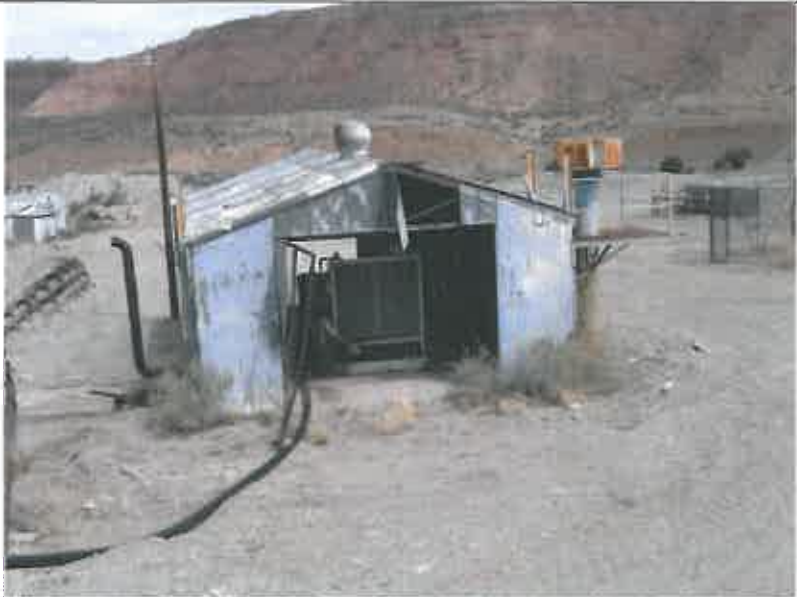
**Sunday Mines Compressor  
Building (before).**

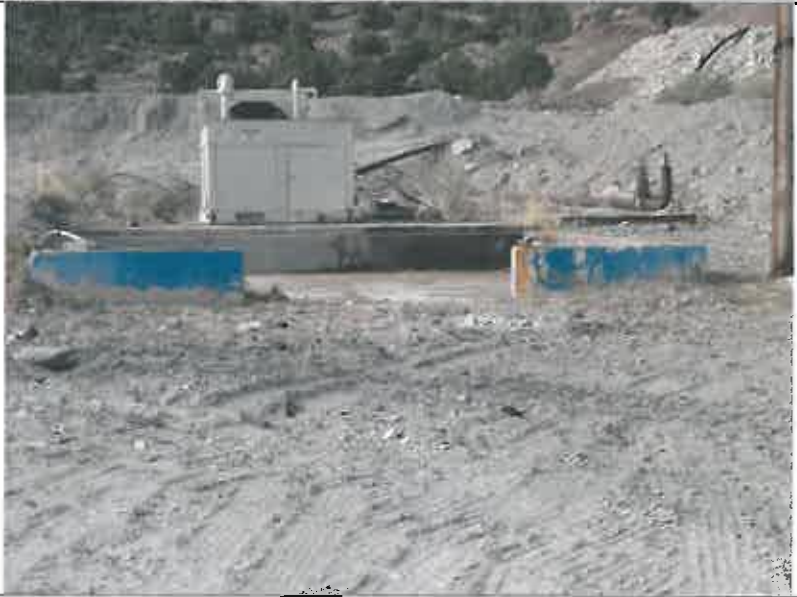
**Sunday Mines Compressor  
Building Removed (after)  
Compressor to be removed by  
contractor.**

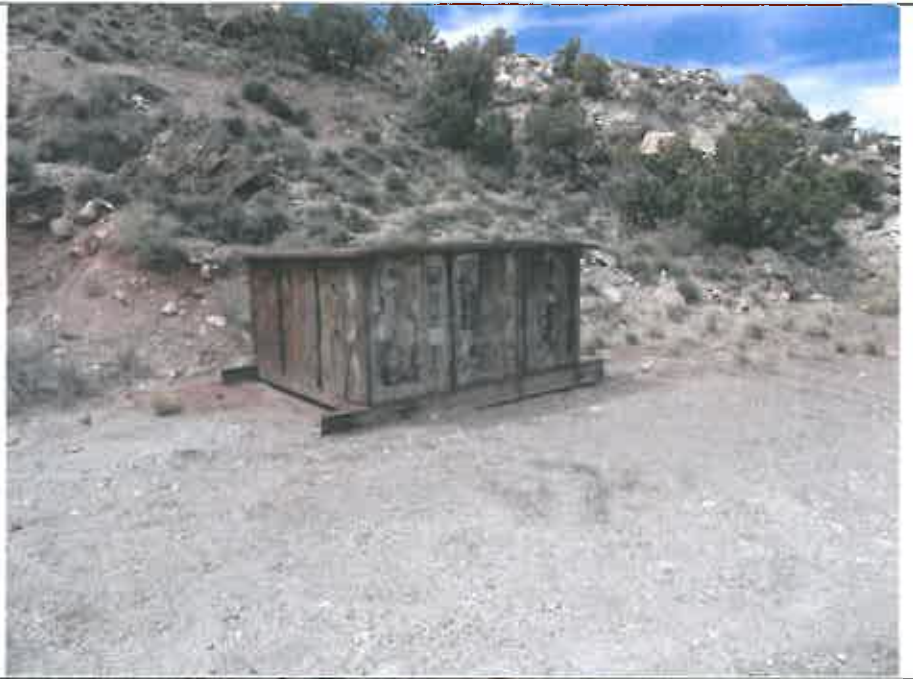
Scrap iron box near the Sunday Portal (before).

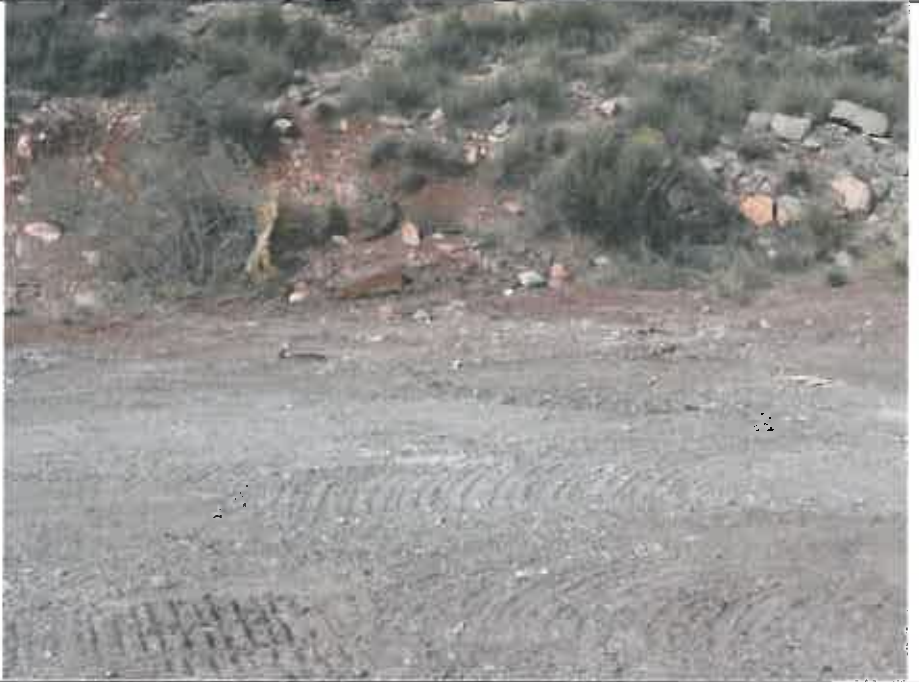
Area where scrap metal box was located (after).

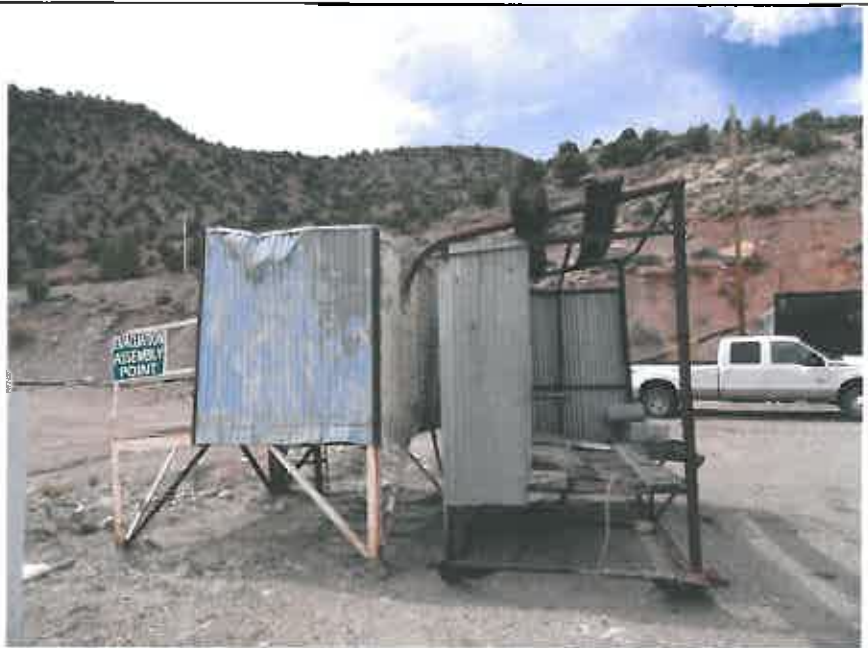
Scrap metal frames located near Sunday portal (before).

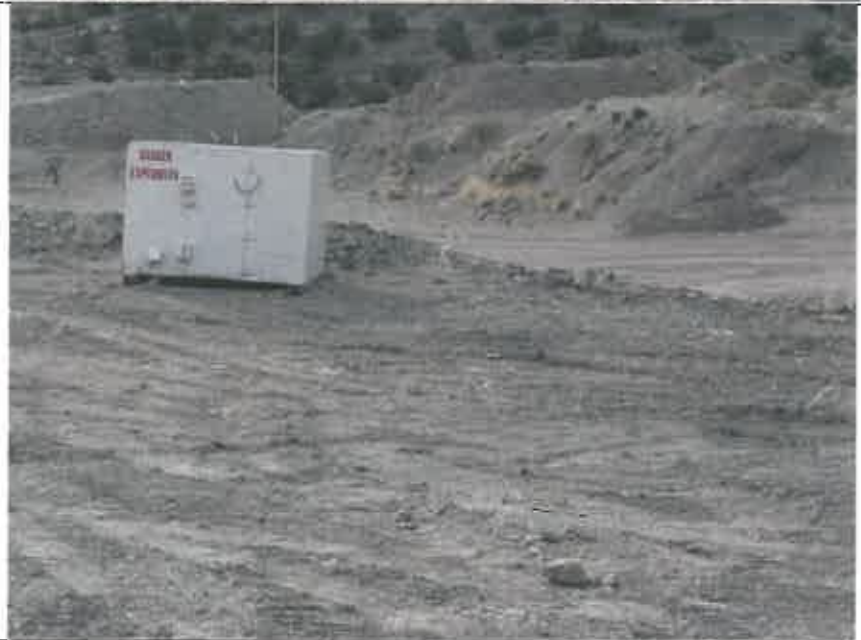
Area where scrap metal frames were located (after).

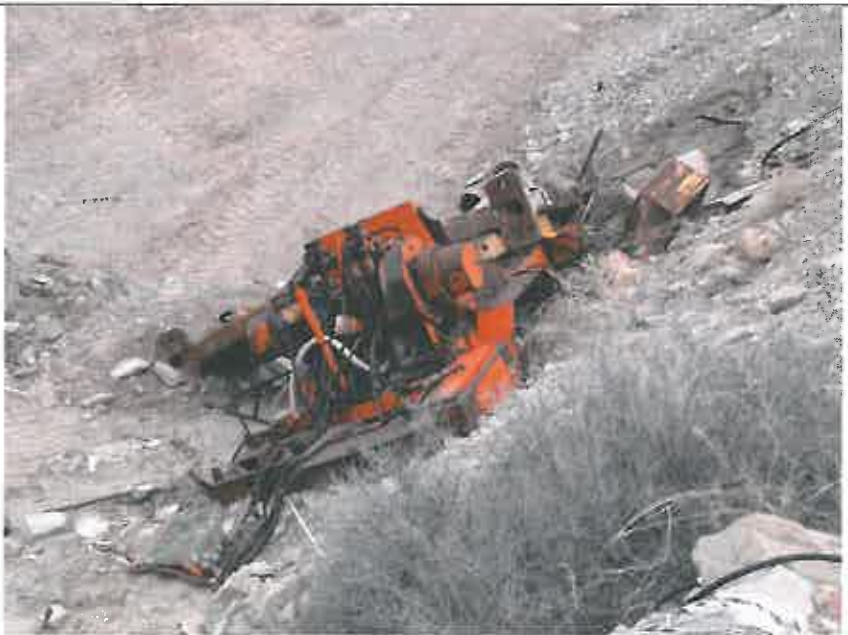
Scrap Iron at the toe of the  
Sunday Mine development rock  
area (before).

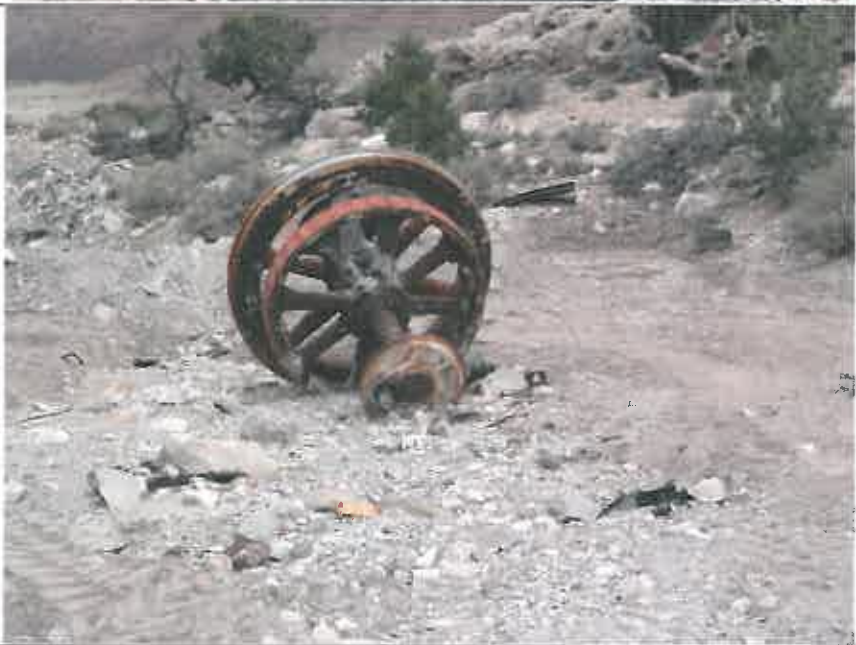
Scrap Iron at the toe of the  
Sunday Mine development rock  
area (before).

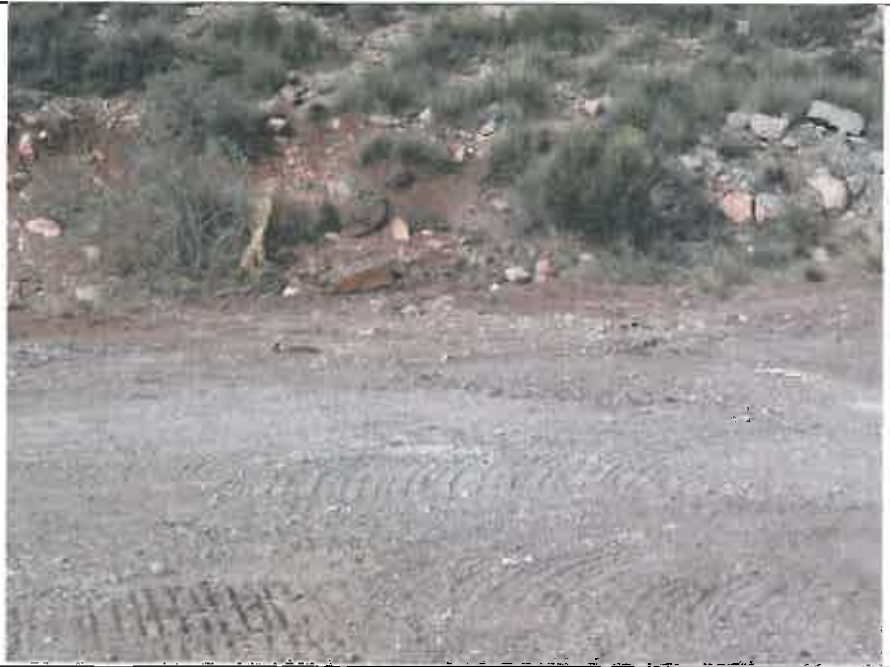
Scrap Iron at the toe of the  
Sunday Mine development rock  
area (after).

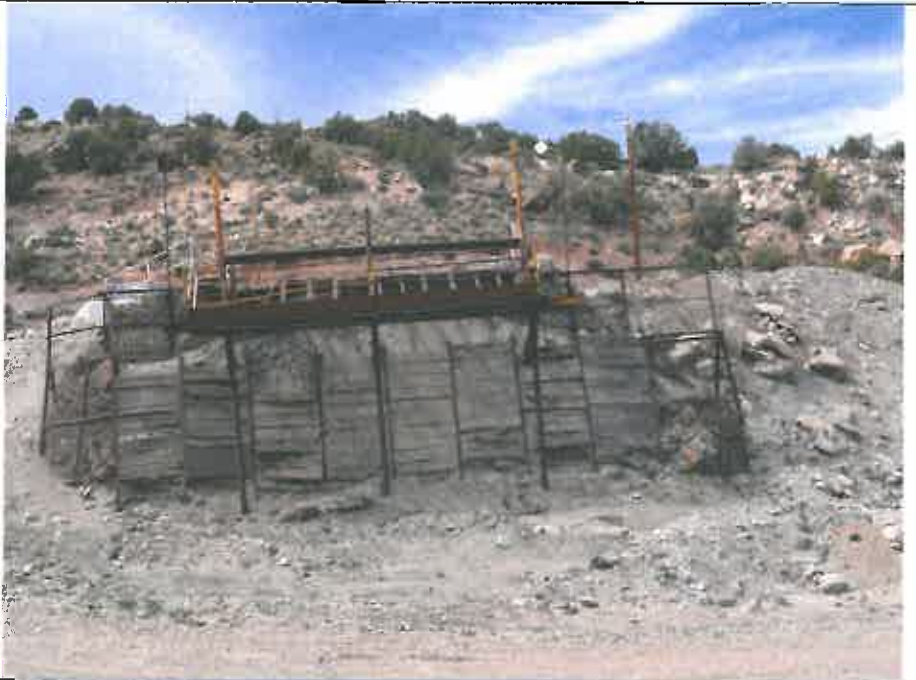
Scrap Iron at the Sunday Mine  
scale (before).

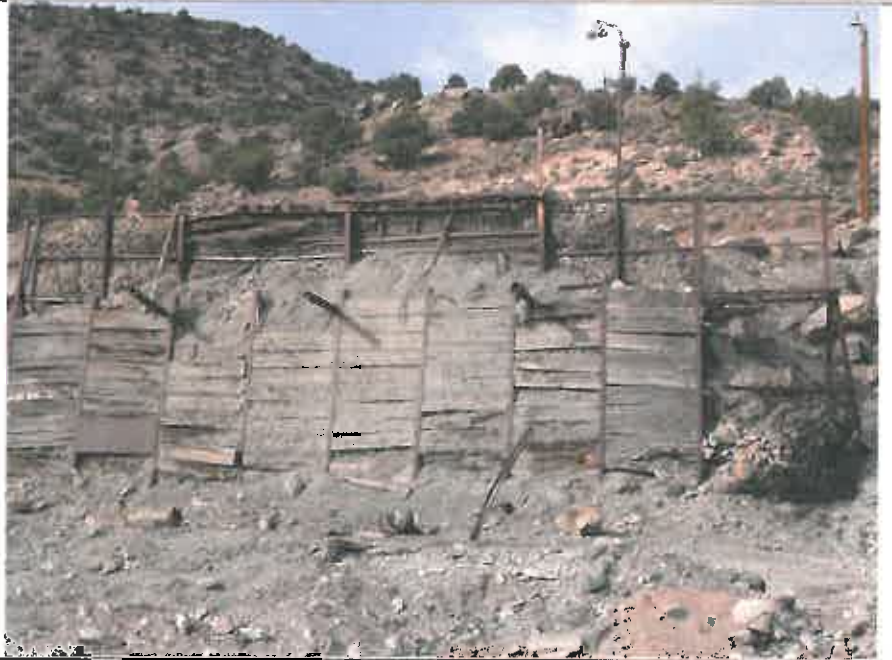
Scrap Iron at the Sunday Mine  
scale (after).

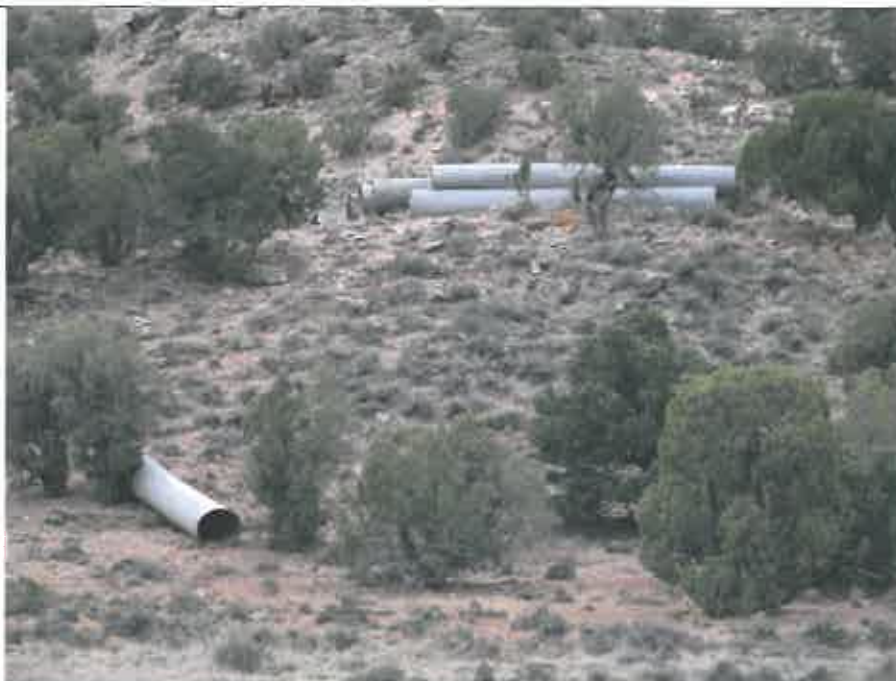
**Metal culverts north of the  
Sunday Mine (before).**

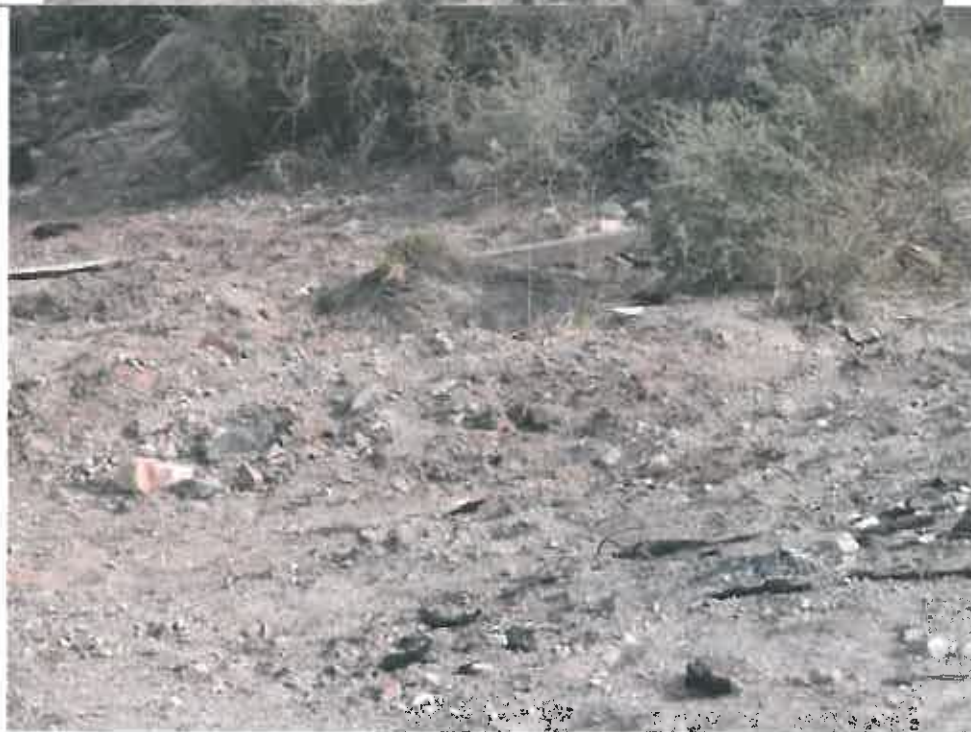
**Metal culverts north of the  
Sunday Mine (after).**

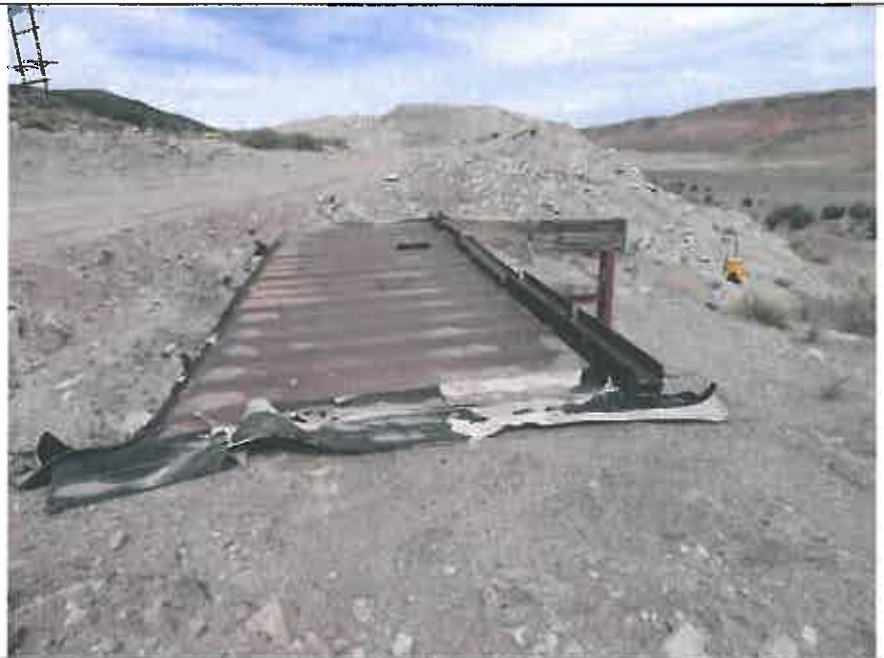
Scale at the Sunday Mine  
(before).

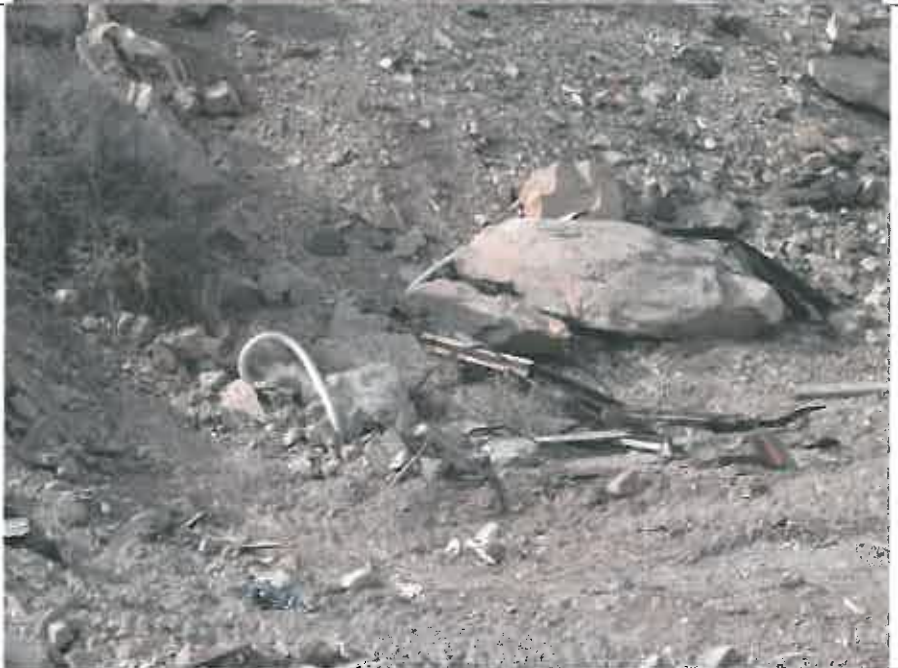
Scale at the Sunday Mine  
(after).

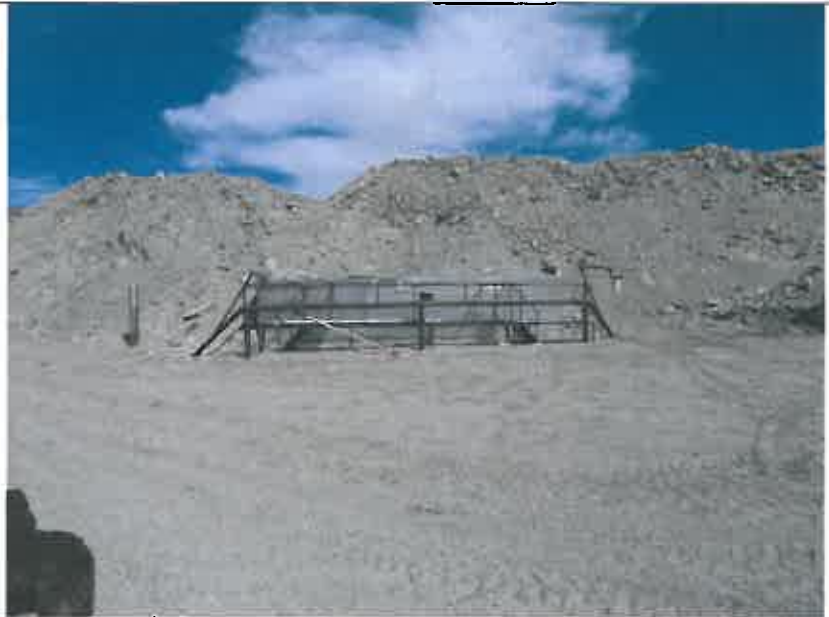
Scrap iron near the Sunday  
Mine east entrance (before).

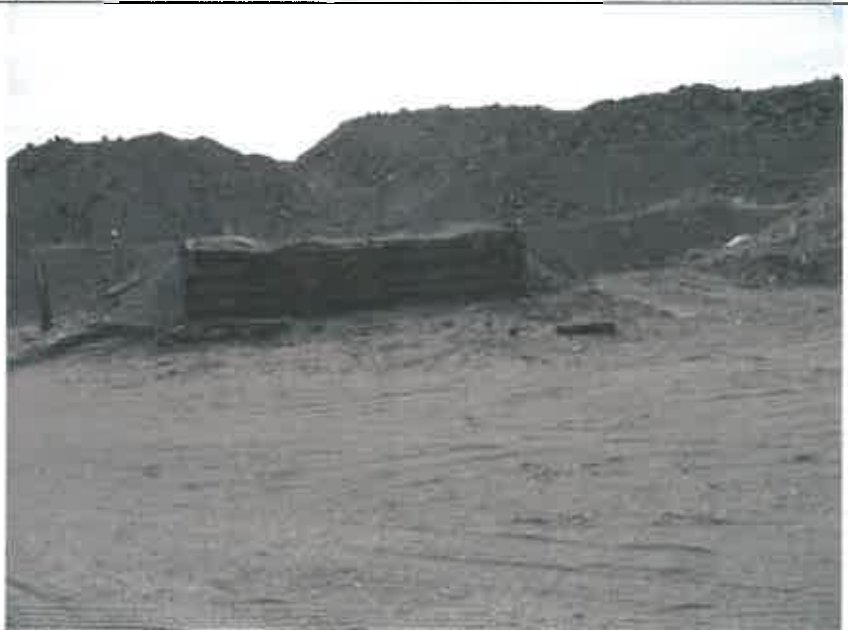
Scrap iron removed near the  
Sunday Mine east entrance  
(after).
