COLORADO DIVISION OF RECLAMATION, MINING AND SAFETY
MINERALS PROGRAM INSPECTION REPORT
PHONE: (303) 866-3567

MINE NAME: Hocker Gravel Pit	MINE/PROSPECTING ID#: M-2004-063	MINERAL: Sand and gravel	COUNTY: La Plata
INSPECTION TYPE: Monitoring	INSPECTOR(S): Kate A. Pickford	INSP. DATE: May 16, 2012	INSP. TIME: 13:45
OPERATOR: Hocker Construction, LLP	OPERATOR REPRESENTATIVE: Rocky Hocker & Glenda Hocker	TYPE OF OPERATION: 112c - Construction Regular Operation

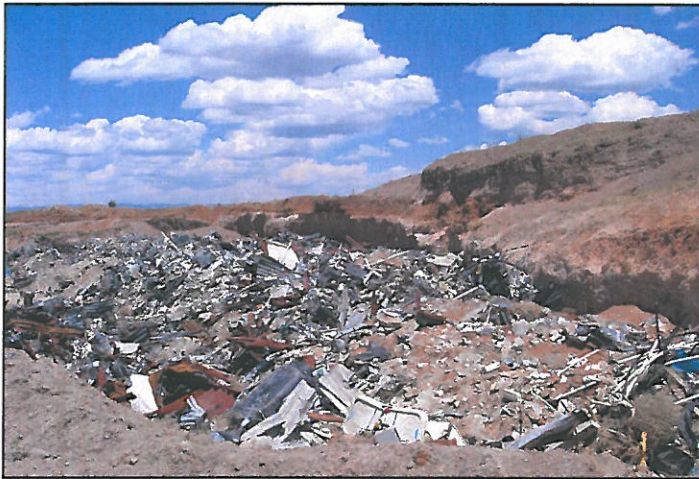
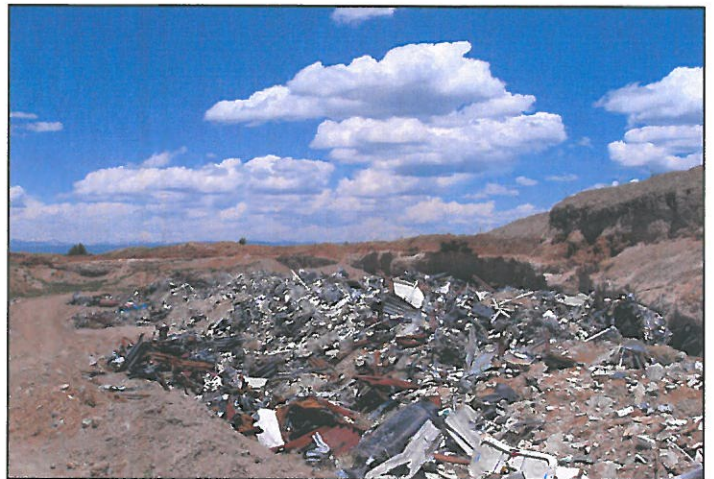
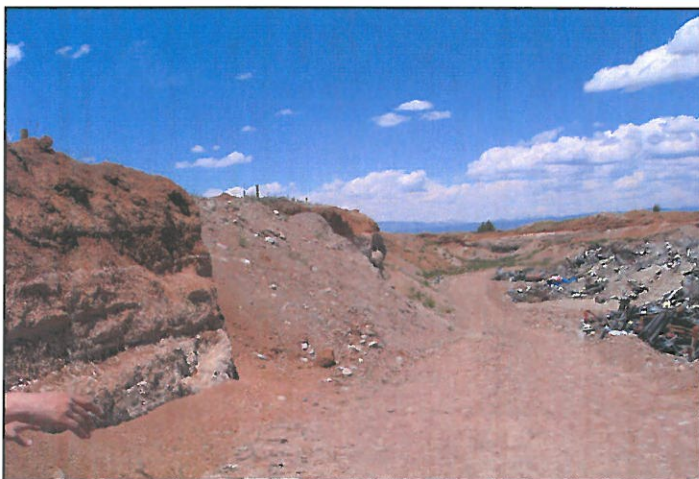
PHOTOGRAPHS

The area of the site where the materials from the demolished casino were placed was observed during this inspection. They have been used as fill for a portion of the pit that is to be backfilled. The material is located adjacent to a road within the pit boundaries that lies about 10 feet below the adjacent ground surface. Mr. Hocker stated that overburden will be used to cover the debris and the current road and bring the surface elevation to the same level as the adjacent land.

On August 9, 2011, the Division received a Technical Revision request from Hocker Construction, LLP, indicating that construction materials would be used as backfill in a portion of this pit. The operator submitted the required certification that the fill consisted of inert material, and the request was approved by the Division on August 18, 2011. The fill at the site appears to be an accurate representation of that described in the approved Technical Revision.

The Division believes that the construction material at the site is inert and is not out of compliance with the parameters of the current permit. The Division found no possible violations at the site.
