COLORADO DIVISION OF RECLAMATION, MINING AND SAFETY
MINERALS PROGRAM INSPECTION REPORT
PHONE: (303) 866-3567

MINE NAME: Ignacio Pit	MINE/PROSPECTING ID#: M-1977-446	MINERAL: Sand and gravel	COUNTY: La Plata
INSPECTION TYPE: Monitoring	INSPECTOR(S): Kate A. Pickford	INSP. DATE: May 16, 2012	INSP. TIME: 14:00
OPERATOR: Hocker Construction, LLP	OPERATOR REPRESENTATIVE: Roy Hocker, Rocky Hocker, & Glenda Hocker	TYPE OF OPERATION: 112c - Construction Regular Operation

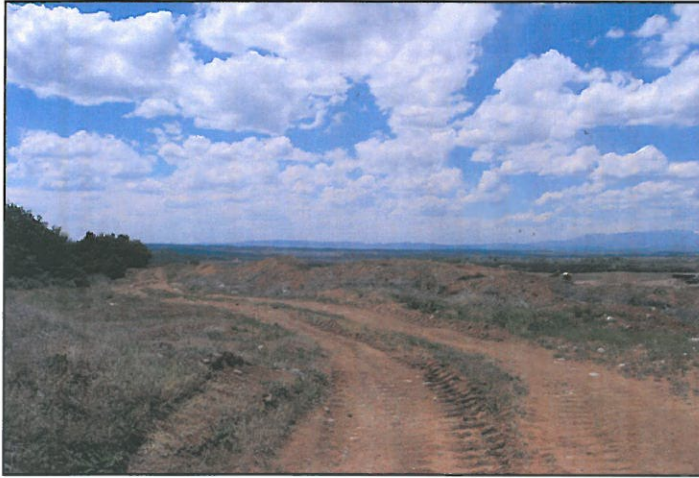
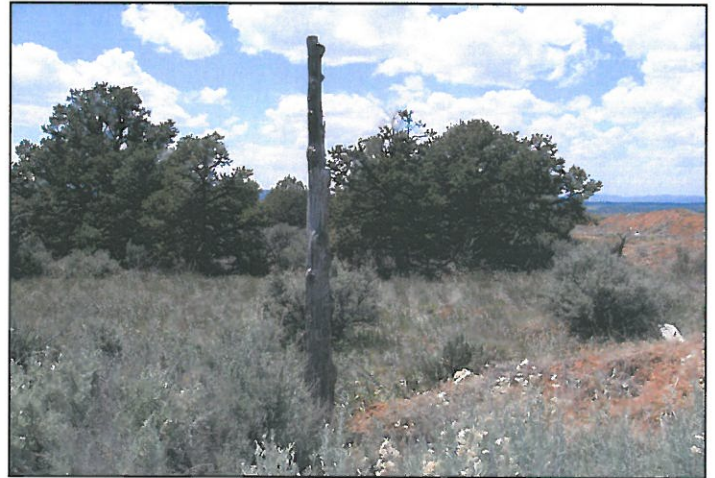
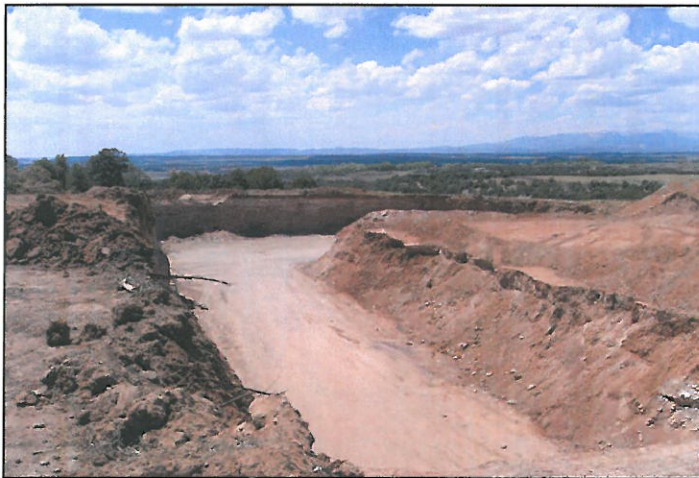
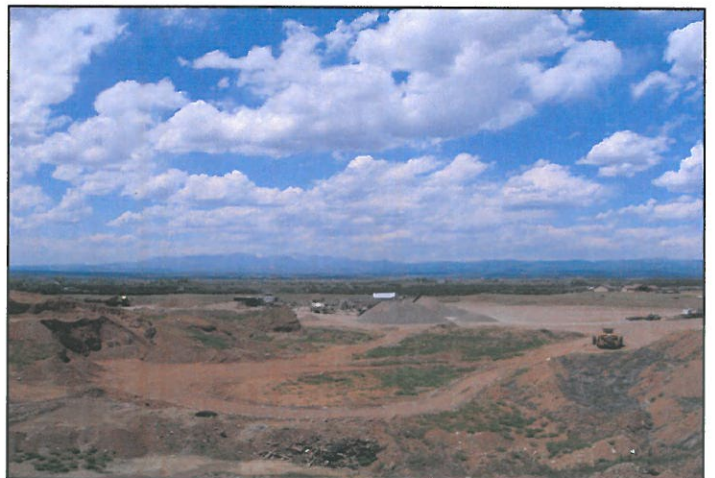
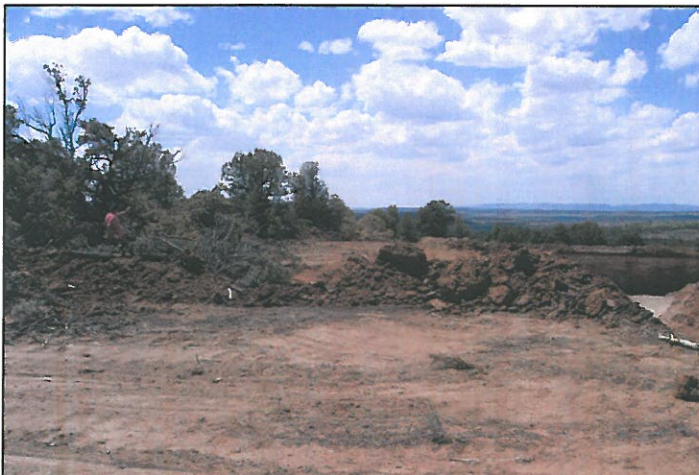
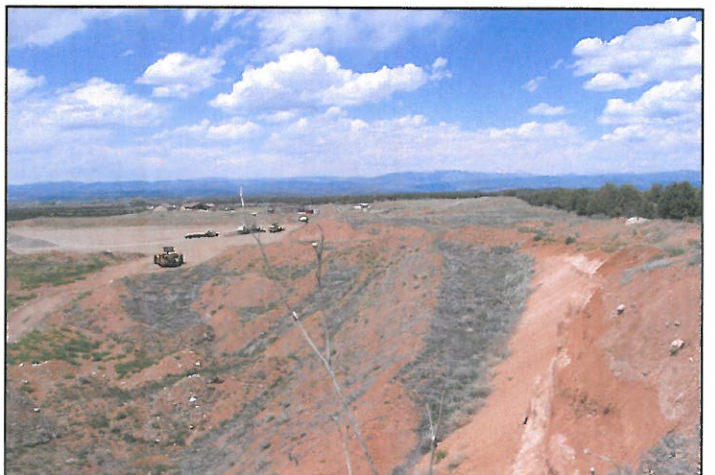
PHOTOGRAPHS

During this inspection, the permit boundary was walked along the south edge of the permit. According to Mr. Hocker, the fence line is not a representation of the property boundary or the permit boundary, but is offset to the north anywhere from 15 to 20 feet. Information in the permit does not conflict with this information. The new mining activity at the site along the southwest boundary is evident and has cut into the access road, but the activity does not appear to be closer than 30 feet of the actual line along any of the southern boundary.

The Division does not find any possible violations of the active permit held by Hocker Construction, LLP for this site. There is a conflict, however, between information contained in the permit and the activity at the site. The original mining plan indicates that the access road that has been mined into will not be mined. Therefore the operator must revise the permit to indicate that this road will be mined into. If the setbacks are to be changed to less than 30 feet, this too will need to be included as a revision to the permit and adequate geotechnical stability analysis submitted to the Division for review to show that there is no risk of offsite damage due to the abbreviated setbacks. Alternatively, the operator may submit an amendment application to the Division, adding the adjacent parcel to the permit. The operator has mentioned the intention of amending the parcel south of the current permit into this permit on numerous occasions in the past, and is reminded that it will be necessary to do so prior to mining in that parcel, in order to stay in compliance with the permit.

CORRECTIVE ACTIONS: The operator shall submit a Technical Revision, with the required \$216 revision fee, to update and clarify the current approved mine plan to reflect existing and proposed activities by the corrective action date. Alternatively, the inadequacies present at the site can be addressed through an amendment to the application adding the parcel to the south of the current permit to the permit. The necessary fee of \$2,229.00 will be required at the time of submittal of the application of this option is taken.
