**COLORADO DIVISION OF RECLAMATION, MINING AND SAFETY**  
**MINERALS PROGRAM INSPECTION REPORT**  
**PHONE: (303) 866-3567**

<b>MINE NAME:</b> Buster Moss Rock	<b>MINE/PROSPECTING ID#:</b> M-2012-018	<b>MINERAL:</b> STN	<b>COUNTY:</b> Boulder
<b>INSPECTION TYPE:</b> Illegal(Unpermitted Operation)	<b>INSPECTOR(S):</b> Michael A. Cunningham	<b>INSP. DATE:</b> May 15, 2012	<b>INSP. TIME:</b> 09:00
<b>OPERATOR:</b> Bernard Buster & Brenda Buster	<b>OPERATOR REPRESENTATIVE:</b> Bernard Buster, Brenda Buster	<b>TYPE OF OPERATION:</b> ILL - Illegal

# Buster Moss Rock (M-2012-018)

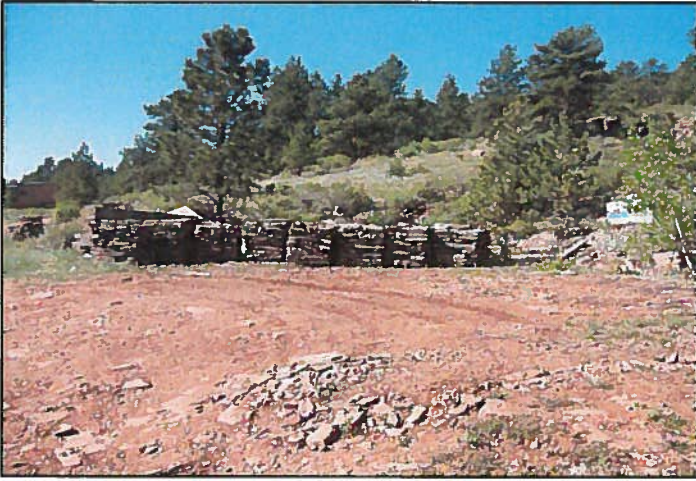
1. Storage Area, facing southwest.

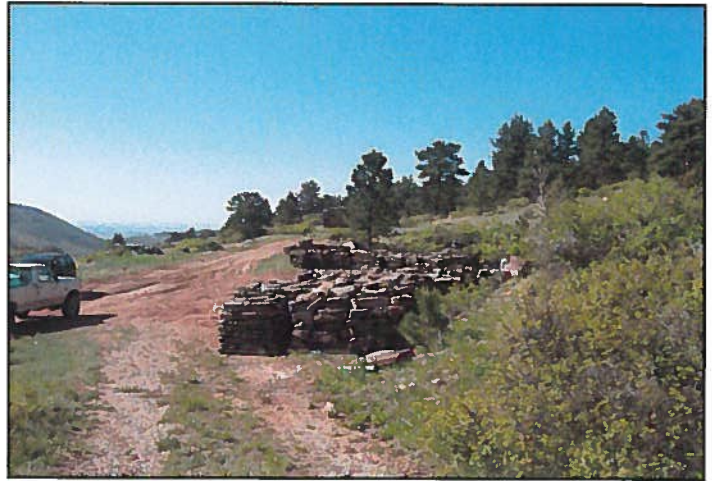
2. Storage area, facing south.

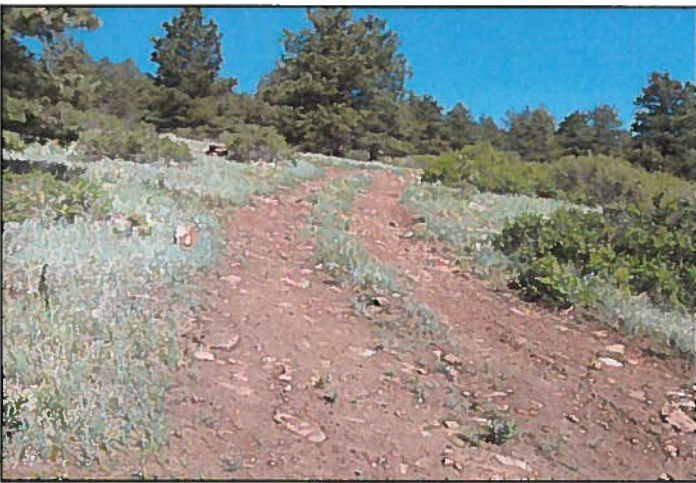
3. Haul road, facing west.

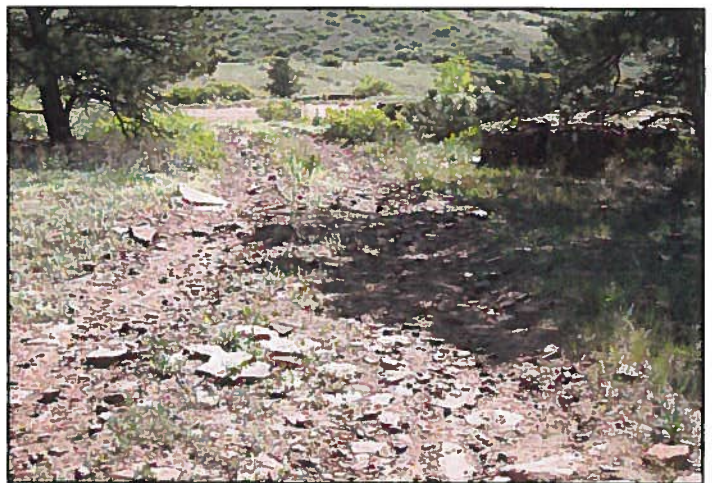
4. Haul road, facing east.

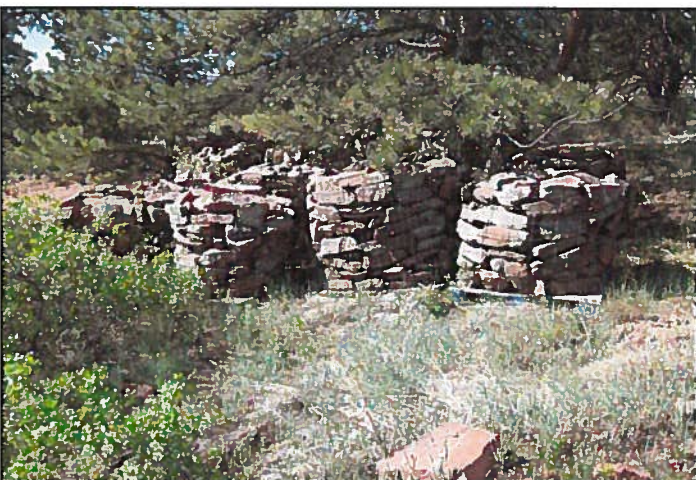
5. Stone on side of haul road.

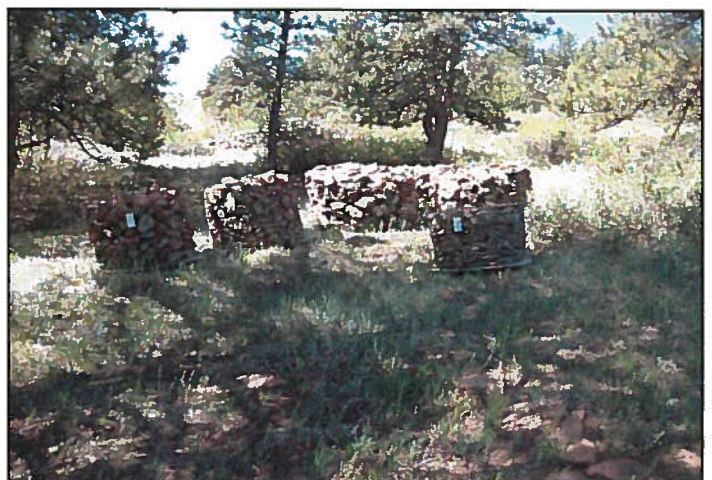
6. Stone on side of haul road.
