COLORADO DIVISION OF RECLAMATION, MINING AND SAFETY
MINERALS PROGRAM INSPECTION REPORT
PHONE: (303) 866-3567

MINE NAME: May Day Idaho Mine Complex	MINE/PROSPECTING ID#: M-1981-185	COMMODITY: Gold and silver	COUNTY: La Plata
INSPECTION TYPE: Monitoring	INSPECTOR(S): Dustin Czapla	INSP. DATE: June 7, 2012	INSP. TIME: 08:30
OPERATOR: Wildcat Mining Corporation	OPERATOR REPRESENTATIVE: Randy Oser	TYPE OF OPERATION: 112d-1 – Designated Mining Operation	
REASON FOR INSPECTION: Monitoring	BOND CALCULATION TYPE: None	BOND AMOUNT: \$ 204,562	
DATE OF COMPLAINT: June 1, 2012	POST INSP. CONTACTS: None	JOINT INSPECTION AGENCY: None	
WEATHER: Clear	INSPECTOR'S SIGNATURE:

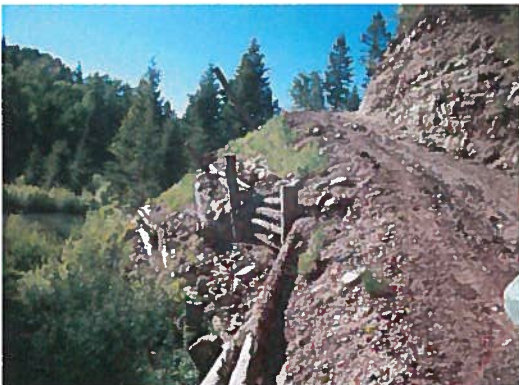
During this inspection, it appeared that the new access road was not being utilized for vehicular access to the site.

Figure 1: New access road

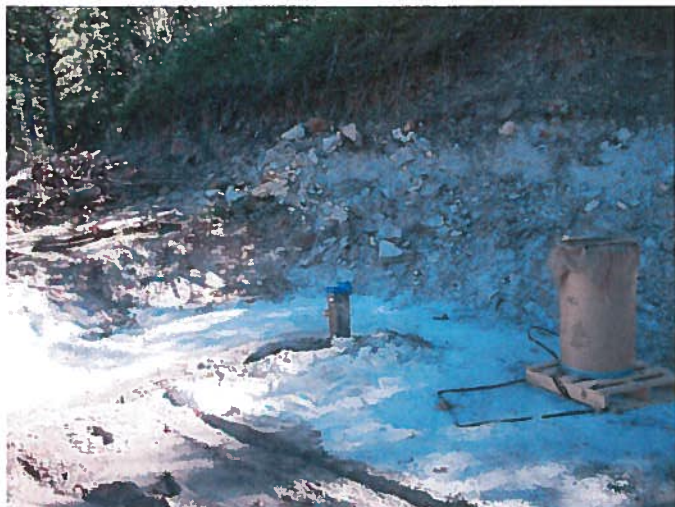
A ground water monitoring well had been installed in this area. Stabilization of the highwall above the collapsed portal was occurring during this inspection. The access road to this area had been graded and stormwater controls installed.

Figure 2: May Day 1 groundwater monitoring well

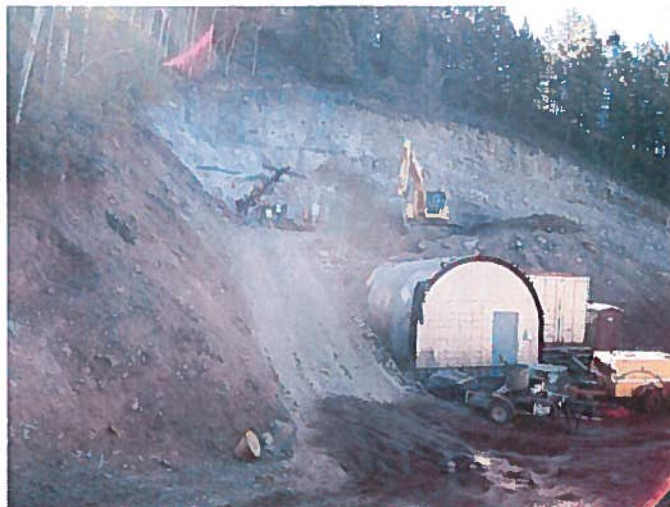
Figure 3: May Day 1 highwall stabilization

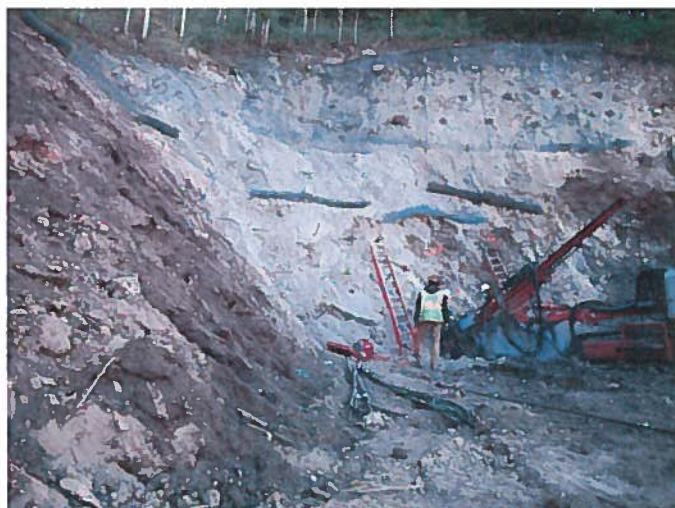
Figure 4: May Day 1 highwall stabilization

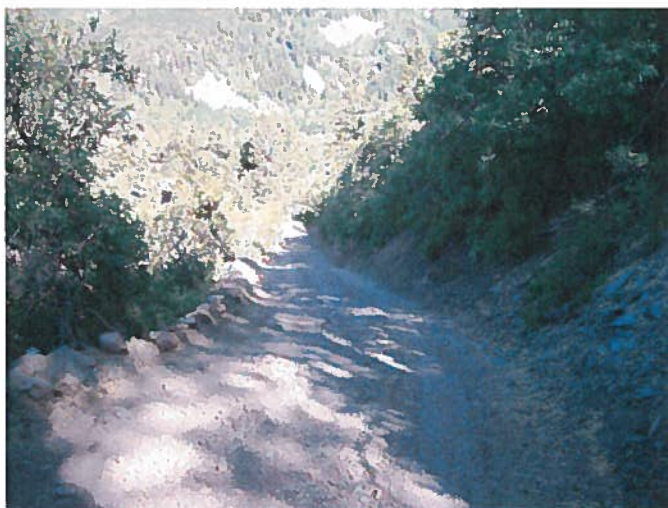
Figure 5: May Day 1 access road

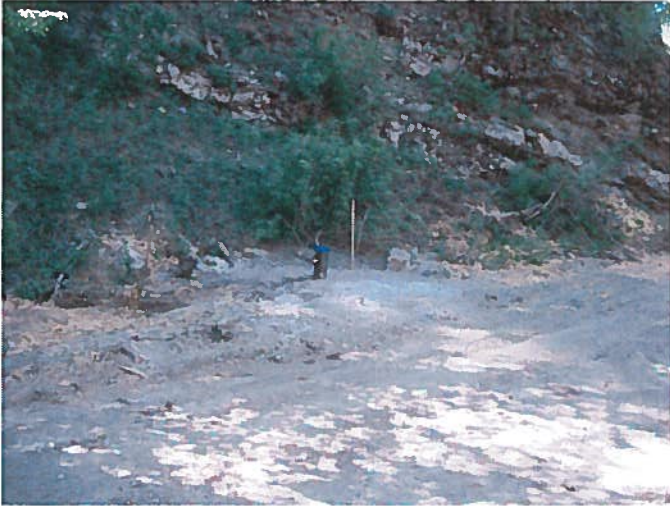
A groundwater monitoring well had been installed on the east side of the access road in this area. Rock from an historical dump pile, located on the west side of the access road, had been removed and used to resurface portions of the access roads, as was approved by the Division on February 10, 2012. Little Deadwood Gulch was dry during this inspection.

Figure 6: May Day 2 groundwater monitoring well

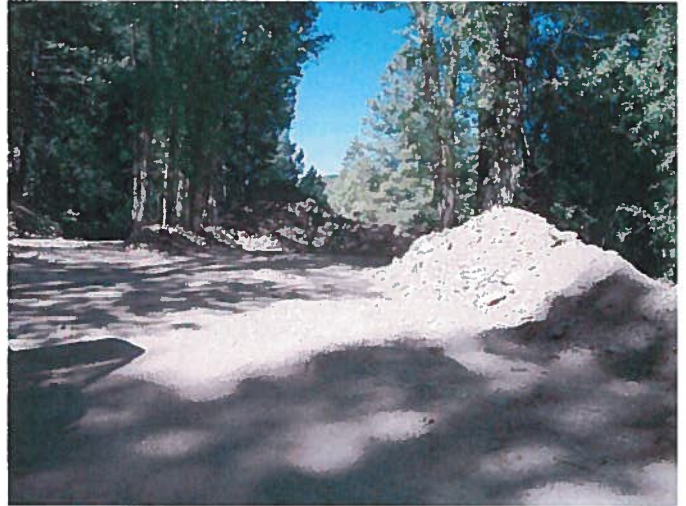
Figure 7: Location of rock pile

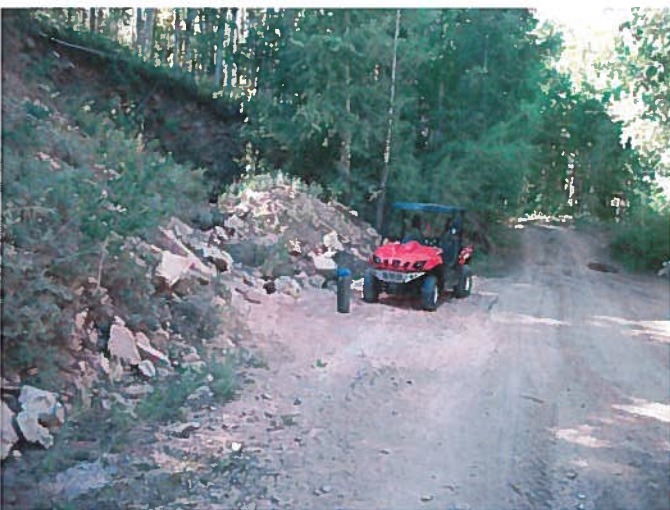
A groundwater monitoring well had been installed at this location, southwest of the building on the east side of the access road. A drill rig was parked in this area, southwest of the building on the west side of the access road. Overall, the area seemed orderly. The access road to this area had been graded with stormwater controls installed.

Figure 8: Idaho groundwater monitoring well

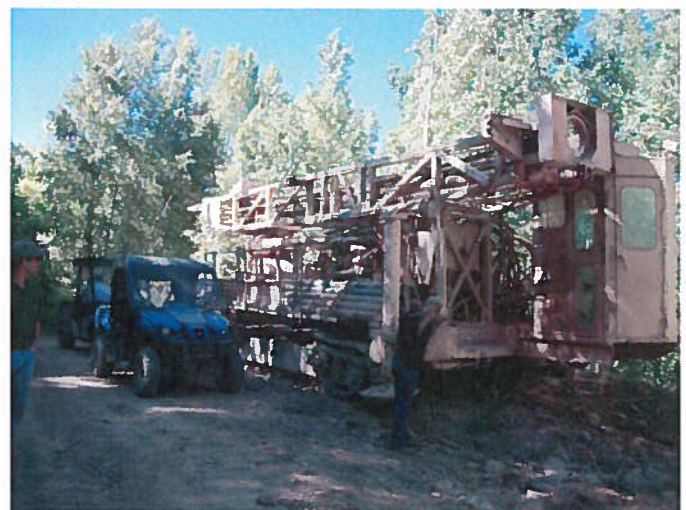
Figure 9: Drill rig located in Idaho area

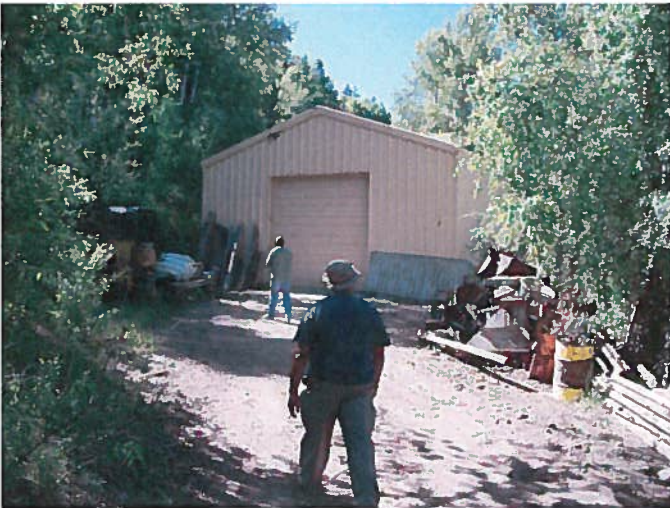
Figure 10: Building in Idaho area

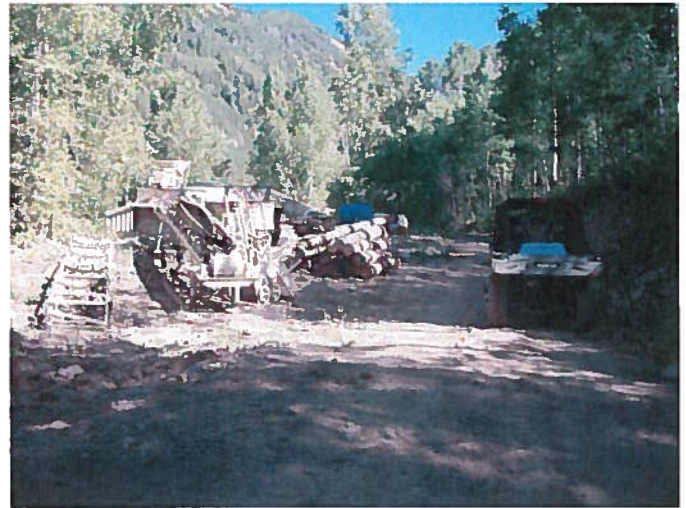
Figure 11: Area on southwest side of building
