**COLORADO DIVISION OF RECLAMATION, MINING AND SAFETY**  
**MINERALS PROGRAM INSPECTION REPORT**  
**PHONE: (303) 866-3567**

| <b>MINE NAME:</b><br>Snyder Quarry | <b>MINE/PROSPECTING ID#:</b><br>M-1977-210 | <b>MINERAL:</b><br>Limestone (general) | <b>COUNTY:</b><br>El Paso |
| <b>INSPECTION TYPE:</b><br>Monitoring | <b>INSPECTOR(S):</b><br>Berhan Keffelew /Tom Kaldenbach | <b>INSP. DATE:</b><br>June 5, 2012 | <b>INSP. TIME:</b><br>13:00 |

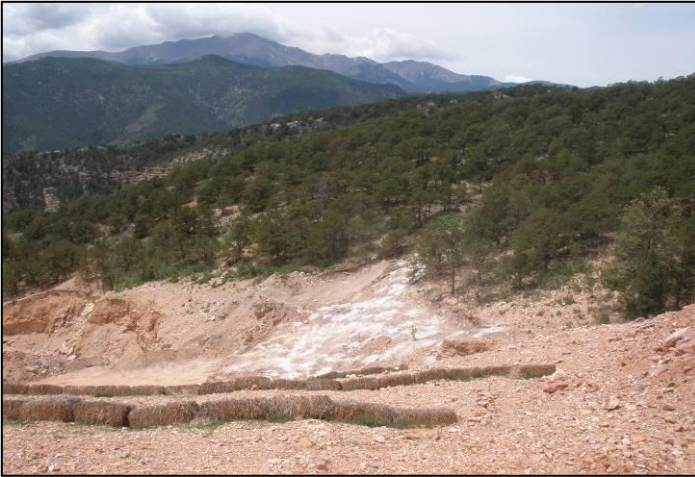
Figure 1 Looking south at area AP, where blast shot will occur.

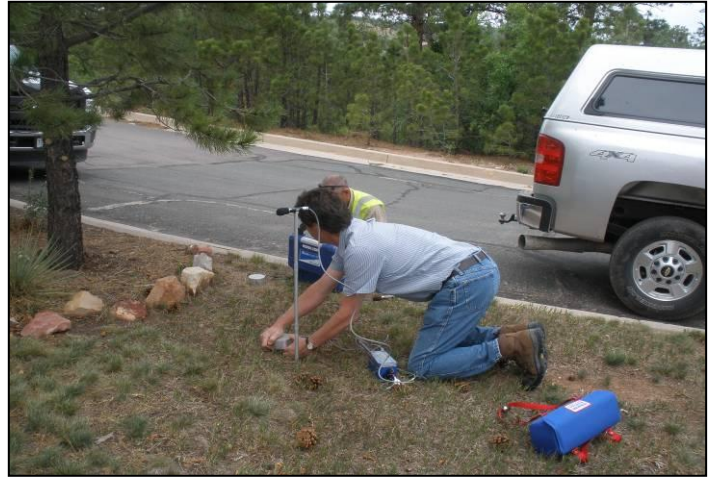
Figure 1 setting up blast monitors by DRMS & Buckley explosives @4515 Monitor Rock DR.

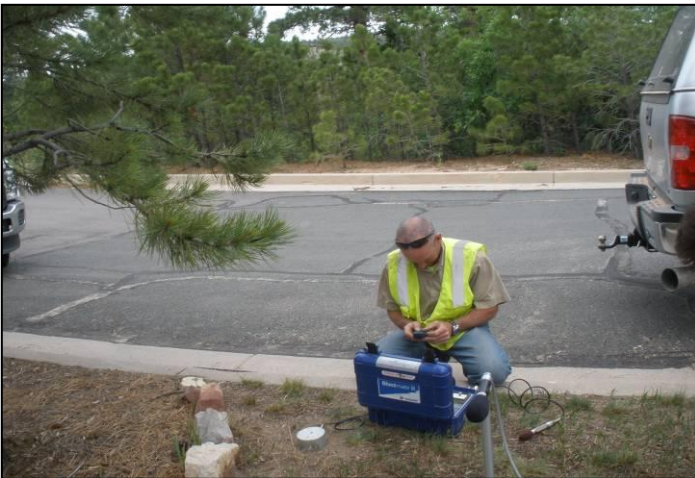
Figure 3 Randy Morris of Buckley explosives (operator's consultant) setting up the blast monitor prior to blast.
