COLORADO DIVISION OF RECLAMATION, MINING AND SAFETY
MINERALS PROGRAM INSPECTION REPORT
PHONE: (303) 866-3567

MINE NAME: Dotsero Cinder Pit	MINE/PROSPECTING ID#: M-1979-155	MINERAL: Volcanic materials	COUNTY: Eagle
INSPECTION TYPE: Monitoring	INSPECTOR(S): Dustin Czapla	INSP. DATE: June 5, 2012	INSP. TIME: 13:00
OPERATOR: Colorado Division of Highways	OPERATOR REPRESENTATIVE: Kane Schneider	TYPE OF OPERATION: 110c - Construction Limited Impact

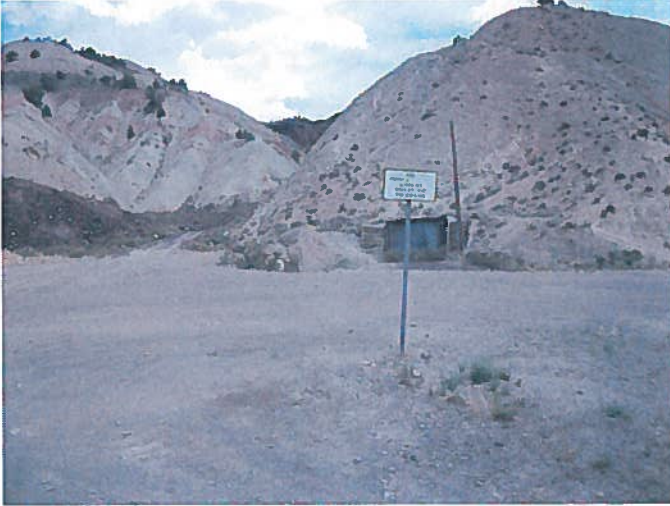
Figure 1: View facing north of the lower stockpile area.

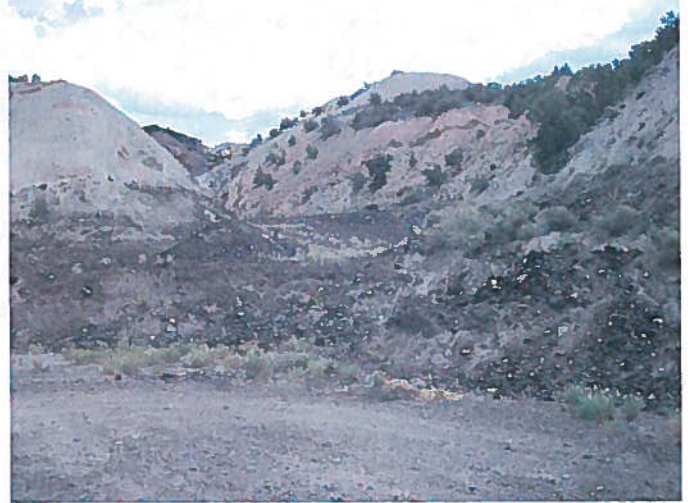
Figure 2: View facing north from the lower stockpile area.

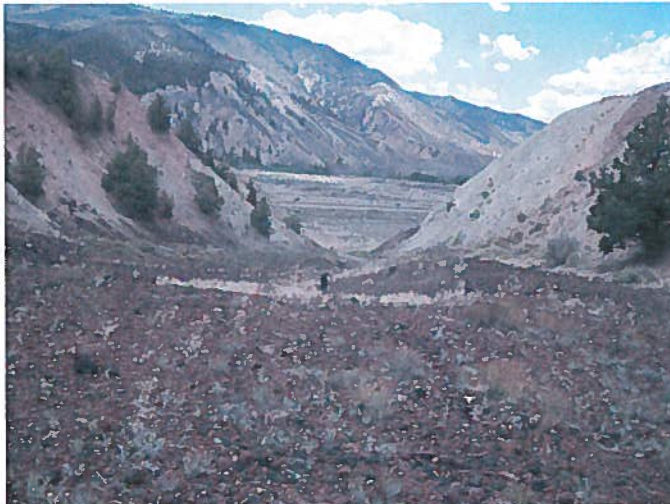
Figure 3: View facing south toward the lower stockpile area.

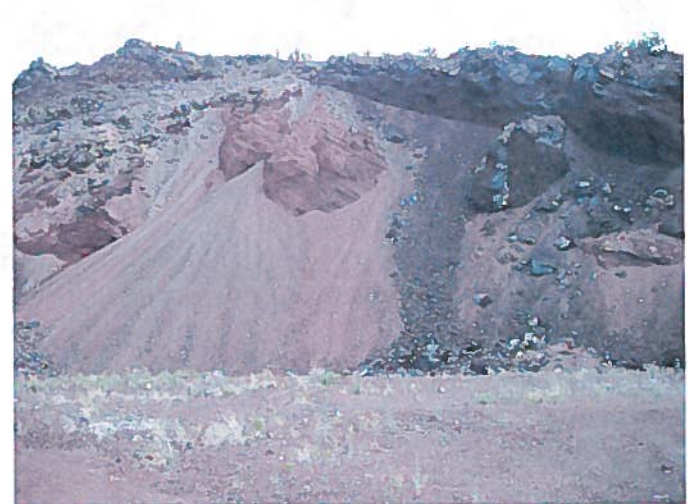
The highwall located in the upper pit area was steep, with slopes ranging from approximately 1H:1V to near vertical. The upper portions appeared potentially unstable. Several large rockfall areas were observed on this highwall. Several areas of trash were observed throughout the pit-floor area, which appeared to be from public use of the area. Noxious weeds were not observed at the site.

Figure 4: View toward the upper pit area highwall.

As stated in the Division's August, 2009 inspection report, reclamation is encouraged if there are no plans for future mining at this site.

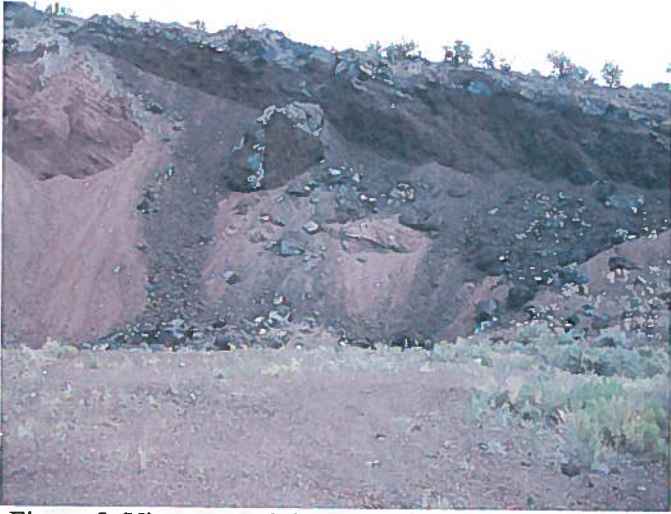
Figure 5: View toward the upper pit area highwall.

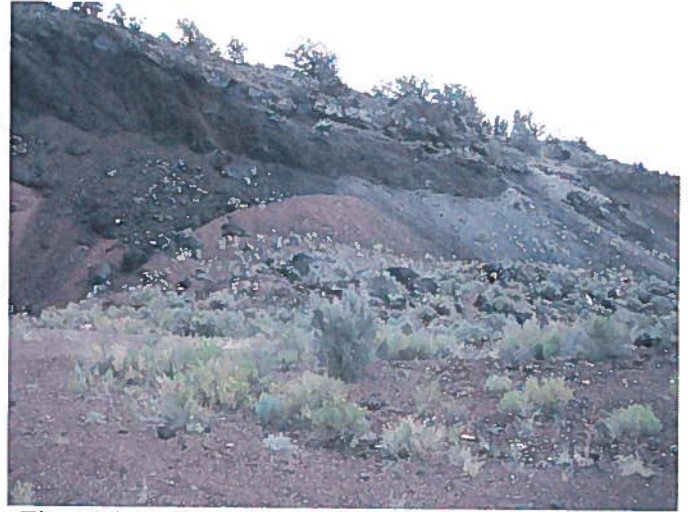
Figure 6: View toward the upper pit area highwall.

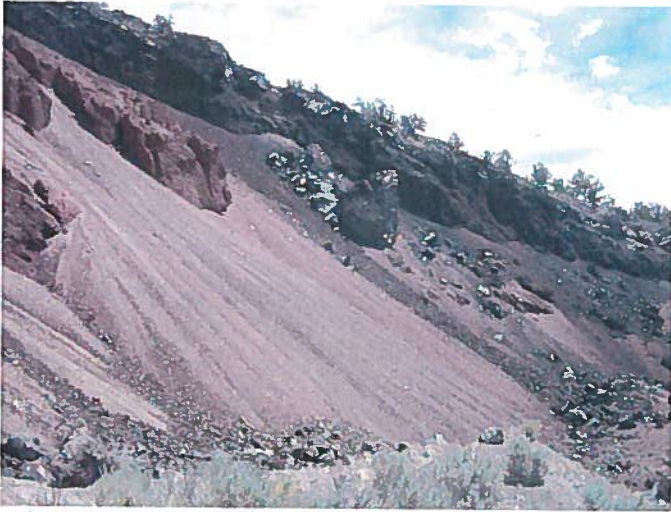
Figure 7: View toward the upper pit area highwall.

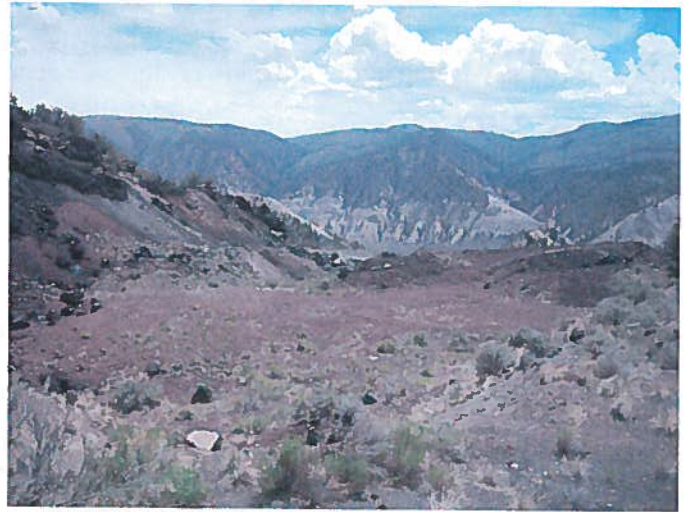
Figure 8: View facing south towards the entrance to the upper pit area.
