COLORADO DIVISION OF RECLAMATION, MINING AND SAFETY
MINERALS PROGRAM INSPECTION REPORT
PHONE: (303) 866-3567

MINE NAME: Dotsero Quarry	MINE/PROSPECTING ID#: M-1987-074	MINERAL: Volcanic materials	COUNTY: Eagle
INSPECTION TYPE: Monitoring	INSPECTOR(S): Dustin M. Czapla	INSP. DATE: June 5, 2012	INSP. TIME: 14:00
OPERATOR: Mayne Block & Stone Company	OPERATOR REPRESENTATIVE: None	TYPE OF OPERATION: 112c - Construction Regular Operation

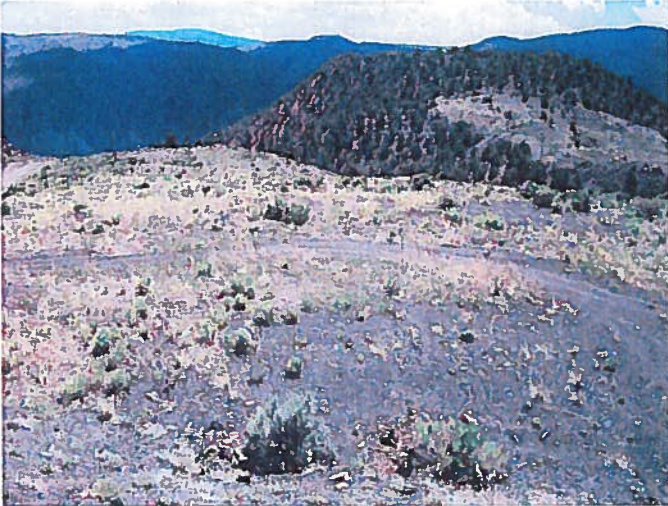
Mining was not occurring during this inspection. Vegetation is becoming well established in the reclaimed southern portion of the permit area. Several pieces of equipment were located in the quarry area. Mined slopes around the quarry appeared to be approximately 1H:1V on average.

Figure 1: View from quarry area, facing south towards reclaimed area.

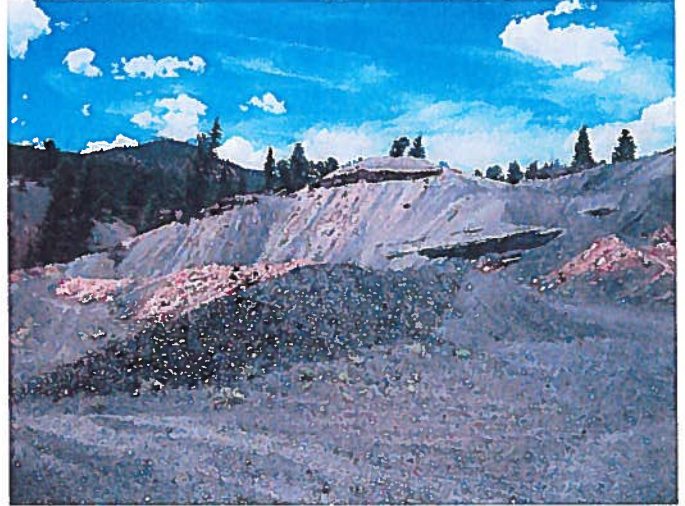
Figure 2: View facing north towards highwall.

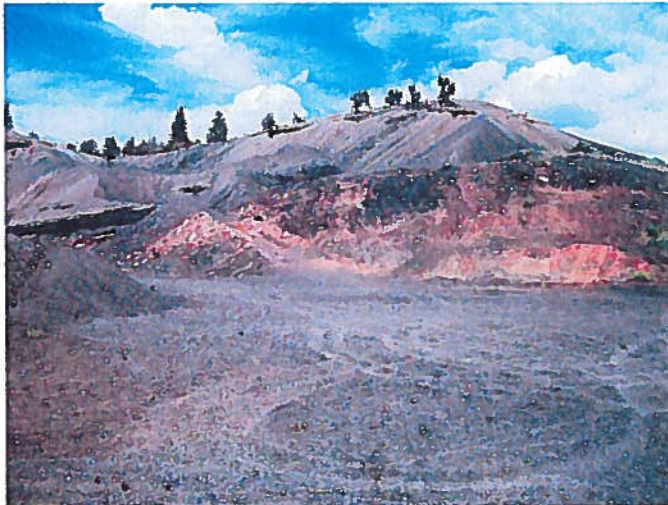
Figure 3: View facing north towards highwall.

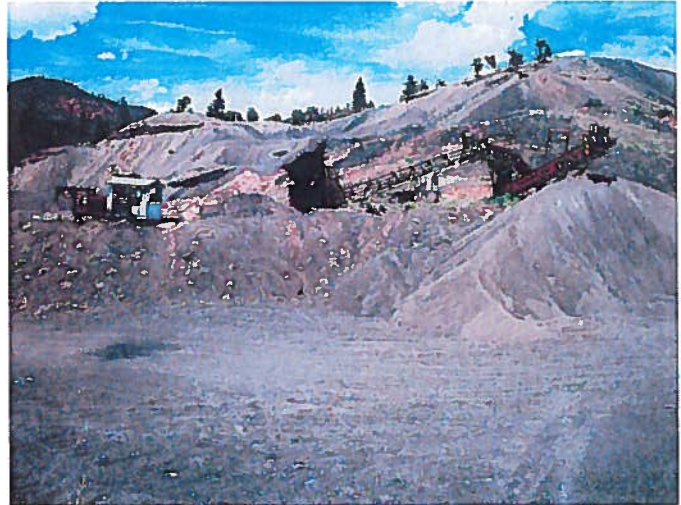
Figure 4: View facing north towards mine area.
