COLORADO DIVISION OF RECLAMATION, MINING AND SAFETY
MINERALS PROGRAM INSPECTION REPORT
PHONE: (303) 866-3567

MINE NAME: Bulldog Mine Operation	MINE/PROSPECTING ID#: M-1977-215	MINERAL: Lead and silver	COUNTY: Mineral
INSPECTION TYPE: Monitoring	INSPECTOR(S): Bob Oswald	INSP. DATE: May 24, 2012	INSP. TIME: 13:30
OPERATOR: Emerald Mining & Leasing, LLC	OPERATOR REPRESENTATIVE: Randy McClure	TYPE OF OPERATION: 112 - Hard Rock Regular Operation

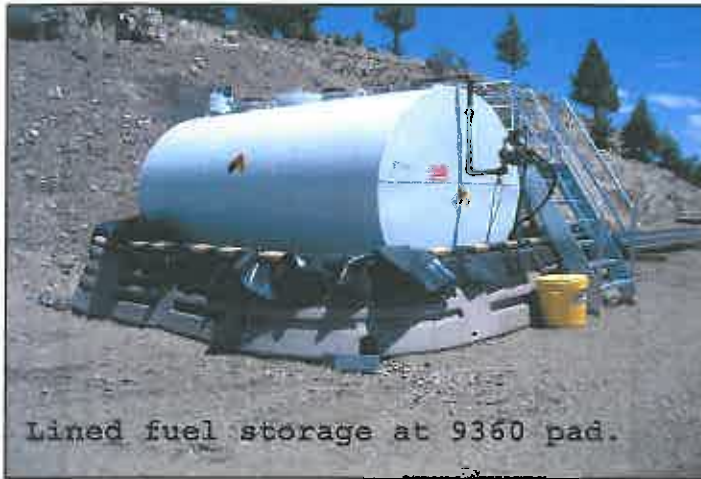
Lined fuel storage at 9360 pad.

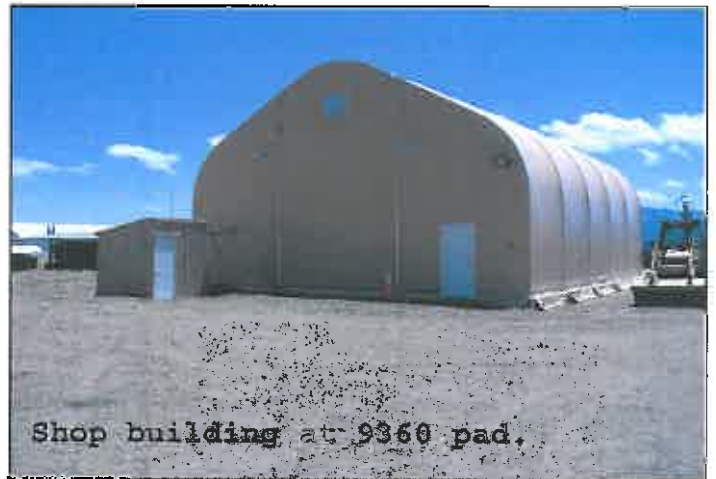
Shop building at 9360 pad.

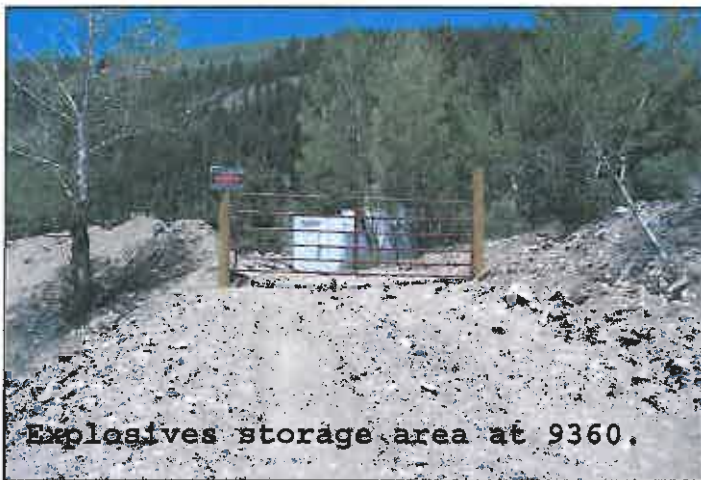
Explosives storage area at 9360.

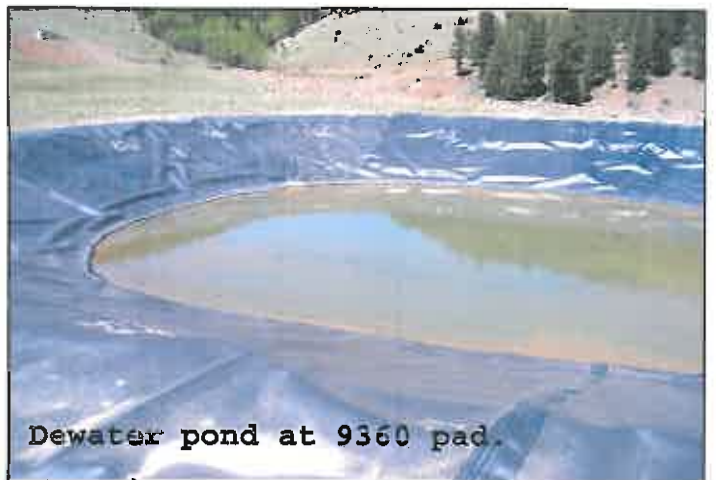
The dewater pond is lined with 80-mil roughened LDPE, with double welded seams. Construction and testing were performed by a specialized contractor. The pond berming which rises above surrounding grade by 3-4 feet, per the approved plan, is composed of dump materials removed from the excavated depression. The pond includes a riprapped spillway, which routes water via swale toward the north end of the 9360 pad. The pond contains about one foot or less of water, all of it being snowmelt from winter. The operator should prepare and submit photos of the pond installation (if available), construction certifications and as-built drawings, plus liner installation and liner testing results to the Division.

Dewater pond at 9360 pad.

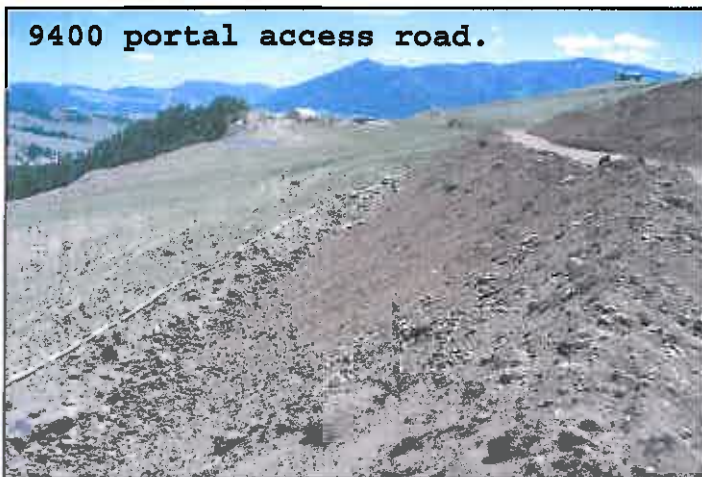
The new access road ramping up to the portal from the 9360 pad has been cut and construction appears complete. It includes cut slope shaping (at 1.5:1 max), drainage controls, safety berm, and gravel surfacing. The outslope below the road appears stable presently. The cut slope and fill slope are covered with the local soil and will be seeded in 2012.

9400 portal access road.

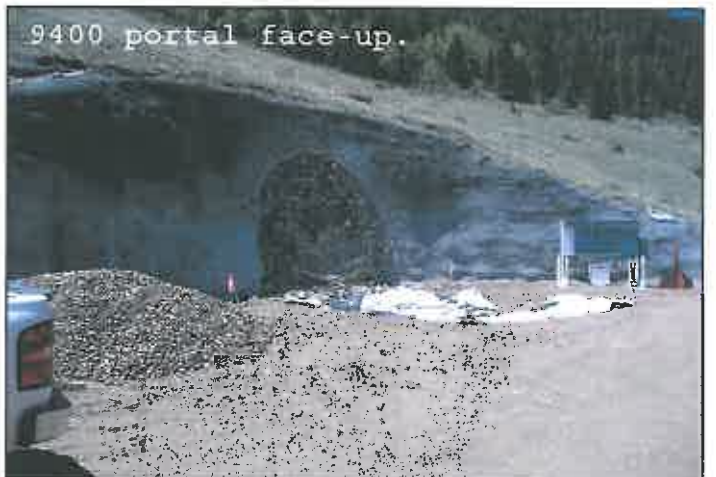
The hillside cut for the new 9400 portal face-up has largely been defined and completed. The cut material has been placed as fill for the beginning of the 9400 pad. Topsoil is being segregated for later use in reclamation. As construction for driving the decline proceeds, additional material will be placed in the proper location and manner to expand the portal bench. The portal face-up has been constructed as approved, with 30-foot soil nails, pressure grouting, heavy wire mesh and shotcrete. The outline of the portal has been defined and concrete cutting has begun. Footers are being set into the bench to support the 14x15 ft arched steel sets for the decline. Steel sets will be installed every four feet as the decline is driven. The construction contractor and his equipment are being mobilized on the site. The upper margins of the concrete extend slightly above surrounding grade, and drainage controls have been installed to divert water away from the face and the pad to improve stability. Temporary electrical panel has been installed on the pad near the portal location, but the temporary overhead electric line has not been extended down to the portal yet.

9400 portal face-up.
