COLORADO DIVISION OF RECLAMATION, MINING AND SAFETY
MINERALS PROGRAM INSPECTION REPORT
PHONE: (303) 866-3567

MINE NAME: Jolly Pit	MINE/PROSPECTING ID#: M-2012-010	MINERAL: Borrow material for	COUNTY: Las Animas
INSPECTION TYPE: Preoperation Inspection	INSPECTOR(S): T C. Wait	INSP. DATE: June 18, 2012	INSP. TIME: 12:20
OPERATOR: Las Animas County	OPERATOR REPRESENTATIVE: Phil Dorenkamp	TYPE OF OPERATION: 112c - Construction Regular Operation

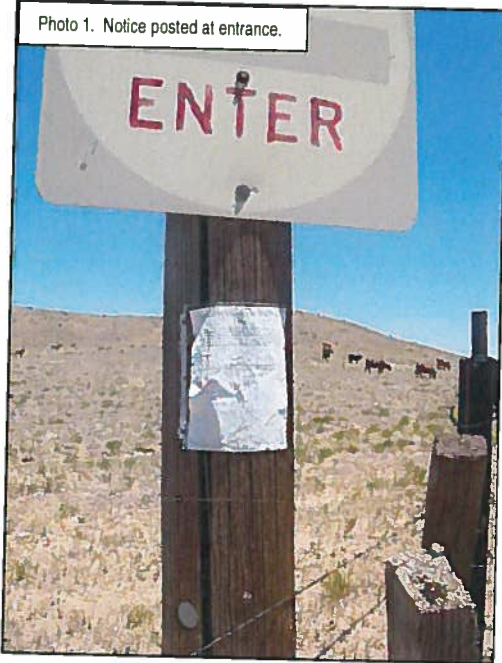
The required public notice per Rule 1.6.2(b) was observed at the access point on a fence post just off the main road. The access road consists of old ranch roads. Some stretches will need improvement to accommodate the mine traffic. No major improvements to the road are anticipated other than occasional grading.

Photo 1. Notice posted at entrance.

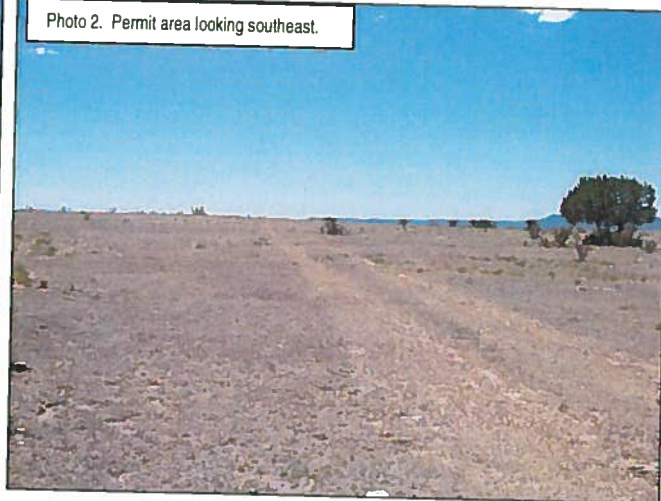
The permit area is not currently marked. The permit boundary coincides with the topography of the hill top where mine operations will occur. Mr. Dorenkamp estimates 15-25 feet of material will be removed from the top of the hill. **The operator will need to clearly mark permit boundaries prior to operations to ensure no off-site disturbances occur.**

Photo 2. Permit area looking southeast.

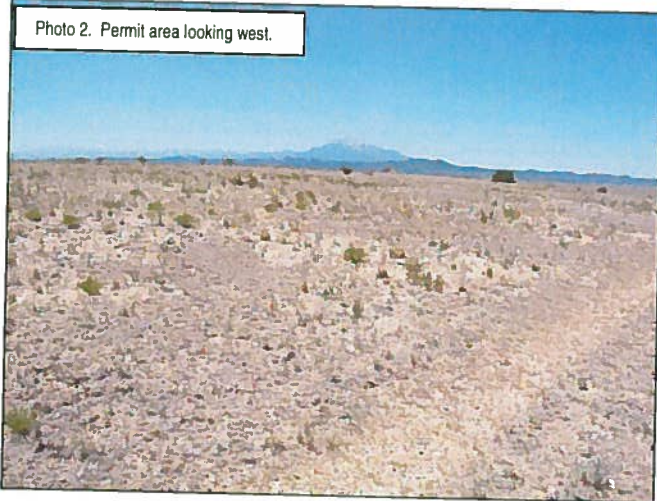
Photo 2. Permit area looking west.

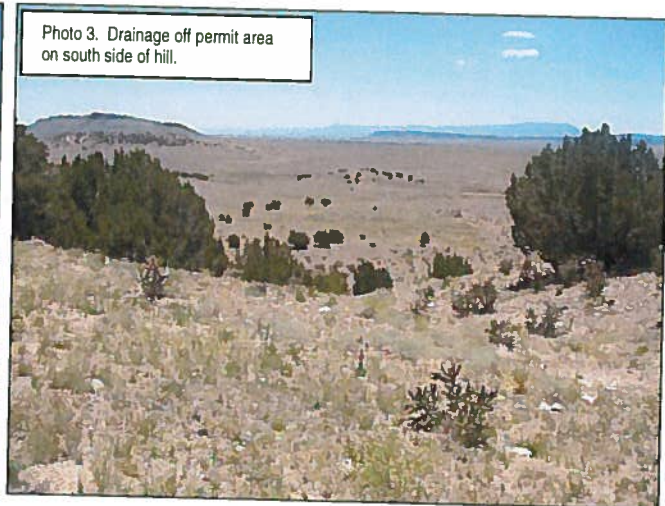
There are existing dry runoff channels extending down the sides of the hill below the permit boundary. The Operator will need to ensure that increased erosion does not occur beyond boundary limits during operations.

Photo 3. Drainage off permit area on south side of hill.

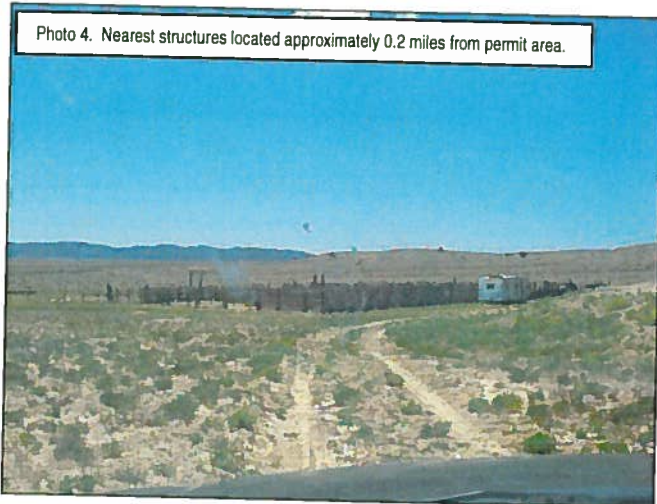
Photo 4. Nearest structures located approximately 0.2 miles from permit area.
