**COLORADO DIVISION OF RECLAMATION, MINING AND SAFETY**  
**MINERALS PROGRAM INSPECTION REPORT**  
**PHONE: (303) 866-3567**

<b>MINE NAME:</b> Lopez Quarry No. 2	<b>MINE/PROSPECTING ID#:</b> M-2007-034	<b>MINERAL:</b> Sand and gravel	<b>COUNTY:</b> Las Animas
<b>INSPECTION TYPE:</b> Monitoring	<b>INSPECTOR(S):</b> T C. Wait	<b>INSP. DATE:</b> June 19, 2012	<b>INSP. TIME:</b> 13:50
<b>OPERATOR:</b> S & S Services	<b>OPERATOR REPRESENTATIVE:</b> Sam Lopez	<b>TYPE OF OPERATION:</b> 110c - Construction Limited Impact

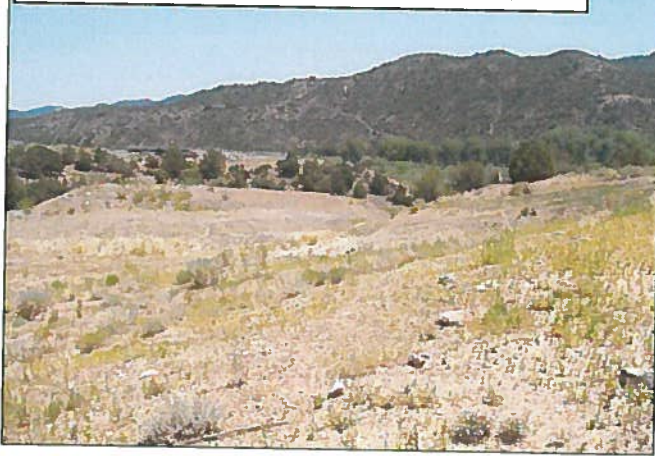
A rip-rap drainage is located on the north site of the permit area. This drainage is in good condition. No groundwater was present or expected.

Photo 1. Looking southeast. Drainage channel is located in center of photo.

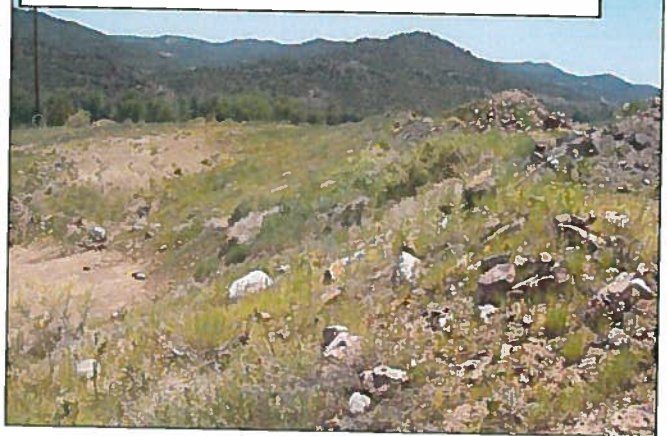
The lower, eastern portion of the site is currently acting as a sediment retention basin. No evidence of off-site sediment transport was observed.

Photo 2. Slopes between lower eastern section and center of permit boundary looking south.

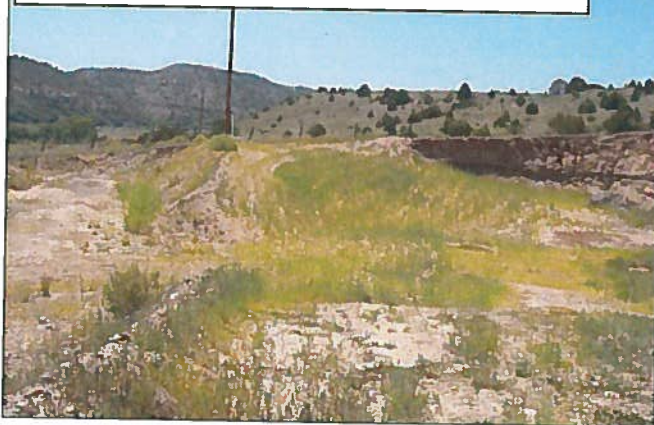
About 5 acres are currently disturbed. Operator states that there is a lot of overburden (18-20 ft) to get to the gravel (4-5 ft).

A small area in the western part of the permit area has been reseeded. Grasses are growing successfully with minimal weeds. The remainder of the site has not been topsoiled or seeded, and moderate weeds are present. The Operator is advised to implement a weed management program to control weed growth.

Photo 3. Area of reclamation in western part of permit. Thick overburden over gravel layer visible in right of photo.

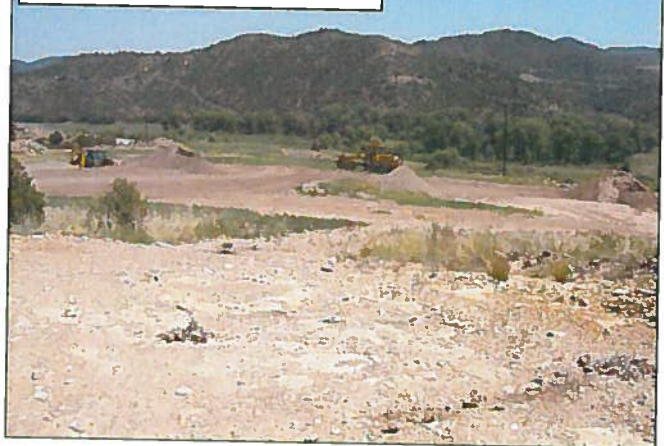
Photo 4. Looking southeast across permit site.
