**COLORADO DIVISION OF RECLAMATION, MINING AND SAFETY  
MINERALS PROGRAM INSPECTION REPORT  
PHONE: (303) 866-3567**

<b>MINE NAME:</b> Wet Canyon Mine	<b>MINE/PROSPECTING ID#:</b> M-2003-072	<b>MINERAL:</b> Sand and gravel	<b>COUNTY:</b> Las Animas
<b>INSPECTION TYPE:</b> Monitoring	<b>INSPECTOR(S):</b> T C. Wait	<b>INSP. DATE:</b> June 19, 2012	<b>INSP. TIME:</b> 11:00
<b>OPERATOR:</b> Michael Browning	<b>OPERATOR REPRESENTATIVE:</b> Michael Browning	<b>TYPE OF OPERATION:</b> 110c - Construction Limited Impact

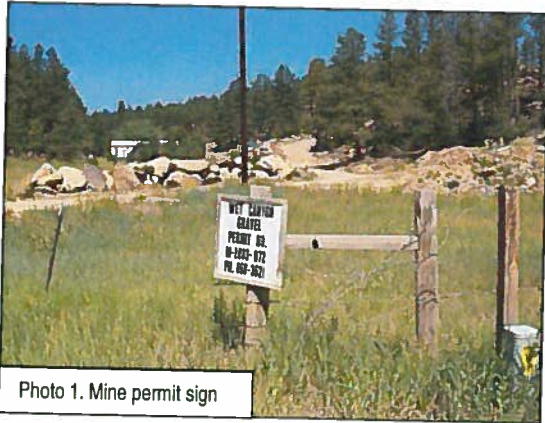
Site is properly marked. Western two boundary corners are in rock, so there are no posts.

Photo 1. Mine permit sign

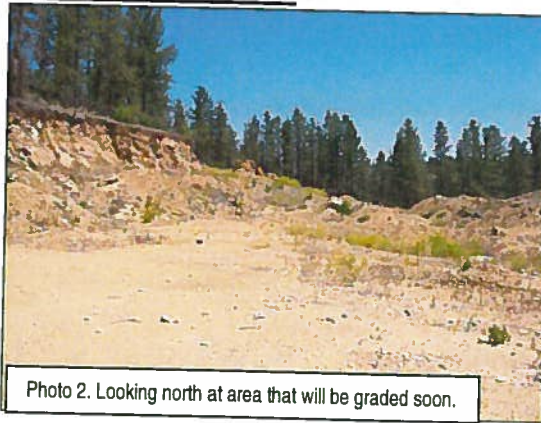
The site is not graded for reclamation. Mining has occurred on two levels within the mine permit and there is a steep sandstone cliff separating them. The Operator indicates grading will begin in the north end shortly.

Photo 2. Looking north at area that will be graded soon.

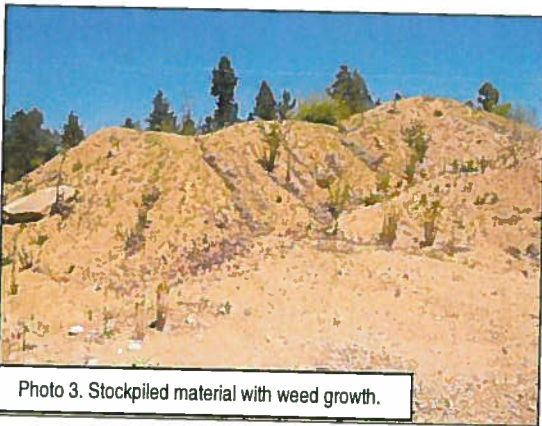
There are several species of weeds growing on the site. The Operator was advised to develop and implement a weed control plan.

Photo 3. Stockpiled material with weed growth.

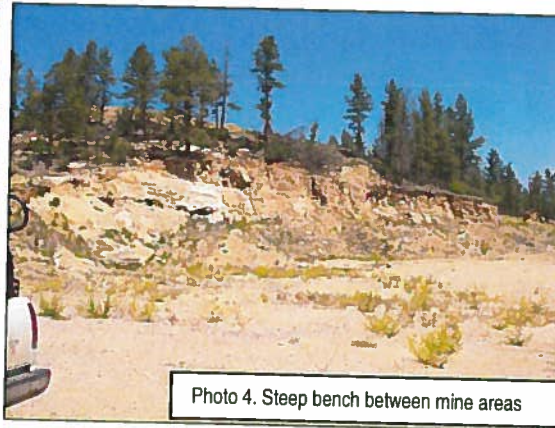
Photo 4. Steep bench between mine areas

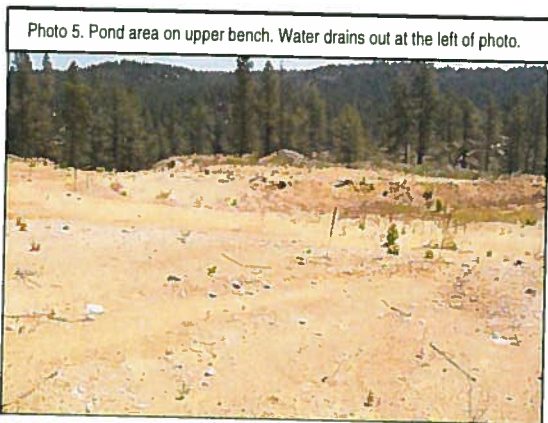
At the time of the inspection, the ground was dry, although evidence of ponding water at the top of the hill and erosive water flow down the road on the northern edge of the permit boundary were noted. Stands of thistles and other weeds were noted. The weeds on site should be dealt with in order to allow the desired vegetation to better establish. There is some debris and a few trailers on site, but no mining operations equipment. According to Mr. Browning, the County periodically requests material that is stockpiled onsite.

Photo 5. Pond area on upper bench. Water drains out at the left of photo.

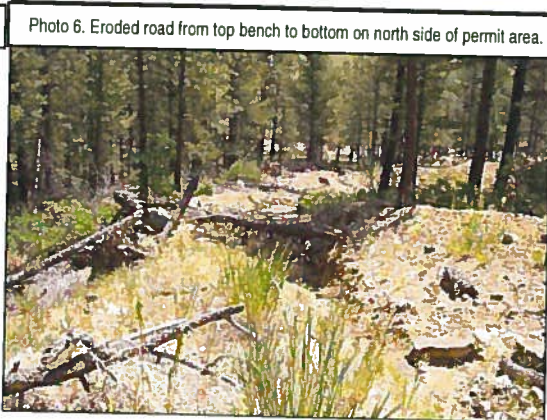
The dirt road on the north side of the mine is highly eroded from storm runoff. The Operator plans on re-grading the road and using rock-lined berms to direct runoff off site.

The road on the north side of the permit area has extensive erosion from stormwater runoff. Operator indicates the road is to be re-graded and a ditch lined with riprap on the side. Care should be taken to ensure

Photo 6. Eroded road from top bench to bottom on north side of permit area.

that adequate stormwater retention is included to reduce off-site sediment transport.

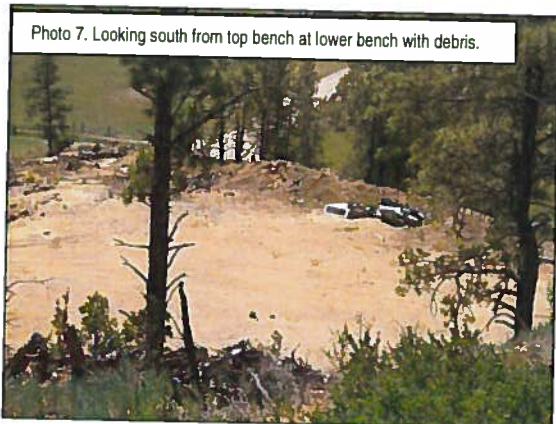
Photo 7. Looking south from top bench at lower bench with debris.

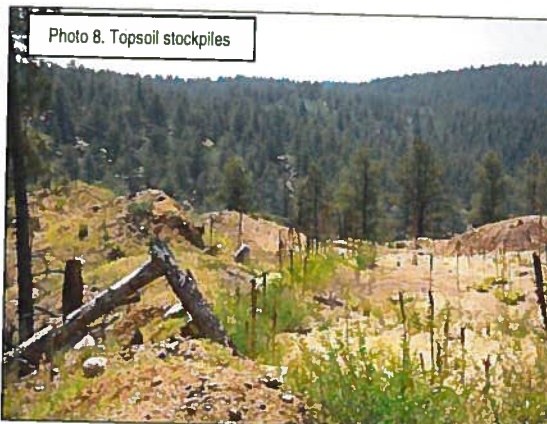
Topsoil stockpiles onsite. Some weed growth.

Photo 8. Topsoil stockpiles
