**COLORADO DIVISION OF RECLAMATION, MINING AND SAFETY**  
**MINERALS PROGRAM INSPECTION REPORT**  
**PHONE: (303) 866-3567**

<b>MINE NAME:</b> Bottomless Pit	<b>MINE/PROSPECTING ID#:</b> M-2001-068	<b>MINERAL:</b> Gravel and sand	<b>COUNTY:</b> Las Animas
<b>INSPECTION TYPE:</b> Monitoring	<b>INSPECTOR(S):</b> T C. Wait	<b>INSP. DATE:</b> June 18, 2012	<b>INSP. TIME:</b> 15:00
<b>OPERATOR:</b> Tamrock Gravel	<b>OPERATOR REPRESENTATIVE:</b> Brent Tamburelli	<b>TYPE OF OPERATION:</b> 112c - Construction Regular Operation

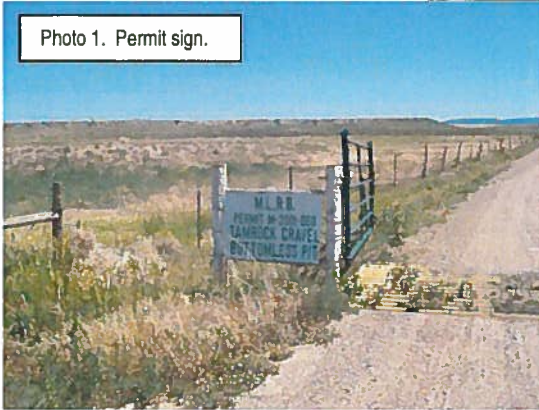
Photo 1. Permit sign.

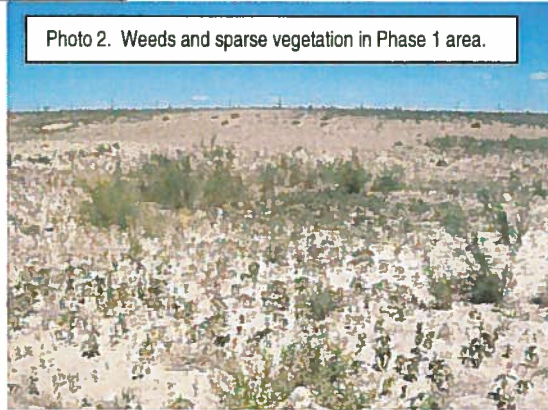
At the time of the inspection, the ground was dry, although evidence of ponding water at the edges of the mined areas was noted. Phases 1 and 2 have been revegetated, however the vegetation is sparse and not well established. Stands of thistles and other weeds were noted. According to Mr. Tamburelli, Tamrock does have a weed mitigation plan. The weeds on site should be dealt with in order to allow the desired vegetation to better establish.

Revegetation in phases 1 and 2 is under way. Vegetation is sparse, and there are some weeds present. Operator states they have a weed mitigation plan in place. Operator was advised to continue weed mitigation to allow desired plants to establish.

Photo 2. Weeds and sparse vegetation in Phase 1 area.

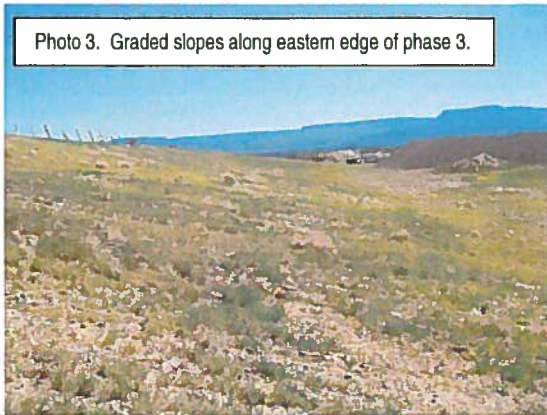
Grading each phase as it is mined and before progressing to next phase. Phases 1 and 2 have been regraded. Phases 3 and 4 have a large quantity of fines that will be graded out in the next month or so. Graded slopes generally 3.5:1 or flatter.

Photo 3. Graded slopes along eastern edge of phase 3.

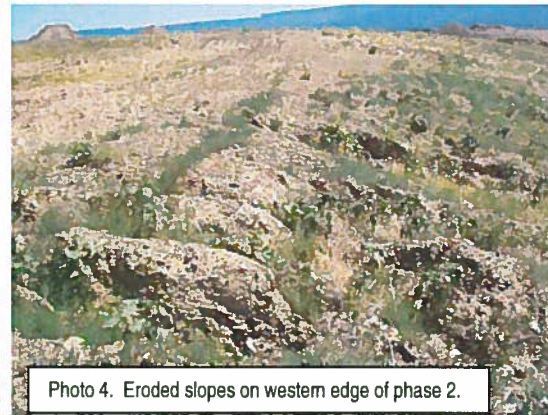
Photo 4. Eroded slopes on western edge of phase 2.

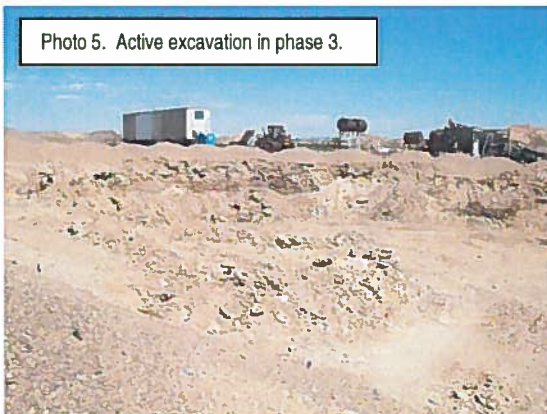
According to Mr. Tamburelli, about 34,000 tons of material is stored in phases 3 and 4 that will be spread during grading prior to placing top soil in the next month. Mining in phase 4 has not been very productive. Mining in phase 3 is now concentrated in two pits about 8-10 ft in depth. As demand for product rises, they will extend mining operations south and west into new phases.

Photo 5. Active excavation in phase 3.

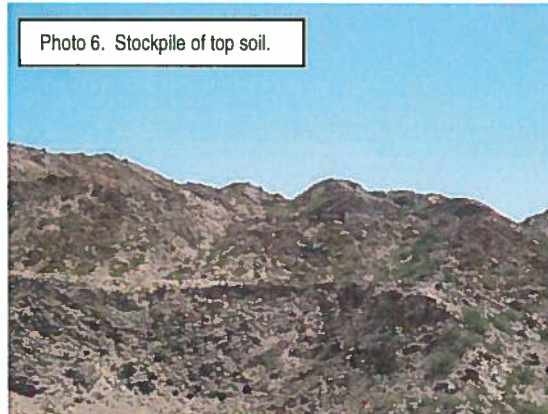
Topsoil stockpiles are present as indicated in the mine plan.

Photo 6. Stockpile of top soil.

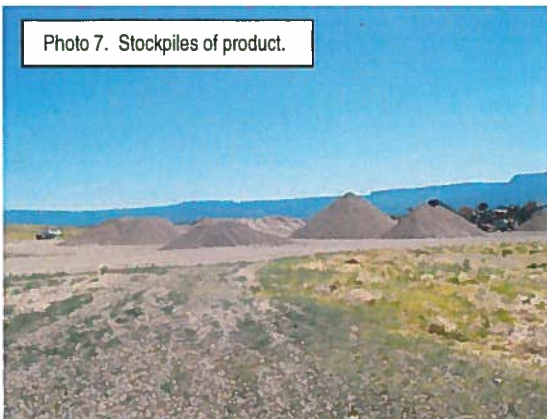
Photo 7. Stockpiles of product.

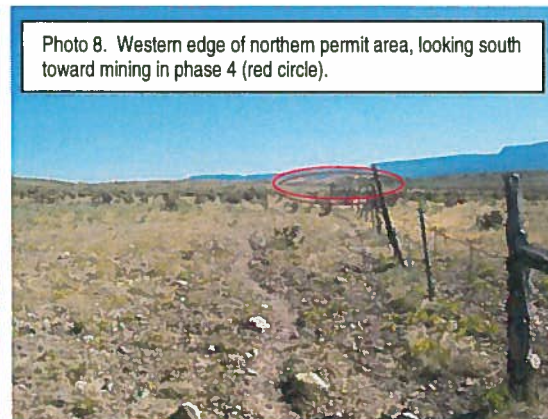
Photo 8. Western edge of northern permit area, looking south toward mining in phase 4 (red circle).
