COLORADO DIVISION OF RECLAMATION, MINING AND SAFETY
MINERALS PROGRAM INSPECTION REPORT
PHONE: (303) 866-3567

MINE NAME: Montgomery Pit	MINE/PROSPECTING ID#: M-1986-104	MINERAL: Sand and gravel	COUNTY: Eagle
INSPECTION TYPE: Monitoring	INSPECTOR(S): Dustin M. Czapla	INSP. DATE: June 5, 2012	INSP. TIME: 11:00
OPERATOR: Oldcastle SW Group, Inc. d.b.a. B & B Excav	OPERATOR REPRESENTATIVE: Jason Burkey	TYPE OF OPERATION: 112c - Construction Regular Operation

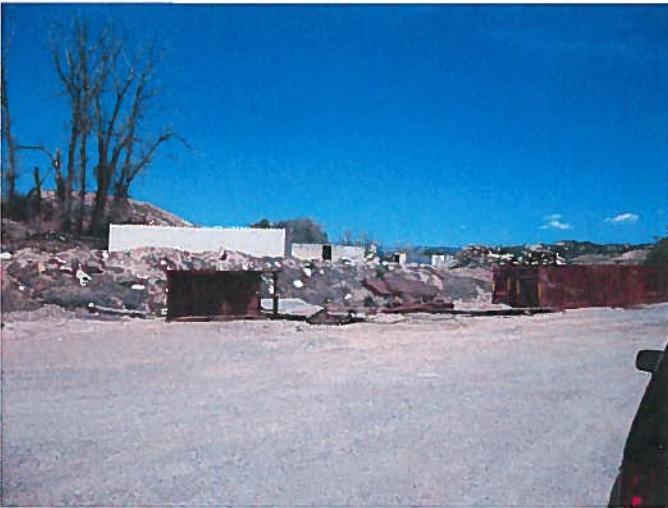
Figure 1: View, facing west, from the east end of the site.

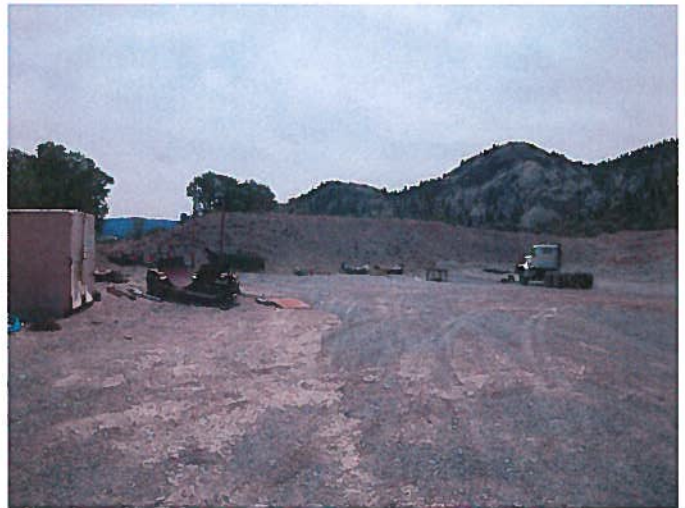
Figure 2: View, facing east, towards the east permit boundary.

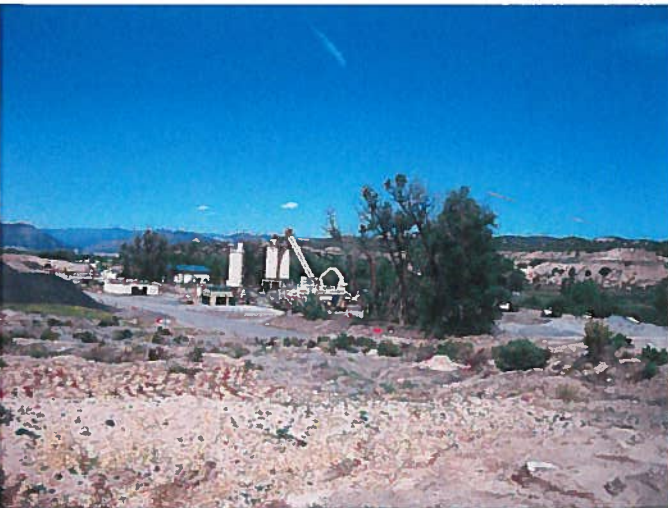
Figure 3: View, facing northwest, towards the plant area.

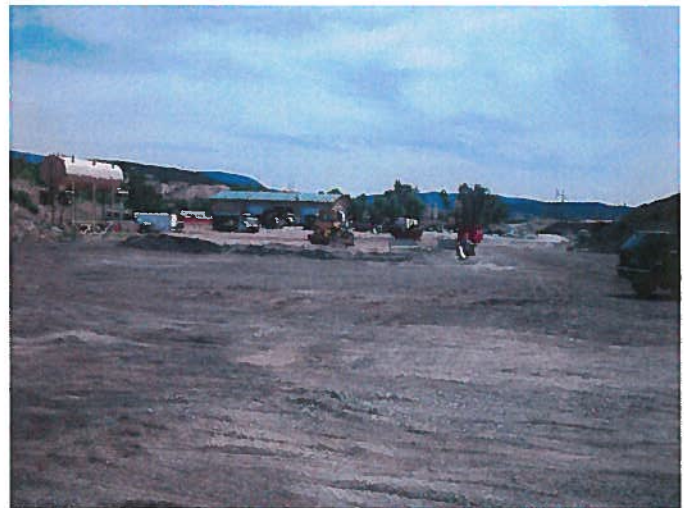
Figure 4: View, facing east, from the west end of the site.
