RECLAMATION PLAN
COLORADO RIVER

AS-BUILT DRAWING
OF RECORD

June 11, 2012

RE: Post Construction Report SPK-2012-00125 Colorado River near Rifle

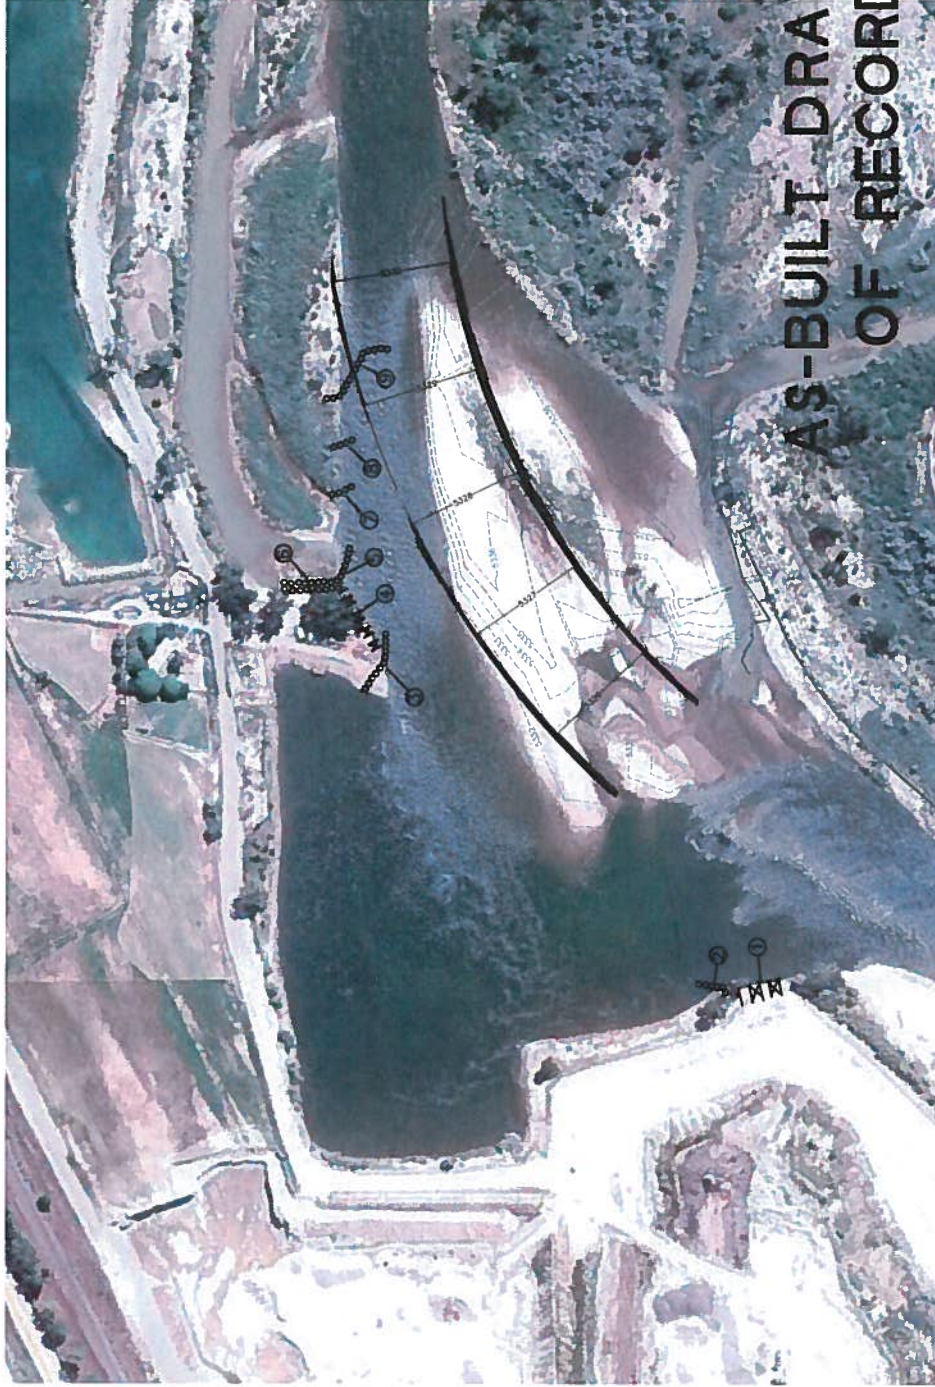
Structure 6 on the Reclamation Plan (now designated Structures 1 and 2 on "as built") consists of a rock vane and a toe wood bench with the rock vane on the upstream side. The toe wood bench consists of 20 to 30 ft logs and woody debris that is placed below the low water line up to the bank full bench elevation. Over 90 percent of the logs are buried and covered with sod mats and willows to provide additional stabilization. The submerged logs provide protective fish habitat.

Structure 5 on the Reclamation Plan originally called for a single vane, a toe wood bench, and the western edge of the side channel rip-rapped. Another rock vane was added to this area to provided additional stability. Willow transplants were placed between the rip rap rocks that followed guidance provided by the Corps during the permitting process (Special Condition 9). The new vane (Designated Structure 5) is connected with the large footer rocks supporting the rip-rap via a buried rock sill.

The J-hook (Structure 9 on "as built") was constructed and placed as shown in the permit application. Grade control is achieved at this structure by placing footer rocks at the bottom of the river bed. Large rocks are placed at 10 to 15 ft. spacing to allow small boats to pass during low water. Observations during peak flow conditions this year (Approximately 4000 cfs) show that the structure is operating as designed protecting the northern river bank and scouring a pool immediately downstream to provide additional hydraulic control on the river.

After the river bank was sloped downstream of the J-hook, two rock sills were added to maintain additional stability. These structures are designed 7 and 8 on the as built drawing.
