Subject: Schwartzwalder Mine (M-1977-300), 7-3-12 inspection report and RTB letter

# COLORADO DIVISION OF RECLAMATION, MINING AND SAFETY MINERALS PROGRAM INSPECTION REPORT

MINE NAME: Schwartzwalder Mine	MINE/PROSPECTING ID#: M-1977-300	MINERAL: Uranium	COUNTY: Jefferson
INSPECTION TYPE: Monitoring	INSPECTOR(S): Tom Kaldenbach, Tim Cazier	INSP. DATE: July 3, 2012	INSP. TIME: 09:30
OPERATOR: Cotter Corporation	OPERATOR REPRESENTATIVE: John Hamrick, Mike Villegrana	TYPE OF OPERATION: 112d-2 - Designated Mining Operation

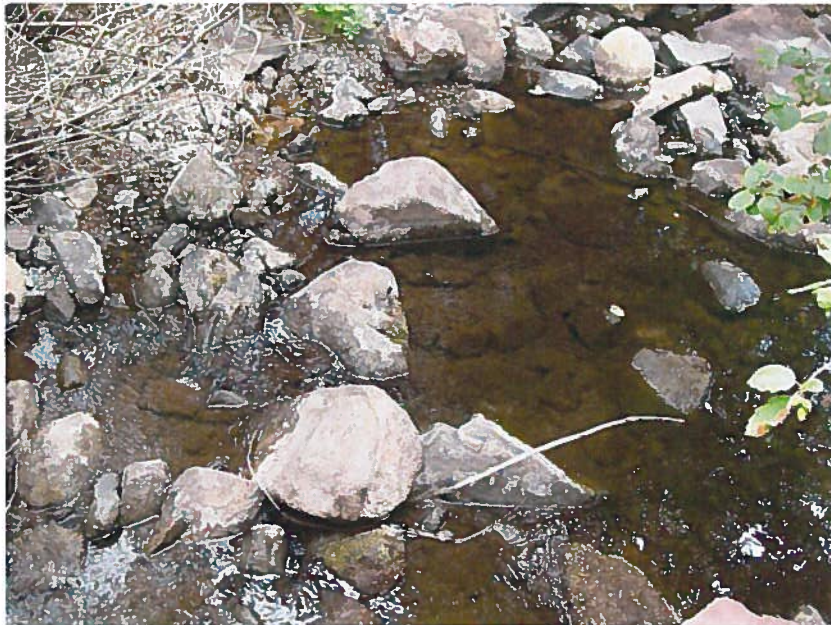
Photo 1 – Ralston Creek at BPL location.

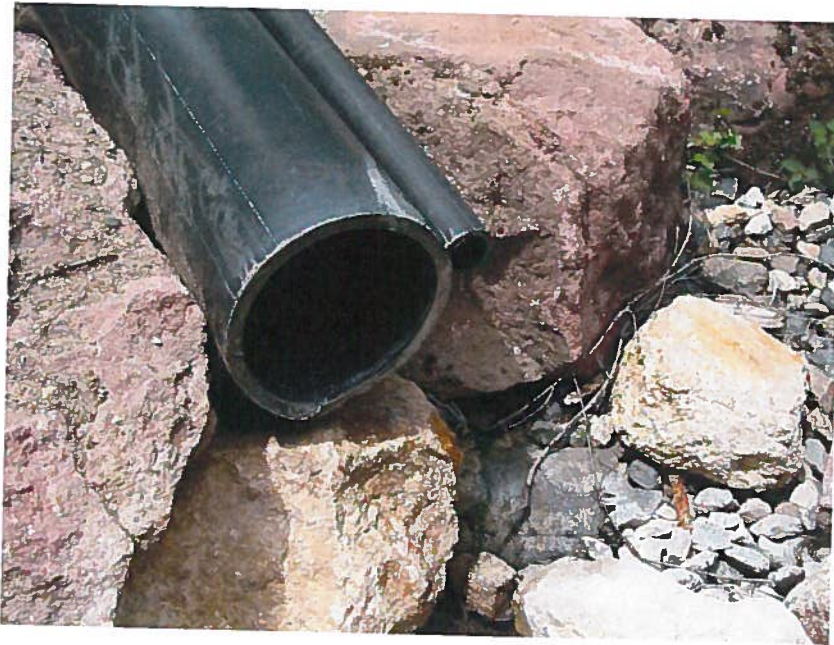
Photo 2 – 18-inch diversion pipeline and 4-inch water treatment pipeline at BPL location (downstream from mine surface facilities area).

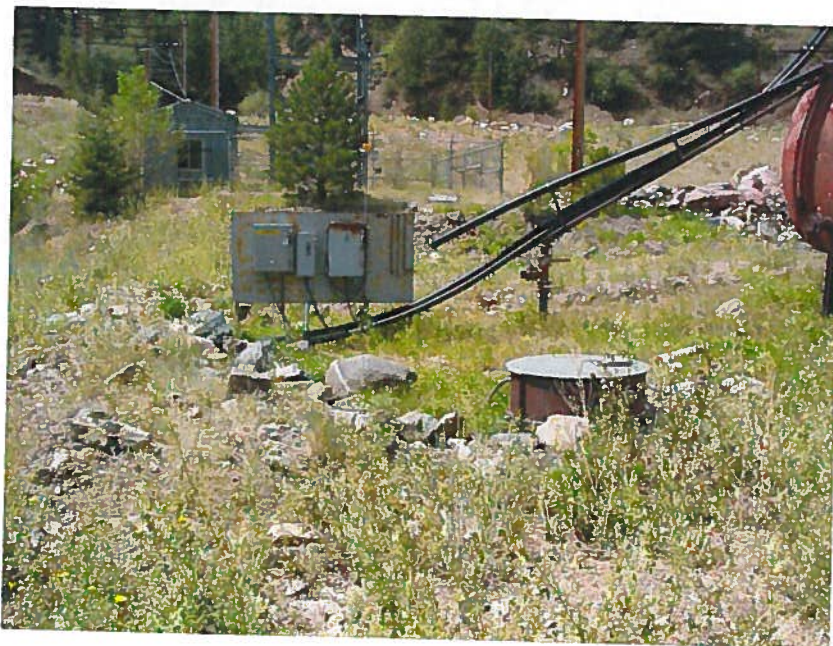
Photo 3 - Sump 4 covered manhole (center right) and control panel (center left). Tank partially in view on right side of photo is no longer in use.

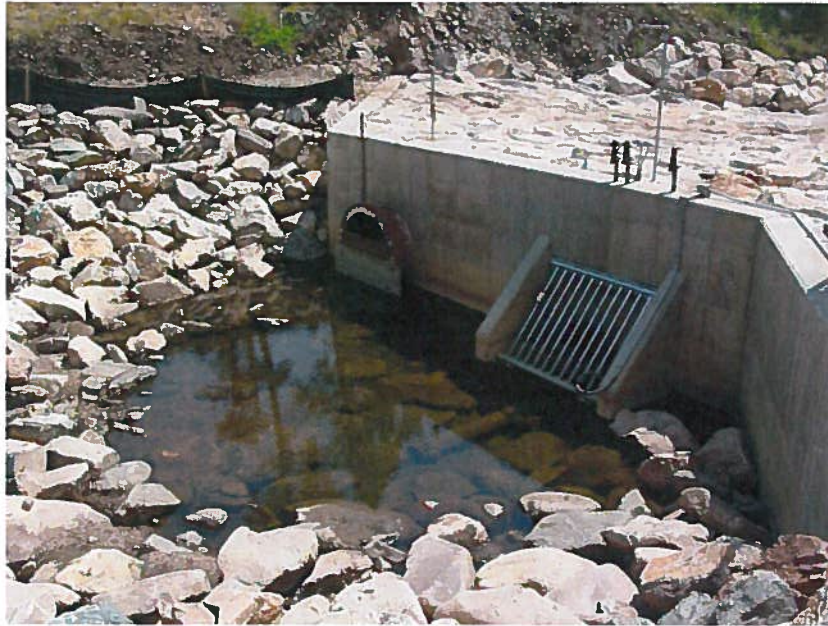
Photo 4 – Ponded Ralston Creek water on upstream side of upper cut-off wall for creek diversion pipeline. 18-inch diameter diversion pipeline is out of view behind trash rack on right side of photo. Steel pipe on left side of photo is stream overflow pipe.

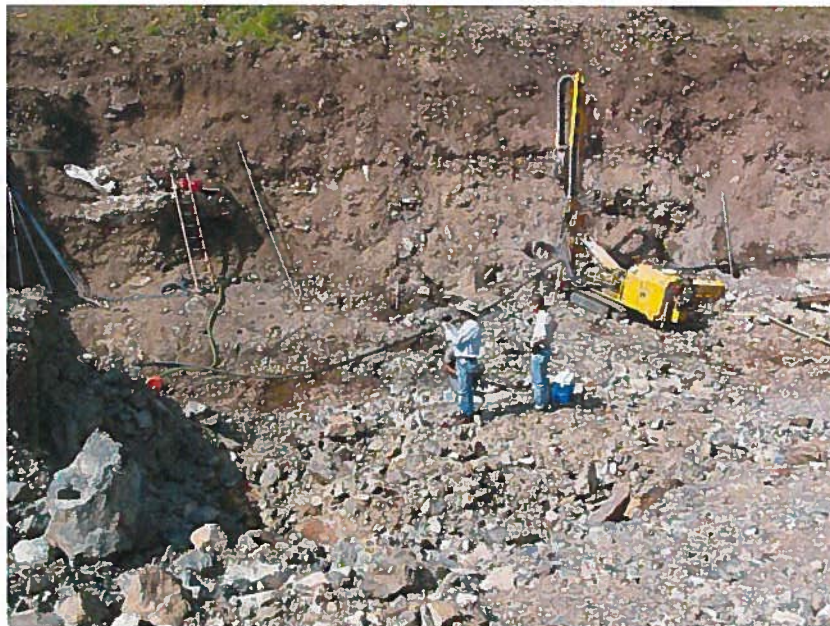
Photo 5 – Inactive drill rig (right side of photo) in grout curtain area that was drilling holes for grout curtain during week prior to this inspection.

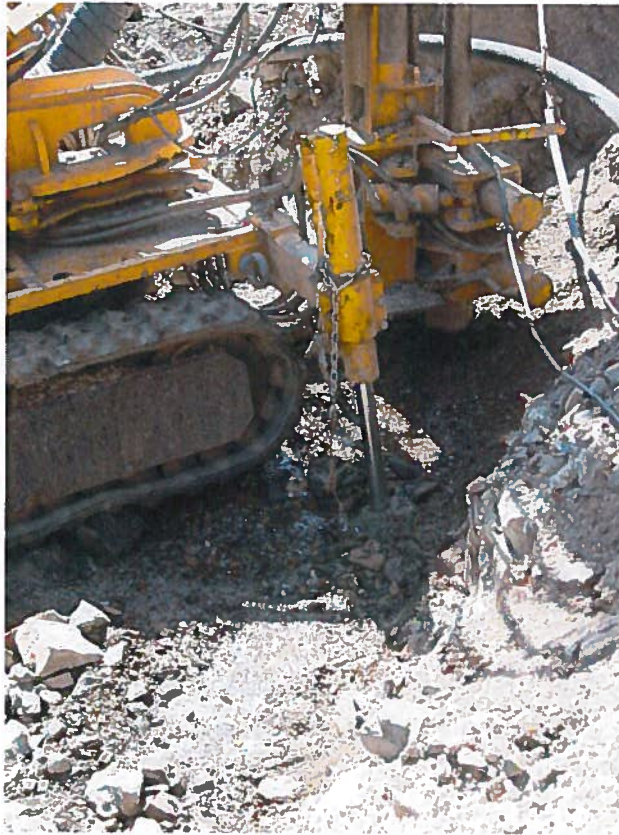
Photo 6 – Close-up of inactive drill rig shown in previous photo. Drill string was still in hole during this inspection and water was flowing out of the hole at less than 1 gpm, and was flowing to nearby low area on ground where DRMS and operator sampled.

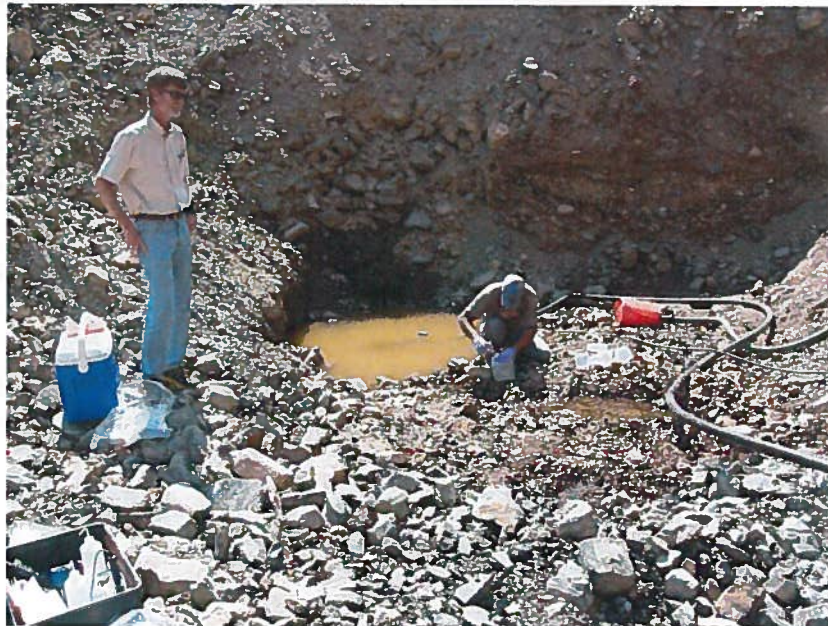
It is reasonable to conclude that the mine pool contributes to the discharge in the grout curtain area. This conclusion is based on the similarity of electroconductivity values in the two locations (see Table 3), the close proximity of the mine pool to the grout curtain area, and the likely elevation difference between the mine pool and the grout curtain area. The Steve Adit is located approximately 200 feet from the grout curtain area. The fractured mass of metamorphic rock that separates the Steve Adit from the grout curtain area provides a subsurface flowpath between those two areas. The elevation of the mine pool was most recently reported as 6,578 feet, which appears to be a few feet higher than the unlabeled elevation contours of the grout curtain area shown on Figure 1 submitted for TR-20.

It appears that water from the mine pool has been discharging from metamorphic rock in the grout curtain area prior to the operator's excavation in that area. The discharge prior to excavation has contaminated water in the alluvial fill, based on the electroconductivities of 2,809  $\mu\text{mhos/cm}$  of the discharge and 300  $\mu\text{mhos/cm}$  of the alluvial water (see Table 3, above). Some of the discharge continues to enter unexcavated alluvial fill material in the grout curtain area. Contamination of the alluvial fill prior to the excavation and continuing today represents a failure to minimize disturbance to the affected land and to the quality of ground water systems after the mining operation and during reclamation (see C.R.S § 34-32-116(7)(g) and Rule 3.1.6). Based on this contamination, the discharge in the grout curtain area is cited as a possible violation of the referenced Statute and Rule.

Photo 7 – Operator's representative (center of photo) collecting sample where water flows to low area in grout curtain area. Black pipe on right side of photo carries water from pump in pool to water treatment plant approximately 400 feet away.
