**COLORADO DIVISION OF RECLAMATION, MINING AND SAFETY**  
**MINERALS PROGRAM INSPECTION REPORT**  
**PHONE: (303) 866-3567**

<b>MINE NAME:</b> Schwartzwalder Mine	<b>MINE/PROSPECTING ID#:</b> M-1977-300	<b>MINERAL:</b> Uranium	<b>COUNTY:</b> Jefferson
<b>INSPECTION TYPE:</b> Monitoring	<b>INSPECTOR(S):</b> Tom Kaldenbach	<b>INSP. DATE:</b> June 28, 2012	<b>INSP. TIME:</b> 13:15
<b>OPERATOR:</b> Cotter Corporation	<b>OPERATOR REPRESENTATIVE:</b> John Hamrick	<b>TYPE OF OPERATION:</b> 112d-2 - Designated Mining Operation

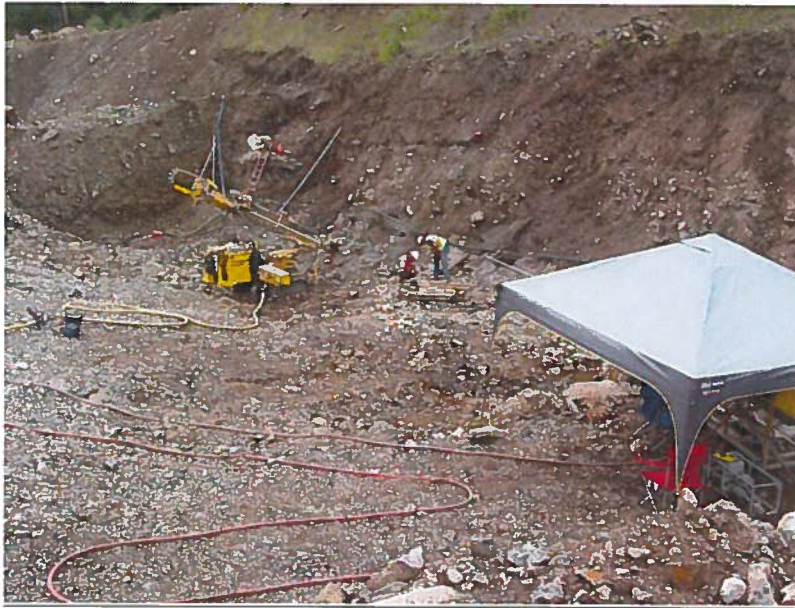
Photo 1 – Grout hole drill rig (left side of photo) and pressure grouting control panel (underneath canopy on right side of photo).

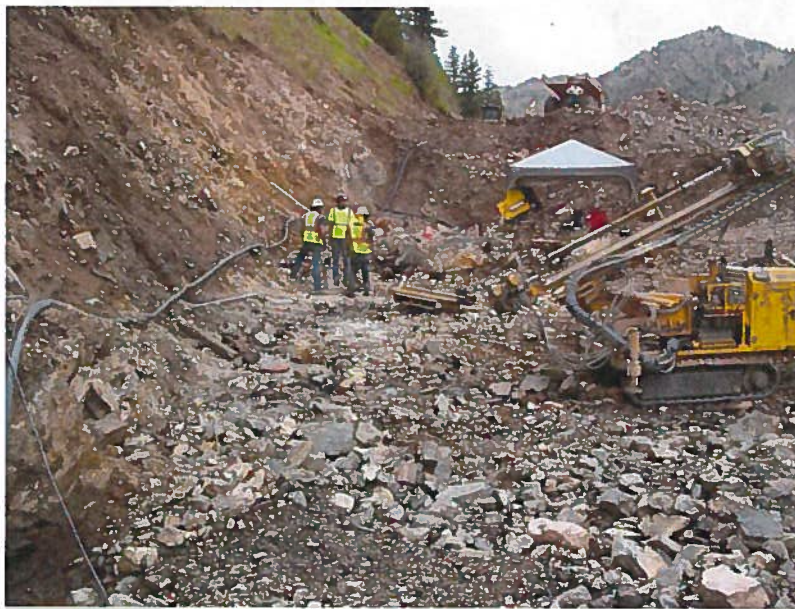
Photo 2 – Grout hole drill rig (on right side of photo).

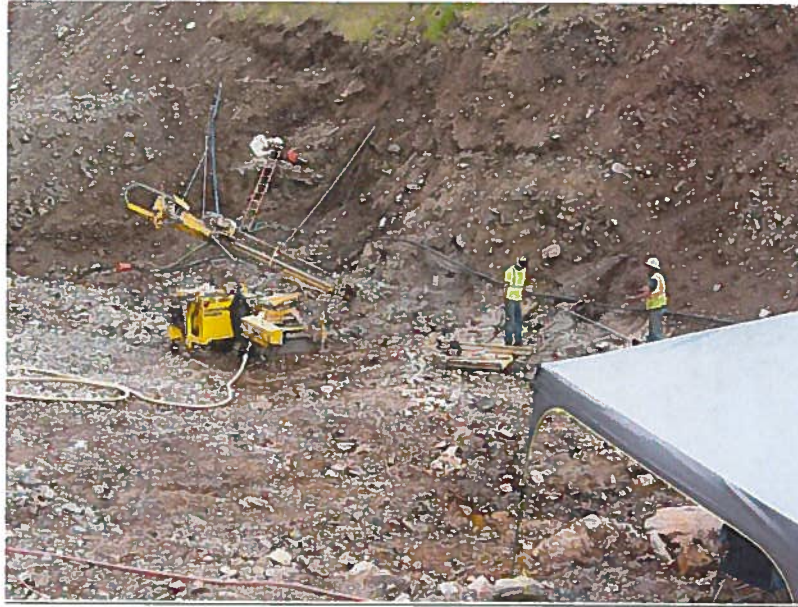
In the project area, there appeared to be four smaller areas, each measuring a few square feet in area, where clear water was trickling out of the metamorphic bedrock and pooling in low areas. The total flow of water coming out of the rock in the four smaller areas was visually estimated to be between 10 and 50 gpm. Water in the lowest of the pooled areas was being pumped into a 4-inch diameter HDPE pipe that led to the treatment plant approximately 400 feet northwest of the project area. From the treatment plant, the water is piped to the CDPS-permitted discharge into Ralston Creek (Outfall 001A, CDPS permit CO-0001244).

Photo 3 – Grout hole project area. Water seeping out of ground pools in low area near left side of photo. Water is pumped from that low spot to water treatment plant approximately 400 feet away.

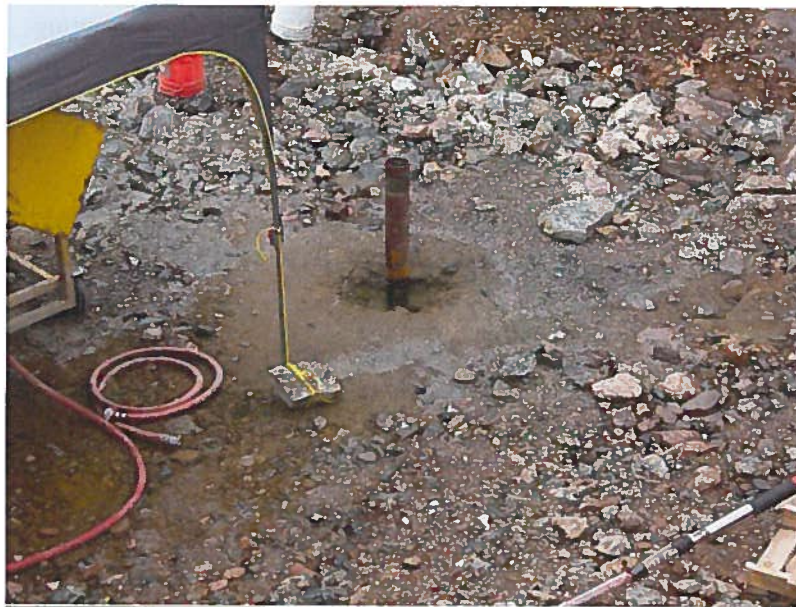
Photo 4 – Water pooled around casing of recently drilled grout hole in grout drilling project area. Water seeps out from around the casing.

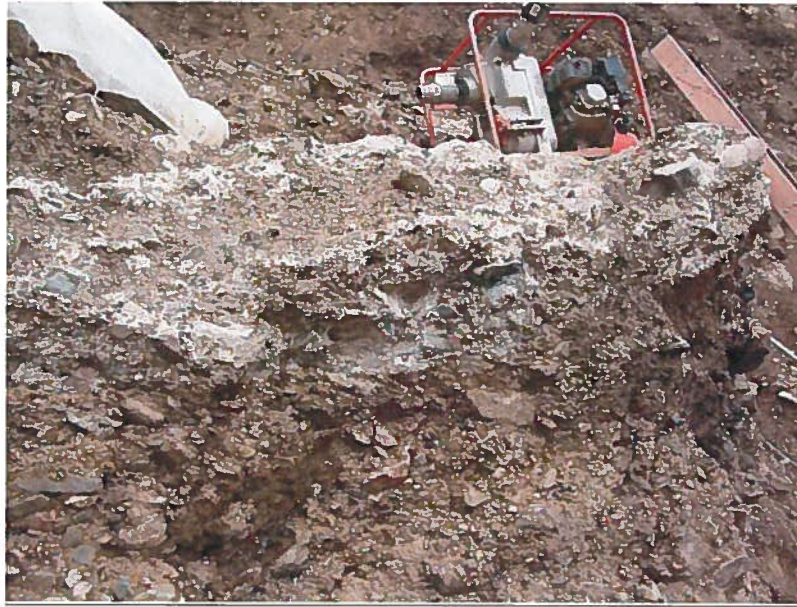
Photo 5 – Light-colored material that crosses photo appears to be old grout in current grouting project area.

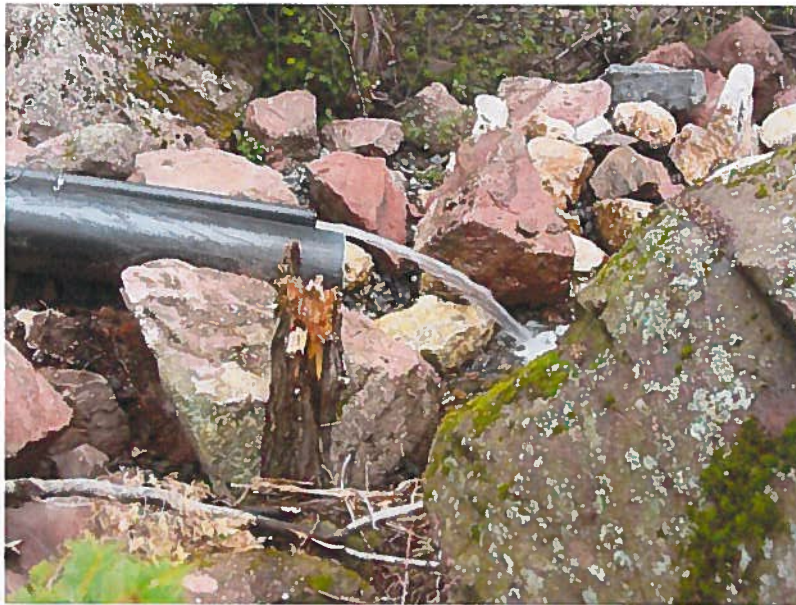
Photo 6 – Treatment plant discharge into dry channel of Ralston Creek at downstream side of permit area (BPL site).

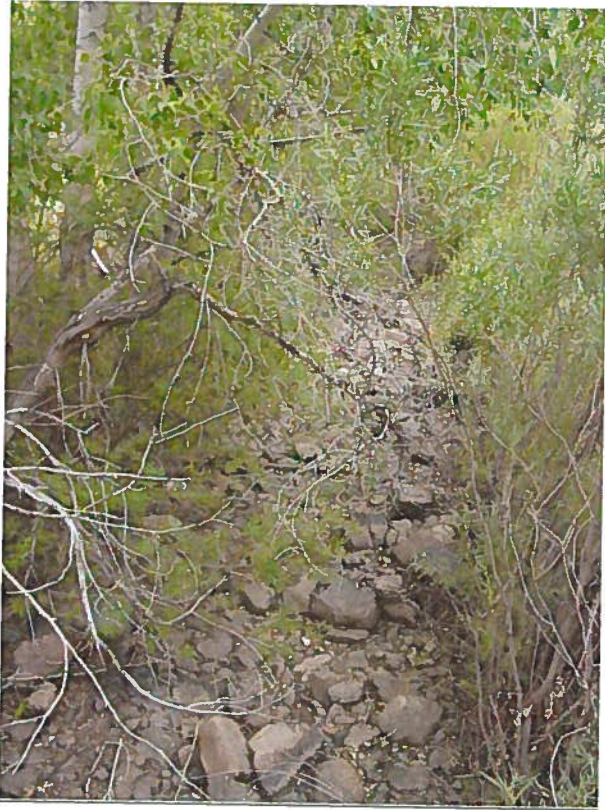
Photo 7 – Dry channel of Ralston Creek, upstream from BPL monitoring location.

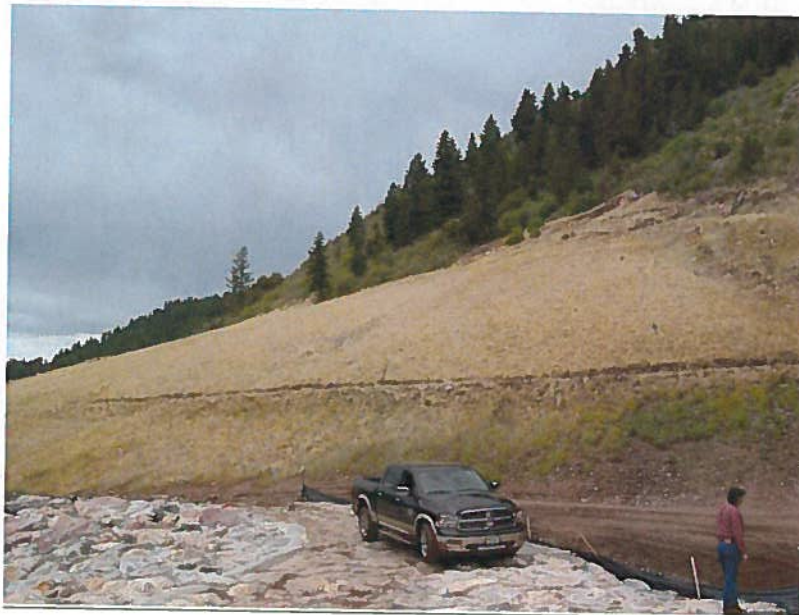
Photo 8 – South waste rock pile.

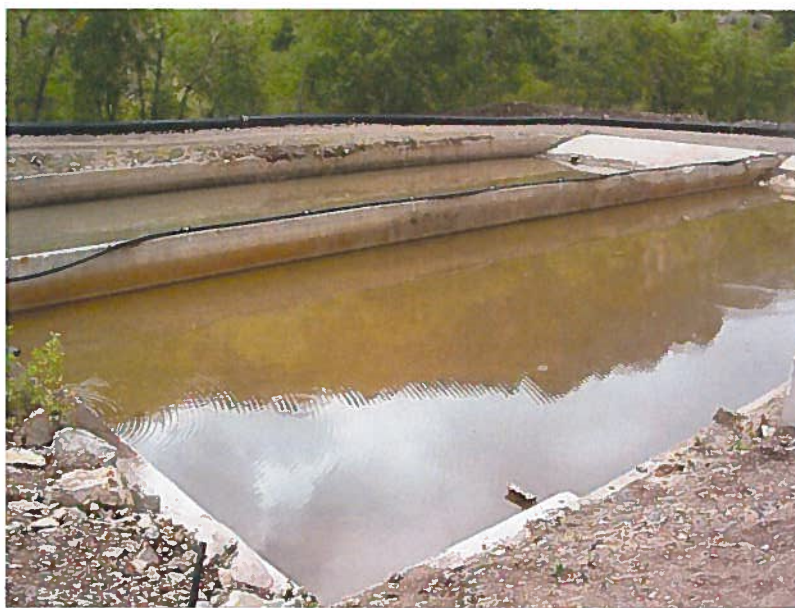
Photo 9 – Two-cell, concrete –lined pond next to treatment plant.
