COLORADO DIVISION OF RECLAMATION, MINING AND SAFETY MINERALS PROGRAM INSPECTION REPORT

MINE NAME:	MINE/PROSPECTING ID#:	MINERAL: COUNTY:	
Krehmeyer Pit	M-2005-070	Gravel and sand Phillips	
INSPECTION TYPE:	INSPECTOR(S):	INSP. DATE: INSP. TIME:	
Monitoring	Berhan Keffelew	June 19.2012 13:00	
OPERATOR:	OPERATOR REPRESENTATIVE:	TYPE OF OPERATION:	
Ritchey's Redi-Mix Concrete, Inc.	Jerry Ritchey	110c - Construction Limited Impact

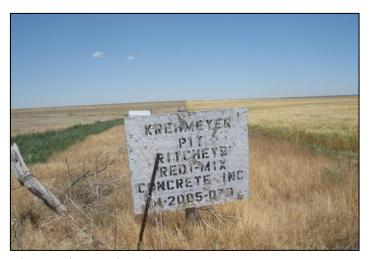
- 3) Permit sign and boundary markers properly posted. There is an adjacent 110 permit (M-2004-037) Evert Pit mining the same river bottom.
- 4) The current financial warranty for the site in the amount of \$7,400.00 is more than adequate to cover the rest of the reclamation. The operation is in compliance with the approved reclamation plan

Figure 1 permit sign

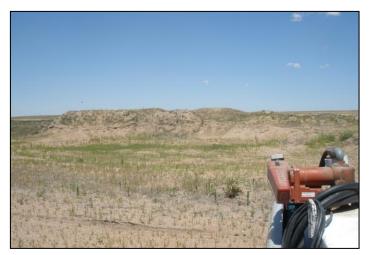
- 2) The approved reclamation plan for the site is to allow the river bed to reclaim the bottom of the channel and the operator to reclaim the embankments. The reclaimed embankments appeared stable and vegetated. There was a small amount of top soil/overburden stockpiled along the east side of the permit area that the operator plans to spread along the embankment.

Figure 3 looking at the small overburden stockpile $% \left\{ 1,2,\ldots ,n\right\}$
