COLORADO DIVISION OF RECLAMATION, MINING AND SAFETY
MINERALS PROGRAM INSPECTION REPORT
PHONE: (303) 866-3567

| MINE NAME: River Valley Resource | MINE/PROSPECTING ID#: M-2001-090 | MINERAL: Sand and gravel | COUNTY: Routt |
| INSPECTION TYPE: Preoperation Inspection | INSPECTOR(S): Dustin M. Czapla | INSP. DATE: July 11, 2012 | INSP. TIME: 08:00 |

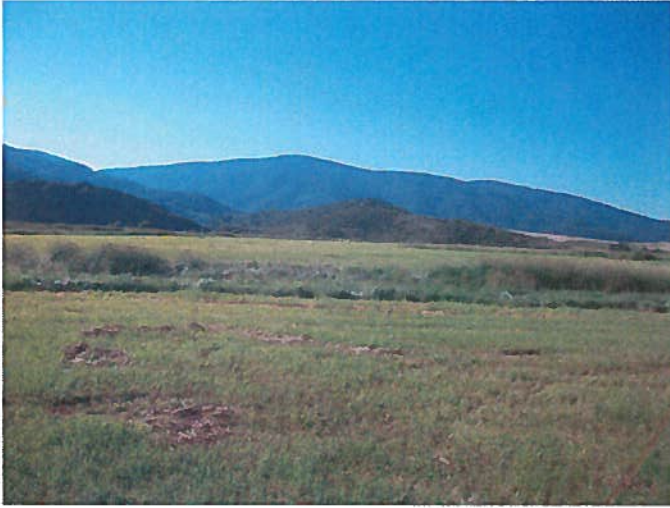
Figure 1: View from the southwest part of the AM2 area, towards the southeast.

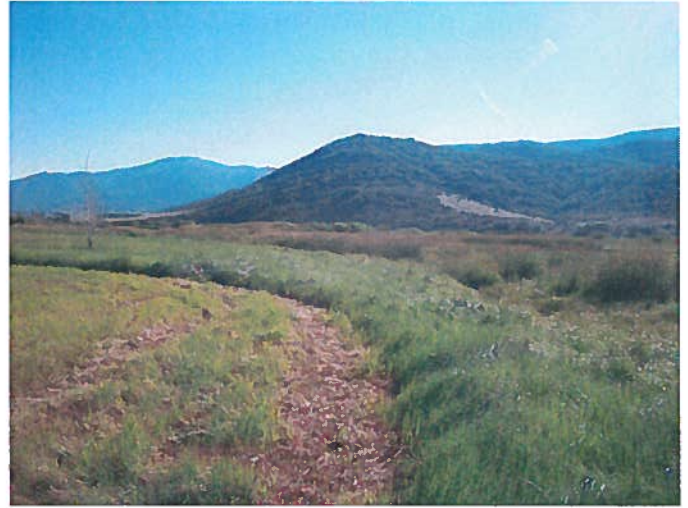
Figure 2: View from the southwest part of the AM2 area, towards the northwest.

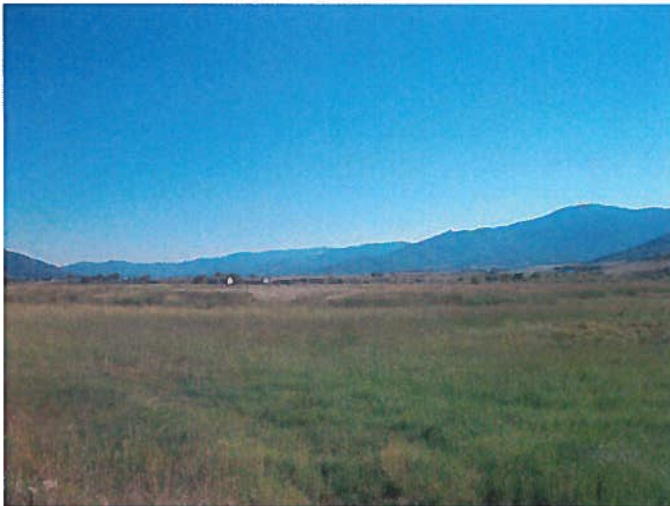
Figure 3: View from the southwest part of the AM2 area, towards the north.

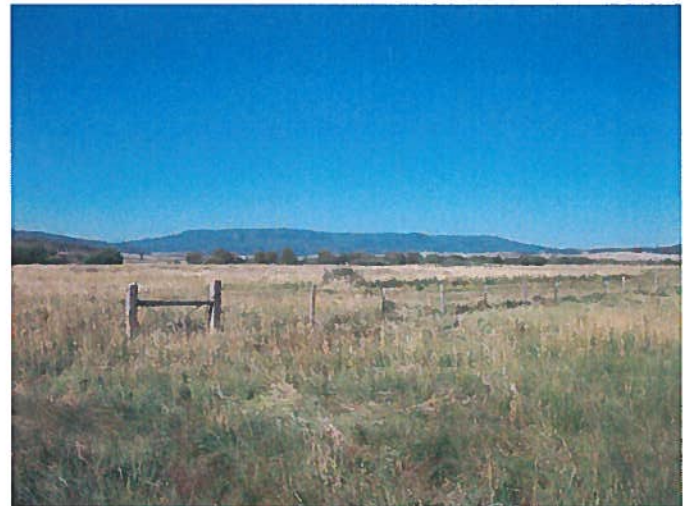
Figure 4: View from the northeast corner of the AM2 area, towards the southwest.

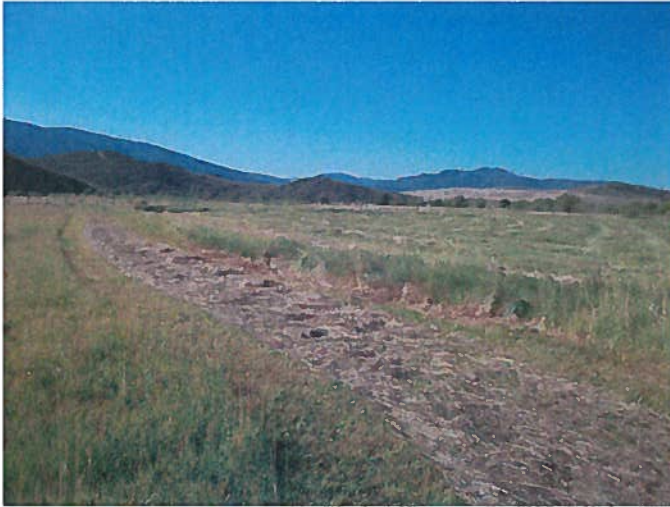
Figure 5: View from the Phase 3-4 area, south towards the Phase 1 process area.

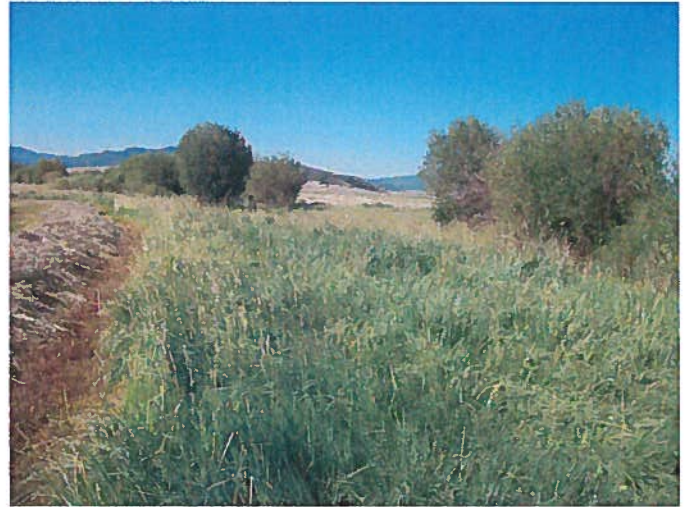
Figure 6: Yampa River bypass near the Phase 4 area.
