COLORADO DIVISION OF RECLAMATION, MINING AND SAFETY
MINERALS PROGRAM INSPECTION REPORT
PHONE: (303) 866-3567

MINE NAME: Greer Pit	MINE/PROSPECTING ID#: M-1985-115	MINERAL: Sand and gravel	COUNTY: La Plata
INSPECTION TYPE: Monitoring	INSPECTOR(S): Kate A. Pickford	INSP. DATE: July 11, 2012	INSP. TIME: 11:40
OPERATOR: J Pat and Lila N Greer	OPERATOR REPRESENTATIVE: Pat Greer	TYPE OF OPERATION: 110c - Construction Limited Impact

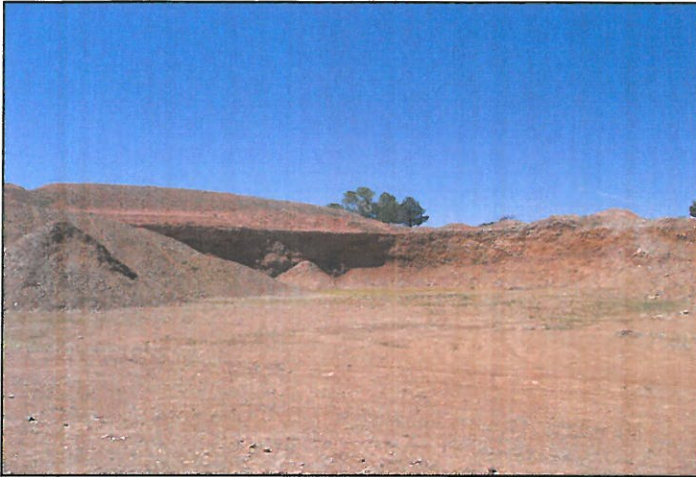
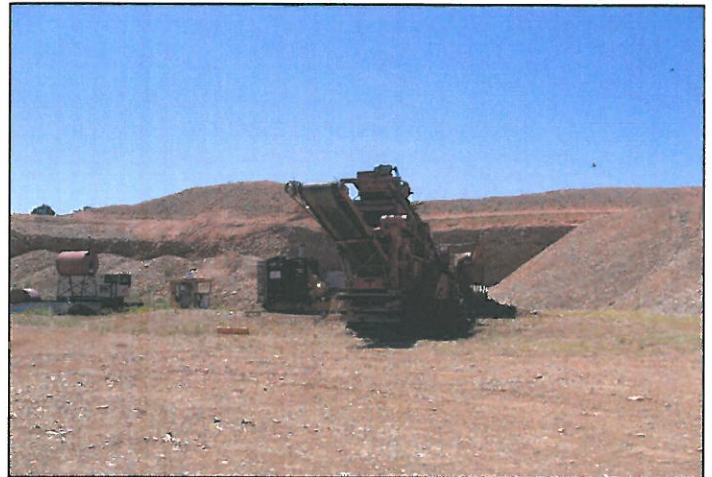
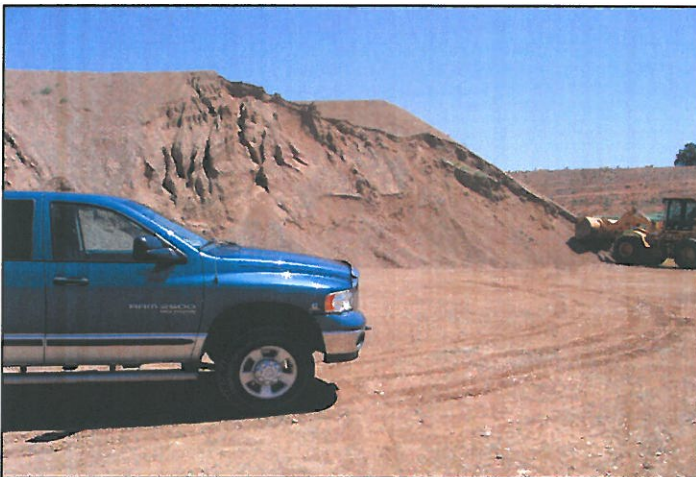
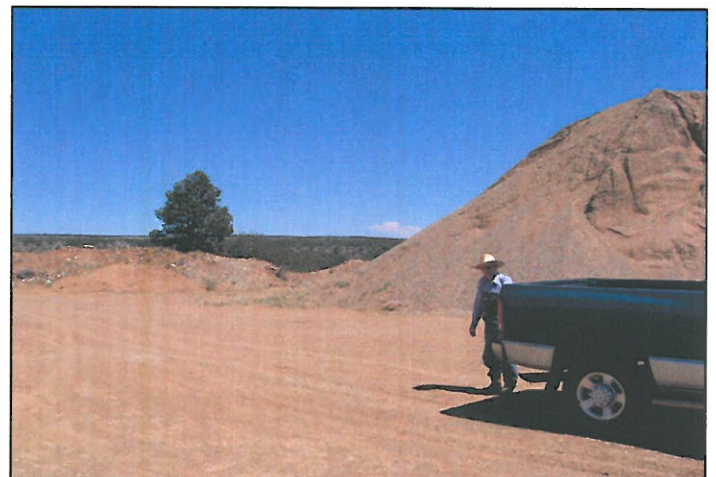
PHOTOGRAPHS

The site is currently in the process of being mined. There is a large stockpile of material on the pit floor. The east side of the pit has been graded to final slope. The south side still consists of a near vertical highwall. Topsoil is stockpiled on top of the highwall area.

No refuse or measurable weeds were present at the site. No problems were observed during the inspection.
