**COLORADO DIVISION OF RECLAMATION, MINING AND SAFETY**  
**MINERALS PROGRAM INSPECTION REPORT**  
**PHONE: (303) 866-3567**

<b>MINE NAME:</b> Chivington Grazing	<b>MINE/PROSPECTING ID#:</b> M-1983-119	<b>MINERAL:</b> Sand and gravel	<b>COUNTY:</b> Kiowa
<b>INSPECTION TYPE:</b> Monitoring	<b>INSPECTOR(S):</b> T C. Wait	<b>INSP. DATE:</b> July 11, 2012	<b>INSP. TIME:</b> 11:40
<b>OPERATOR:</b> Kiowa County	<b>OPERATOR REPRESENTATIVE:</b> Rodney Hopkins	<b>TYPE OF OPERATION:</b> 110c - Construction Limited Impact

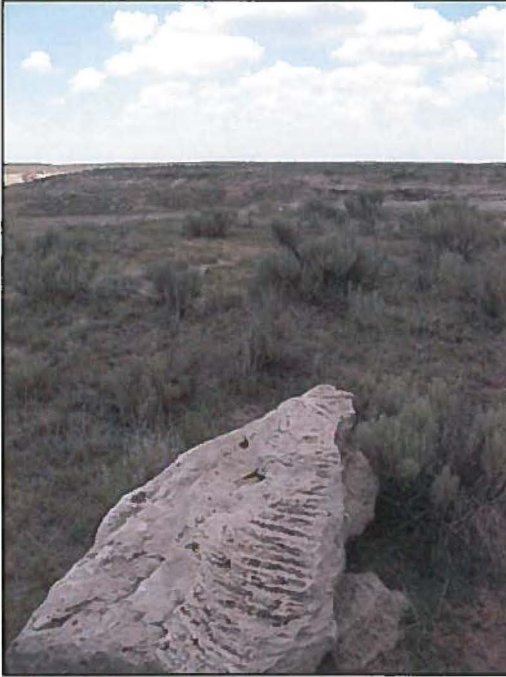
The site has a permit sign and the corners are marked with large rocks. A ditch has been constructed along the northern and eastern parts of the site.

Photo 1. Boundary marker

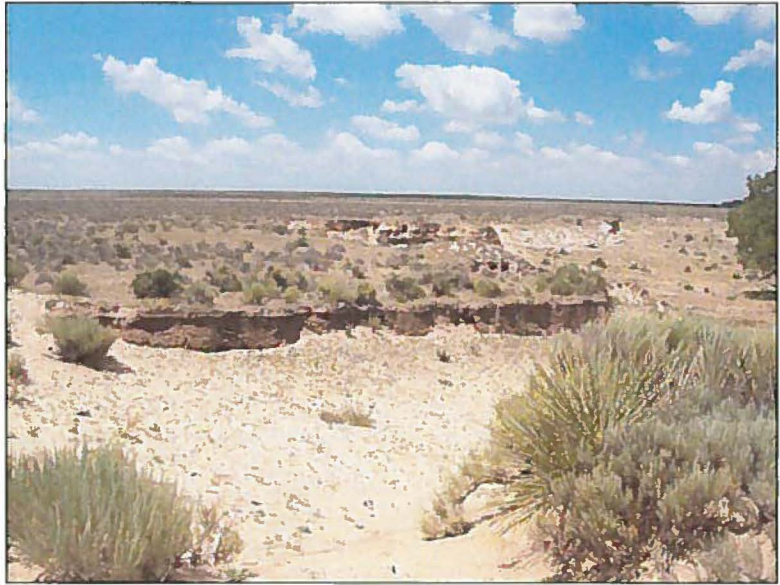
The eastern area of the site is still being mined to some extent. There was a pile of shale material in the center of the site that Mr. Hopkins thought was brought in by the property owner. The headwall extends approximately 1500 feet around the perimeter of the site and is about 20 ft in height with near vertical slopes.

The most recently active are of the pit is along the eastern side.

Photo 2. Eastern part of pit looking south.

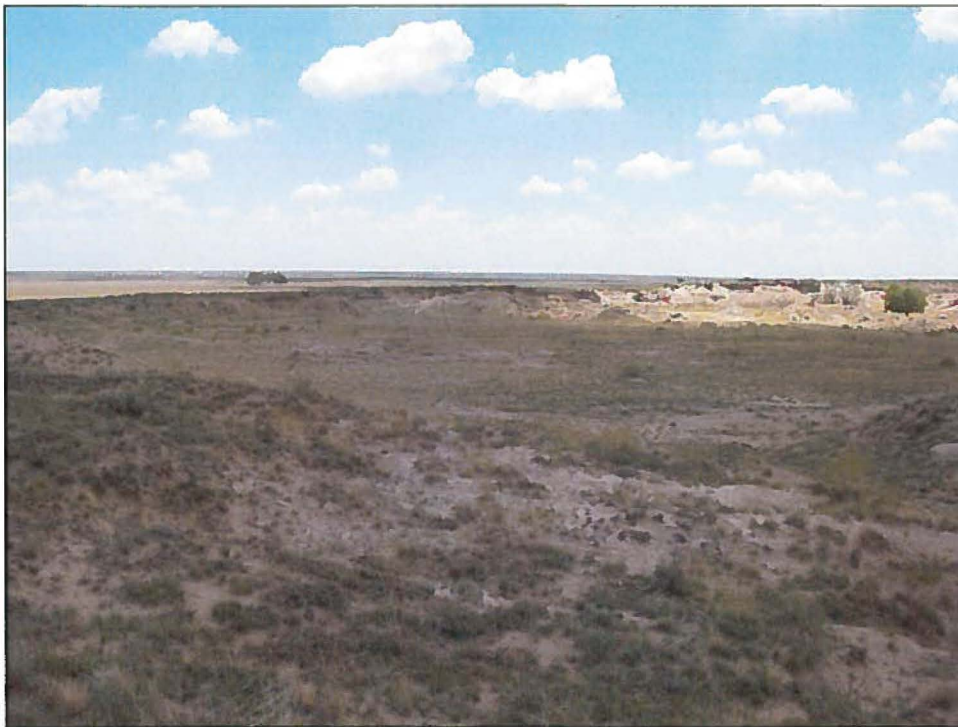
About 50% of the site includes a highwall that is 20 ft or higher and nearly vertical. Portions of this highwall on the north side are close enough to the permit boundary that either soil will need to be brought in or the permit boundary will need to be amended to allow a 3:1 slope grade as required for reclamation.

There was pre-law mining in this area on the western and southern parts of the current permit boundary. This pre-law activity sits adjacent to the permit and has not been properly reclaimed. While the operator is not responsible for this pre-law mining, it should be noted that it is there.

Photo 3. Looking northeast. Pre-law workings are in foreground. Highwall is visible in back.
