COLORADO DIVISION OF RECLAMATION, MINING AND SAFETY
MINERALS PROGRAM INSPECTION REPORT
PHONE: (303) 866-3567

MINE NAME: Midwestern Farms	MINE/PROSPECTING ID#: M-1993-059	MINERAL: Sand and gravel	COUNTY: Prowers
INSPECTION TYPE: Monitoring	INSPECTOR(S): T C. Wait	INSP. DATE: July 11, 2012	INSP. TIME: 09:10
OPERATOR: Midwestern Farms Resource dba Eastern Colo Aggregates	OPERATOR REPRESENTATIVE: Joe Baxter, Travis Hunter	TYPE OF OPERATION: 112c - Construction Regular Operation

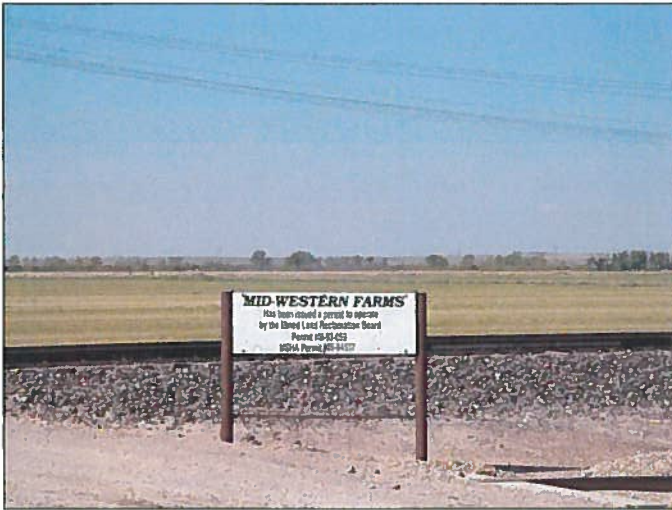
Photo 1. Permit sign, looking southwest

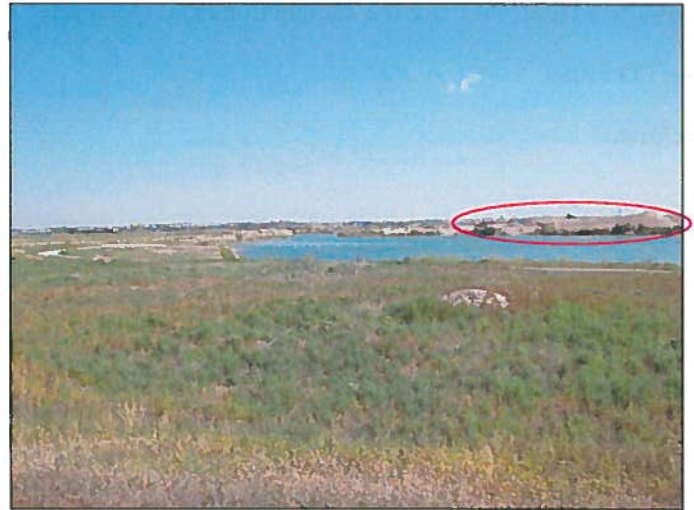
Based on the conditions of the site at the time of the inspection, the western portion of the site is ready for release. If a formal release request is received by DRMS within 60 days of this inspection report, an additional release inspection by DRMS will not be required. The fishing pond will need improvements for bank stability and tamarisk control. The mine activity in the remainder of the site appears to be in compliance with DRMS regulations.

Noted areas of Tamarisk throughout the permit area. Tamarisk is prevalent beyond the permit boundary in the Arkansas River flood plain. A weed management plan should be implemented to manage the tamarisk and other weeds so that they do not become problematic.

Photo 2. Fishing pond and cropland area, looking north from southern boundary (Tamarisk areas in red).

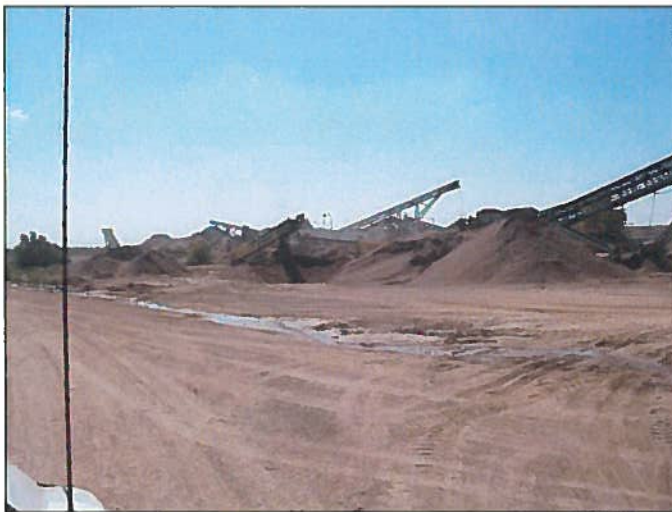
Photo 3. Crusher area

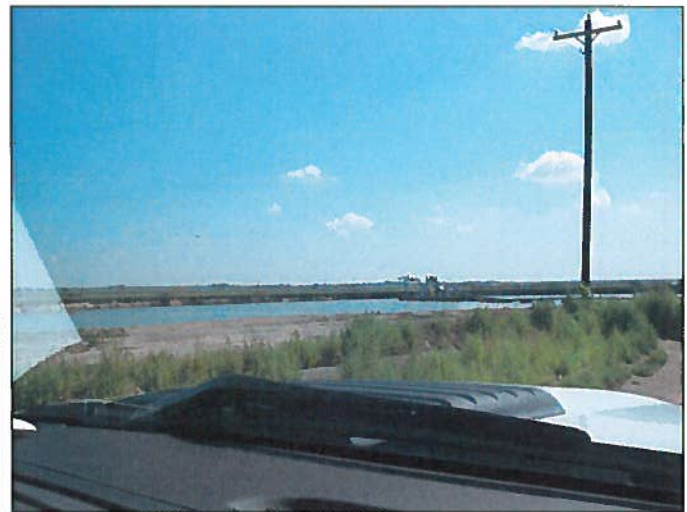
The operator estimates the active area is about 120 acres, and dredging to a depth of 85 feet.

Photo 4. Active dredge operations in Phase 2.
