COLORADO DIVISION OF RECLAMATION, MINING AND SAFETY MINERALS PROGRAM INSPECTION REPORT

MINE NAME:	MINE/PROSPECTING ID#:	MINERAL:	COUNTY:
North Clear Creek Const. Materials Mine	M-2006-039	Borrow	Garfield
INSPECTION TYPE:	INSPECTOR(S):	INSP. DATE:	INSP. TIME:
Monitoring	Travis H. Marshall	July 17, 2012	10:30
OPERATOR:	OPERATOR REPRESENTATIVE:	TYPE OF OPERATION:	
Chevron U.S.A. Inc.	Julie Justus	110c - Construction Limited Impact

PERMIT #: M-2006-039 INSPECTOR'S INITIALS: THM INSPECTION DATE: July 17, 2012

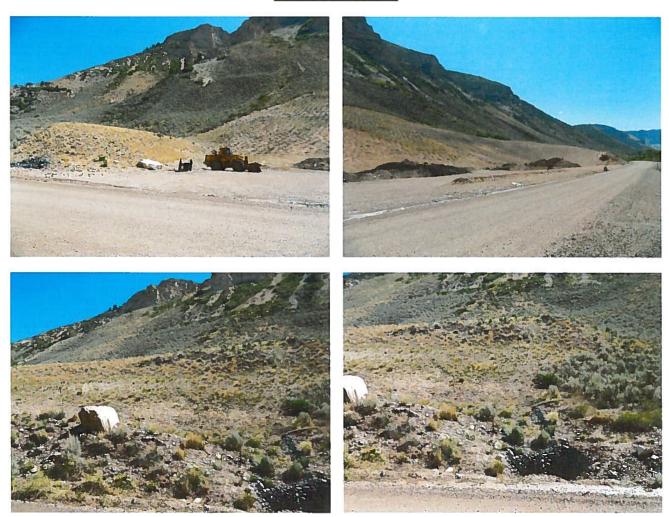
PHOTOGRAPHS

Various pieces of heavy equipment were located within the permit area. The mine was inactive during the inspection. It appeared that only 2-3 acres of reserve material remains.
