**COLORADO DIVISION OF RECLAMATION, MINING AND SAFETY**  
**MINERALS PROGRAM INSPECTION REPORT**  
**PHONE: (303) 866-3567**

<b>MINE NAME:</b> Shot Rock Pit	<b>MINE/PROSPECTING ID#:</b> M-2012-023	<b>MINERAL:</b> Crushed stone material	<b>COUNTY:</b> Las Animas
<b>INSPECTION TYPE:</b> Preoperation Inspection	<b>INSPECTOR(S):</b> T C. Wait	<b>INSP. DATE:</b> July 24, 2012	<b>INSP. TIME:</b> 15:55
<b>OPERATOR:</b> Tamrock Gravel	<b>OPERATOR REPRESENTATIVE:</b> Brent Tamburelli	<b>TYPE OF OPERATION:</b> 112c - Construction Regular Operation

<b>REASON FOR INSPECTION:</b> Pre-operation Inspection	<b>BOND CALCULATION TYPE:</b> Complete Bond	<b>BOND AMOUNT:</b> TBD
<b>DATE OF COMPLAINT:</b> NA	<b>POST INSP. CONTACTS:</b> None	<b>JOINT INSP. AGENCY:</b> None
<b>WEATHER:</b> Partly-Cloudy	<b>INSPECTOR'S SIGNATURE:</b>

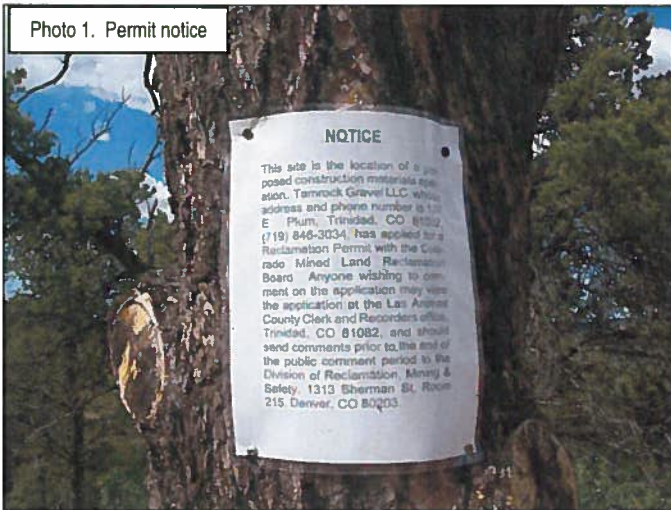
Notice is posted on a tree in the permit area. The proposed permit boundaries are marked with t-posts.

Photo 1. Permit notice

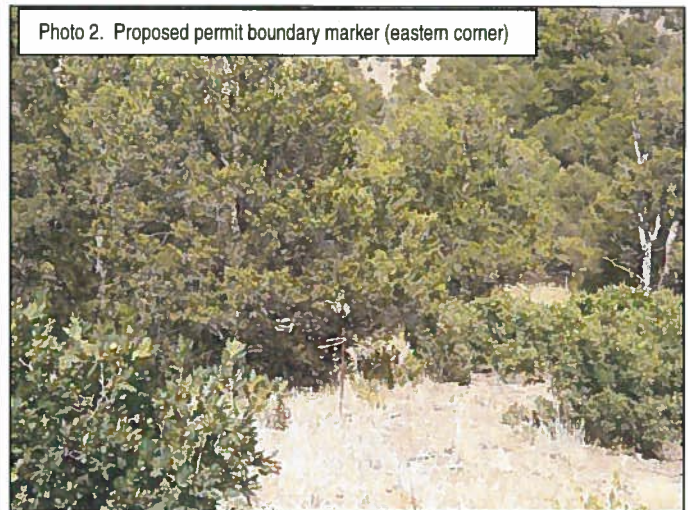
Photo 2. Proposed permit boundary marker (eastern corner)

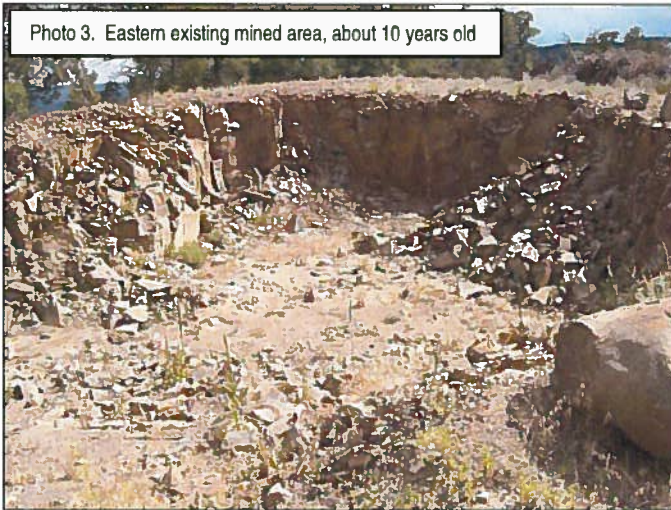
Photo 3. Eastern existing mined area, about 10 years old

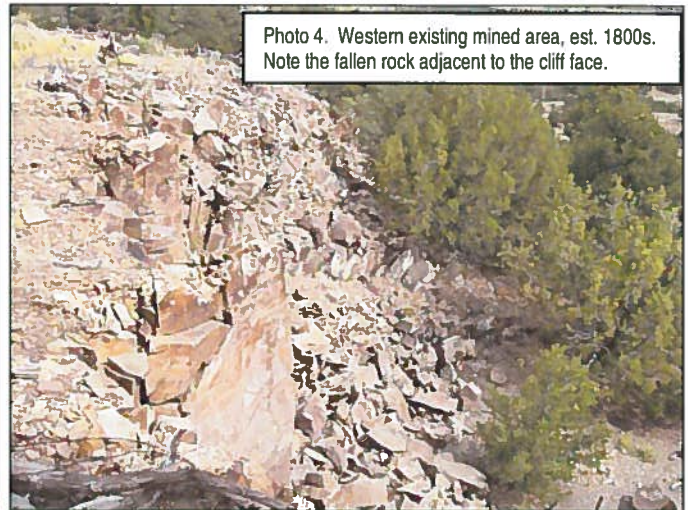
Photo 4. Western existing mined area, est. 1800s. Note the fallen rock adjacent to the cliff face.

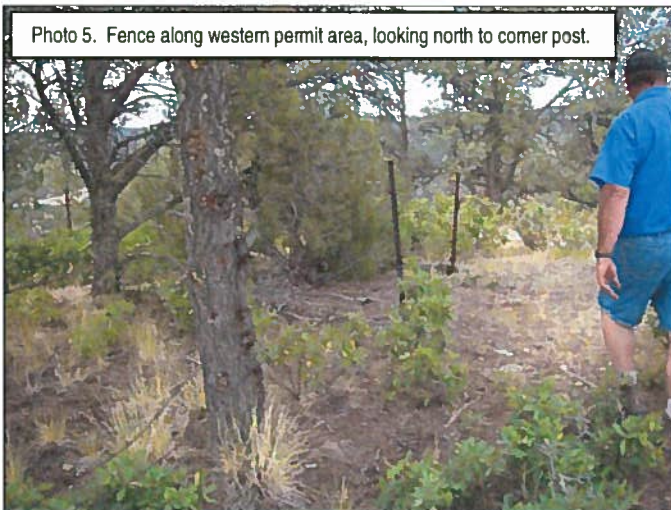
Photo 5. Fence along western permit area, looking north to corner post.

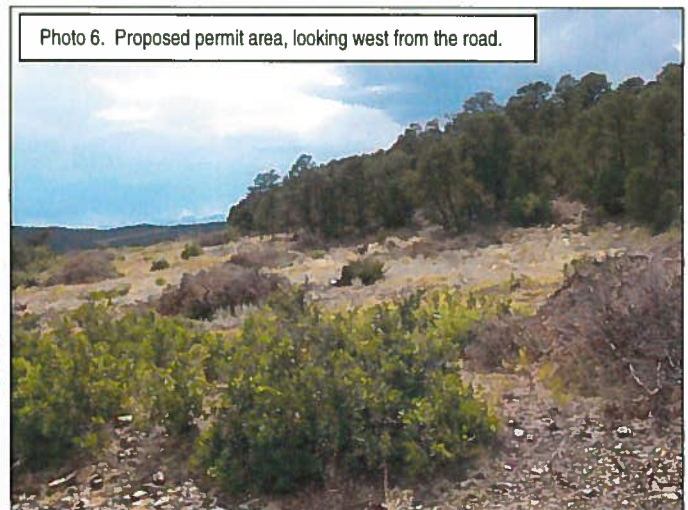
Photo 6. Proposed permit area, looking west from the road.
