COLORADO DIVISION OF RECLAMATION, MINING AND SAFETY
MINERALS PROGRAM INSPECTION REPORT
PHONE: (303) 866-3567

MINE NAME: Mancos Gravel Pit	MINE/PROSPECTING ID#: M-1985-031	MINERAL: Sand and gravel	COUNTY: Montezuma
INSPECTION TYPE: Monitoring	INSPECTOR(S): Wallace H. Erickson	INSP. DATE: August 16, 2012	INSP. TIME: 09:45
OPERATOR: Montezuma County	OPERATOR REPRESENTATIVE: Randy Smith	TYPE OF OPERATION: 112c - Construction Regular Operation

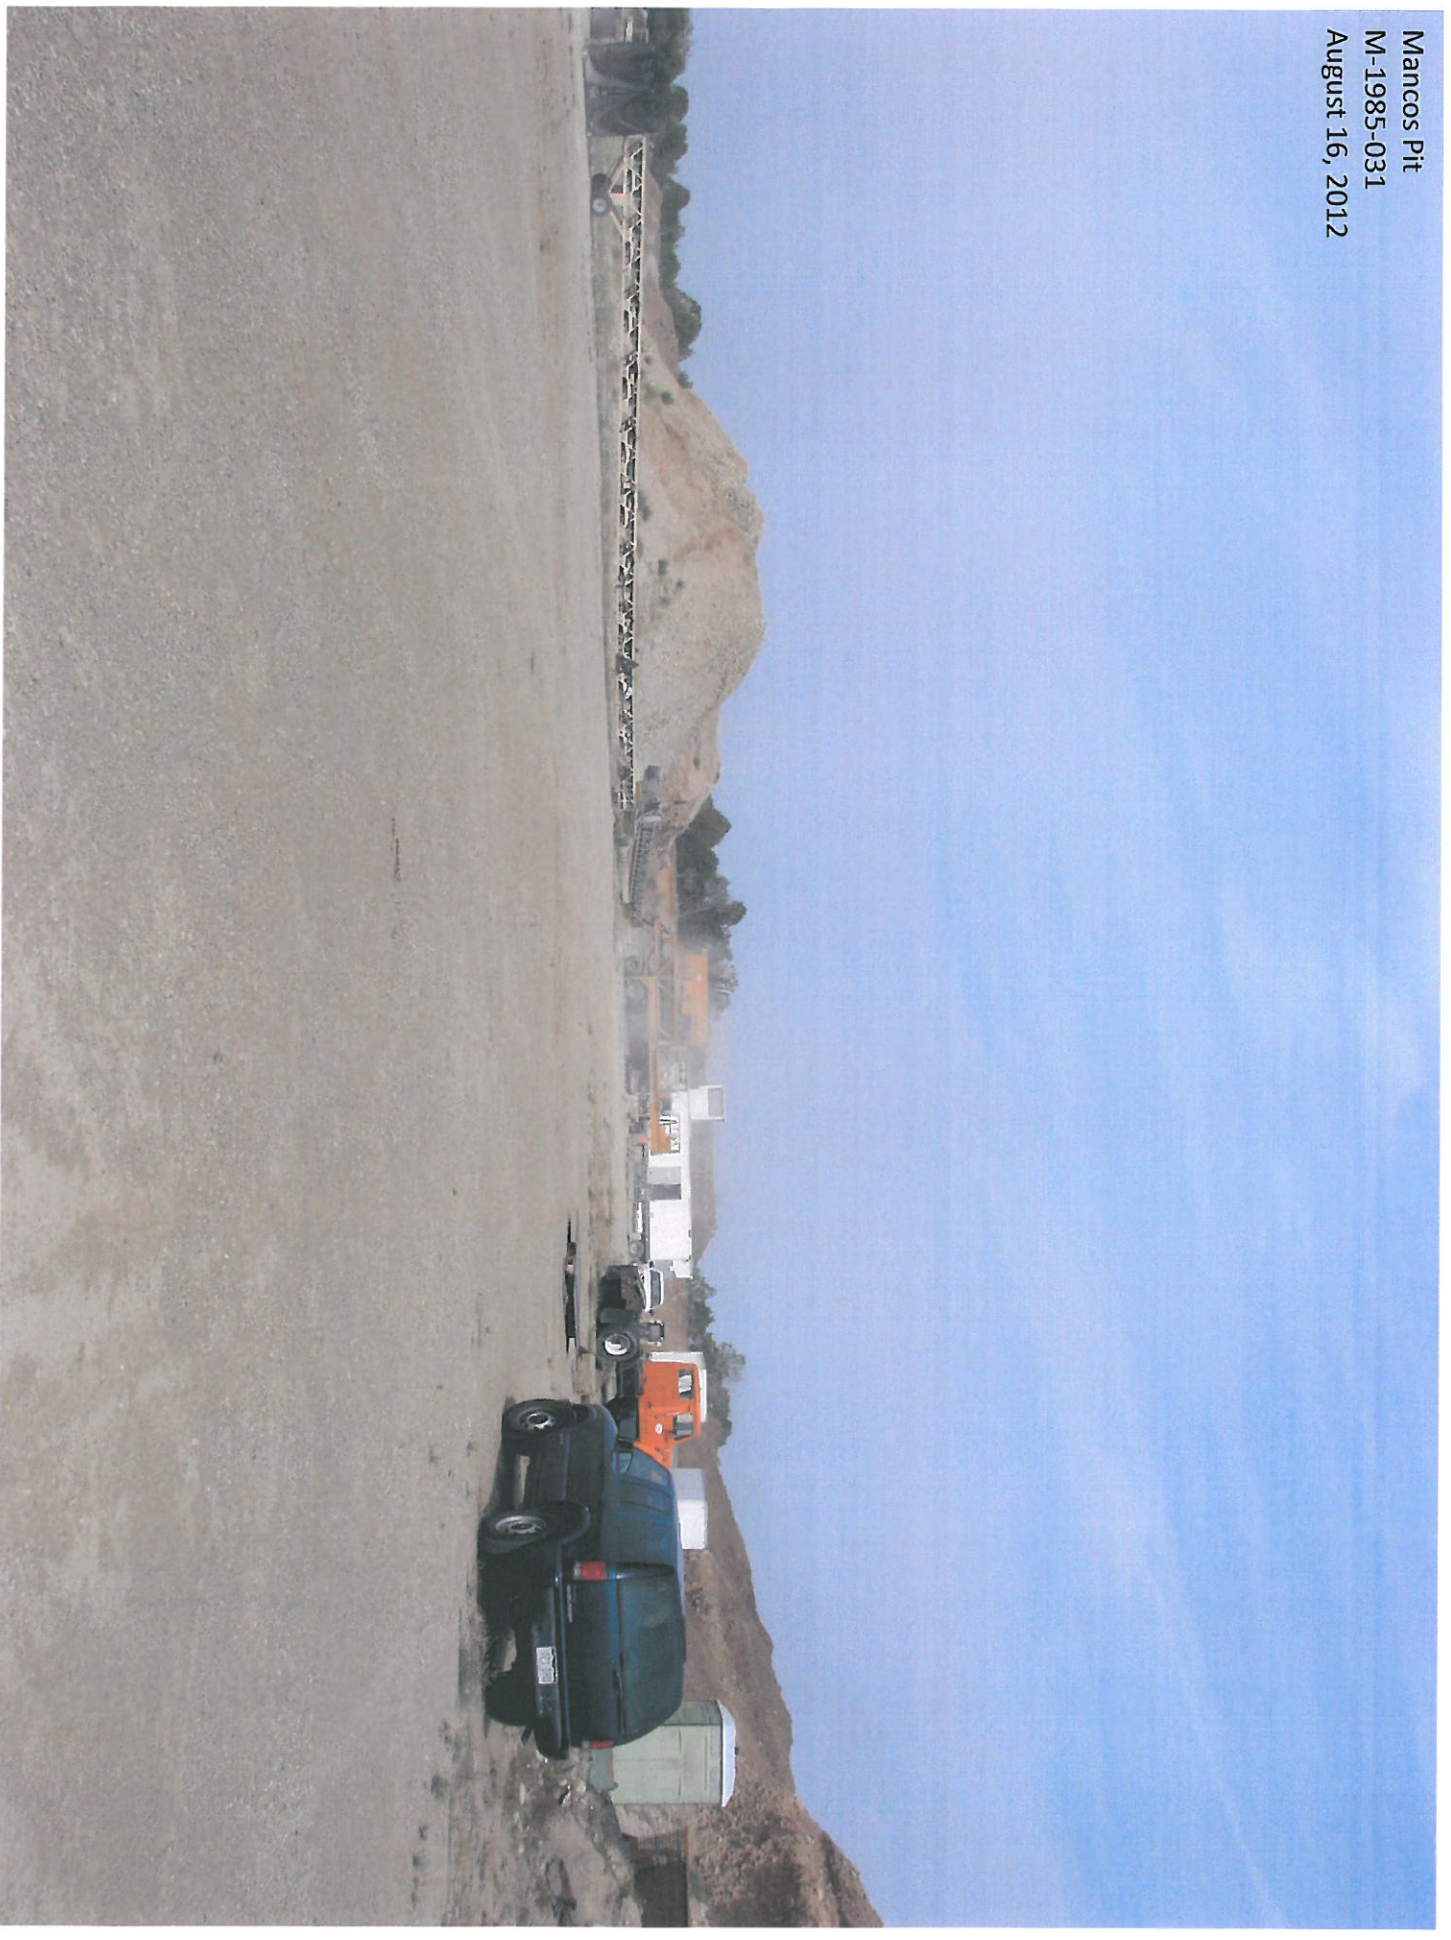
Mancos Pit
M-1985-031
August 16, 2012

Mining activities have advanced into the Phase 3 area, as delineated on the mining and reclamation maps, and appeared compliant with permit conditions. As shown in the enclosed photos, the crusher was active, processed materials were being stockpiled. The permit area includes previous agricultural lands. Irrigated fields are located up gradient of the active pit area. The Operator indicated the mining operation occasionally intercepts minor drainage from these up gradient areas, evident in intermittent drainage from the highwall and/or along the shale strata immediately underlying the gravel deposit. Minor water was flowing in the natural drainage channel, evident on the south side of the processing yard and extending down gradient and off permit. Minor water was also observed at an isolated location in the reclaimed Phase 2 area, immediately west of the processing yard. The water at the Phase 2 reclaimed areas was several inches deep. Willows, cat tails, rushes and sedges were present at the location of minor water in the Phase 2 reclaimed area. The drainage appeared associated with the irrigation activity located up gradient of the active pit area; otherwise the wetted area should receive additional backfill as necessary to ensure the ground water is not exposed. Deer were observed in the Phase 2 reclaimed area.
