COLORADO DIVISION OF RECLAMATION, MINING AND SAFETY
MINERALS PROGRAM INSPECTION REPORT
PHONE: (303) 866-3567

MINE NAME: Nicolas Pit	MINE/PROSPECTING ID#: M-1991-104	COMMODITY: Sand and Gravel	COUNTY: Gunnison
INSPECTION TYPE: Monitoring	INSPECTOR(S): Dustin Czapla	INSP. DATE: August 14, 2012	INSP. TIME: 10:00
OPERATOR: Gunnison County	OPERATOR REPRESENTATIVE: Alan Moore	TYPE OF OPERATION: 110(c)	
REASON FOR INSPECTION: Monitoring	BOND CALCULATION TYPE: None	BOND AMOUNT: \$ NA	
DATE OF COMPLAINT: NA	POST INSP. CONTACTS: None	JOINT INSPECTION AGENCY: None	
WEATHER: Clear	INSPECTOR'S SIGNATURE:

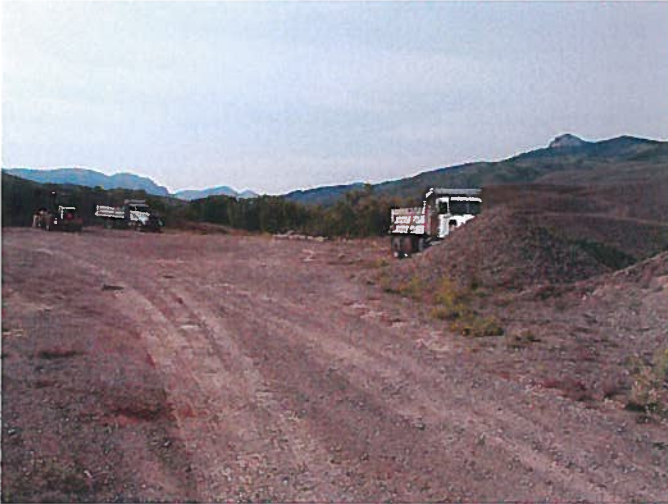
Figure 1: View facing south from near site entrance.

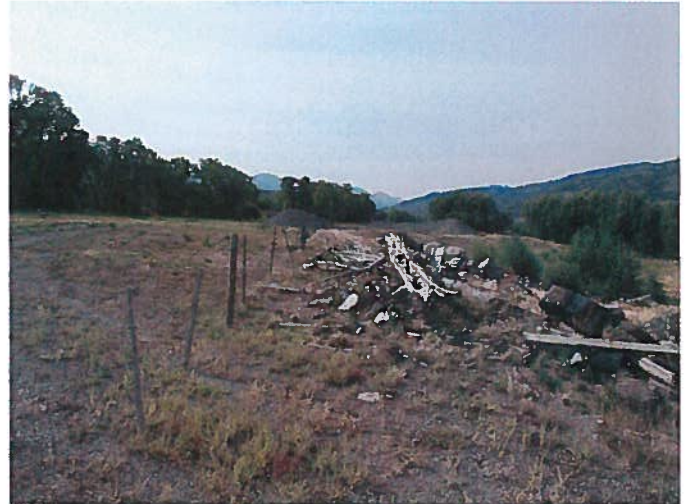
The affected area was marked by fencing that was clearly visible and adequate to delineate the affected area boundary.

Figure 2: View facing south down fence line separating the original and amended permit boundaries. The amended area is seen on the left side of the fence.

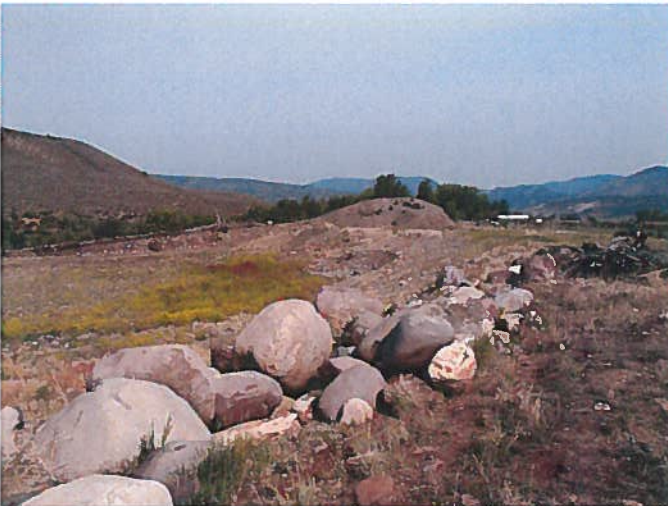
Some stockpile removal was occurring during this inspection. Evidence of any recent excavation was not noted. The county typically mines and crushes enough material to last for approximately three years, so active mining/processing is infrequent at this site.

Figure 3: View facing northwest toward mine face and crushing area.

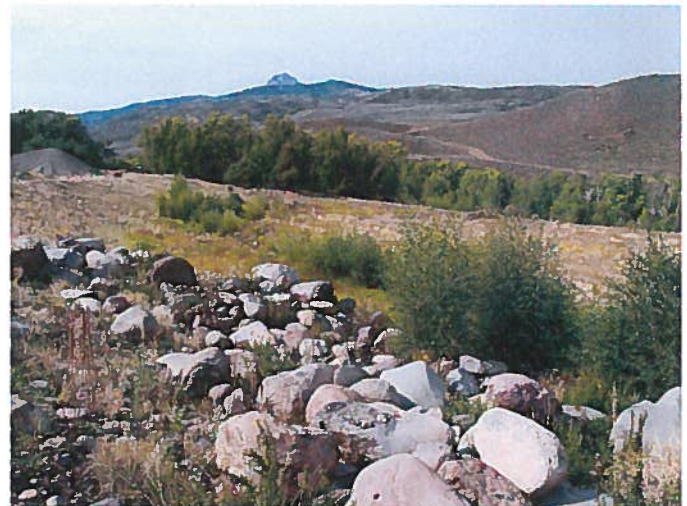
Mined slopes were left at 2H:1V or less and appeared stable.

Figure 4: View facing southwest toward mined area.
