COLORADO DIVISION OF RECLAMATION, MINING AND SAFETY
MINERALS PROGRAM INSPECTION REPORT
PHONE: (303) 866-3567

MINE NAME: Tamarcaz Pit	MINE/PROSPECTING ID#: M-1985-072	COMMODITY: Sand and Gravel	COUNTY: Gunnison
INSPECTION TYPE: Monitoring	INSPECTOR(S): Dustin Czapla	INSP. DATE: August 15, 2012	INSP. TIME: 12:30
OPERATOR: Gunnison County	OPERATOR REPRESENTATIVE: Alan Moore	TYPE OF OPERATION: 110(c)	
REASON FOR INSPECTION: Monitoring	BOND CALCULATION TYPE: None	BOND AMOUNT: \$ NA	
DATE OF COMPLAINT: NA	POST INSP. CONTACTS: None	JOINT INSPECTION AGENCY: None	
WEATHER: Clear	INSPECTOR'S SIGNATURE:

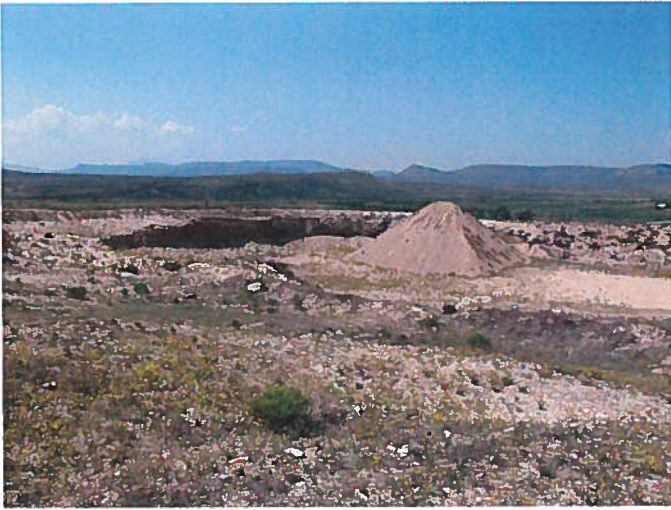
Evidence of any recent excavation was not noted. The county typically mines and crushes enough material to last for approximately three years, so active mining/processing is infrequent at this site. A near-vertical highwall was left along the south pit boundary. Other mined slopes were left at approximately 3H:1V. Two gravel stockpiles were located on the pit floor. Topsoil stockpiles were located at the northeast rim of the pit.

Figure 1: View toward the south highwall.

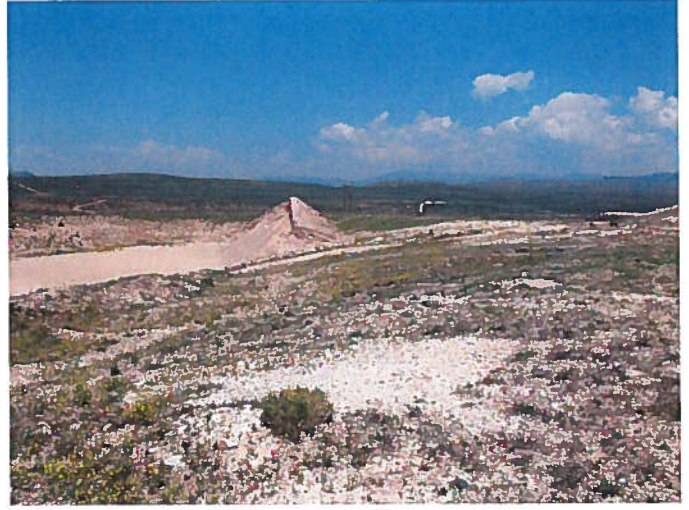
Figure 2: View toward the north pit area.

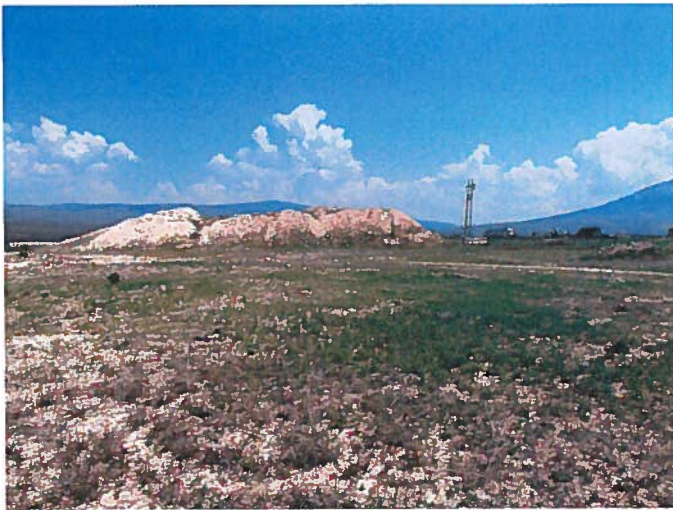
Figure 3: Topsoil pile located at the northeast side of the pit.

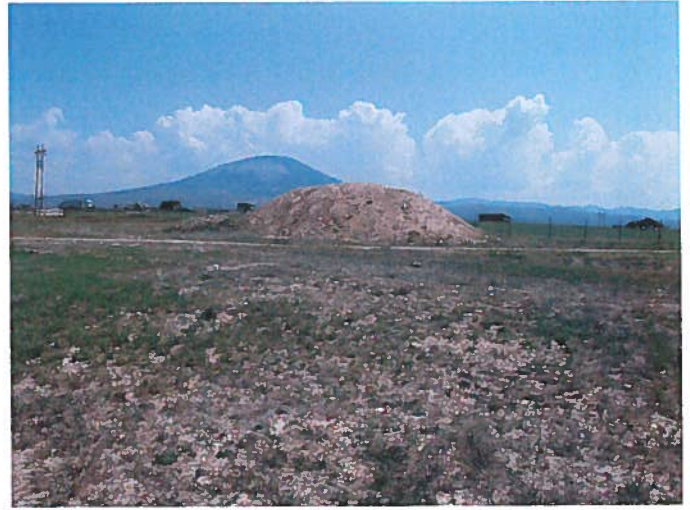
Figure 4: Topsoil pile located at the northeast side of the pit.
