COLORADO DIVISION OF RECLAMATION, MINING AND SAFETY MINERALS PROGRAM INSPECTION REPORT

MINE NAME:	MINE/PROSPECTING ID#:	COMMODITY:	COUNTY:
Mountain View Pit	M-1981-002	Sand and Gravel	Gunnison
INSPECTION TYPE:	INSPECTOR(S):	INSP. DATE:	INSP. TIME:
Monitoring	Dustin Czapla	August 17, 2012	09:00
OPERATOR:	OPERATOR REPRESENTATIVE:	TYPE OF OPERATION:	
Town of Crested Butte	Bob Gilley, Rodney Due	110(c)	
REASON FOR INSPECTION:	BOND CALCULATION TYPE:	BOND AMOUNT:	
Monitoring	None	\$ NA	
DATE OF COMPLAINT:	POST INSP. CONTACTS:	JOINT INSPECTION AGENCY:	
NA	None	None	
WEATHER:	INSPECTOR'S SIGNATURE:	SIGNATURE DATE:	
Clear		August 21, 2012

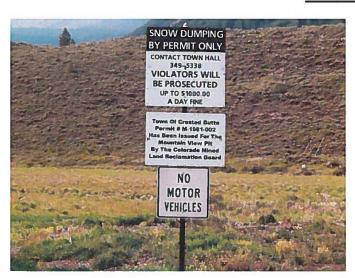
Adequate mine identification signage was noted at the entrance to the site.

Figure 1: Mine ID sign located at site entrance.

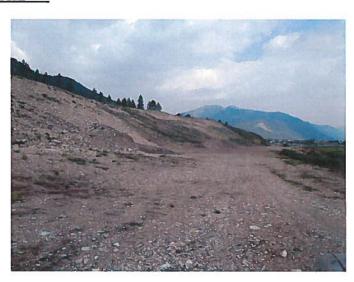
Figure 2: View of site, facing northwest, from the east side of the permit area.

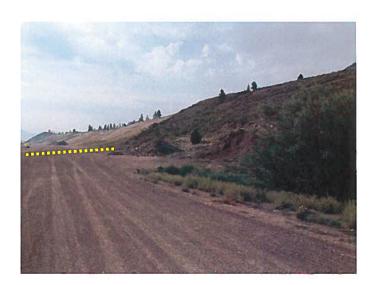
The affected area was marked by survey lathe that was clearly visible and adequate to delineate the affected area boundary.

Figure 3: View of site, facing southeast, from the west side of the permit area. The yellow line is the approximate west permit boundary.
