COLORADO DIVISION OF RECLAMATION, MINING AND SAFETY
MINERALS PROGRAM INSPECTION REPORT
PHONE: (303) 866-3567

MINE NAME: Dickerson Pit	MINE/PROSPECTING ID#: M-1978-305	COMMODITY: Granite/Volcanic	COUNTY: Gunnison
INSPECTION TYPE: Monitoring	INSPECTOR(S): Dustin Czaplá	INSP. DATE: August 15, 2012	INSP. TIME: 8:00
OPERATOR: Gunnison Aggregate Resources, LLC	OPERATOR REPRESENTATIVE: Warren Wilcox	TYPE OF OPERATION: 112(c)	
REASON FOR INSPECTION: Monitoring	BOND CALCULATION TYPE: Complete	BOND AMOUNT: \$ 66,518.00	
DATE OF COMPLAINT: NA	POST INSP. CONTACTS: None	JOINT INSPECTION AGENCY: None	
WEATHER: Clear	INSPECTOR'S SIGNATURE:

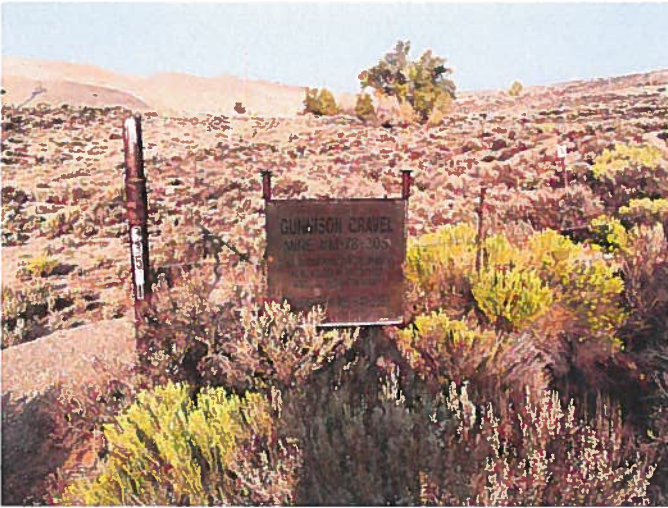
Adequate mine identification signage was noted at the entrance to the site.

Figure 1: Mine ID sign located at site entrance.

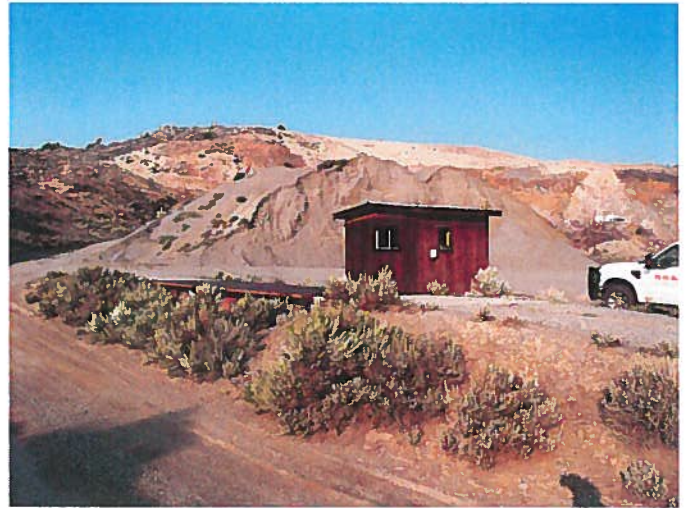
A scale and small scale house were located at the east side of the pit area. A stockpile of crushed material was located in this area as well. The disturbance footprint at the site did not appear to have increased since the last inspection. Any excavation that has occurred at the site has merely lowered the pit floor elevation.

Figure 2: Scale and scale house located on the east side of the pit area. Reclaimed slopes can be seen in the background.

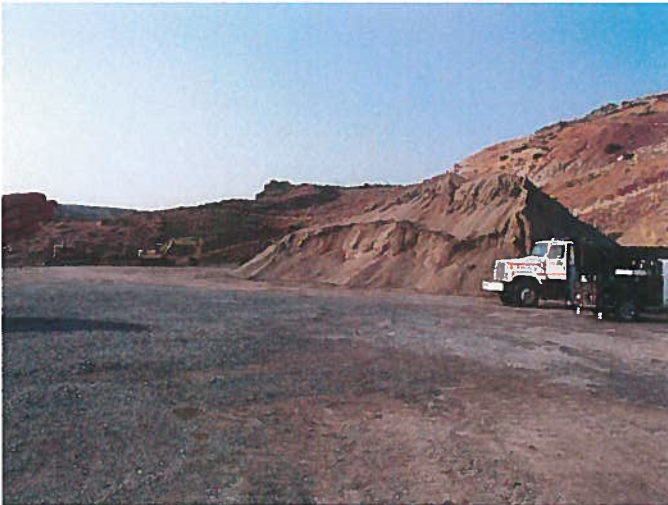
Figure 3: View from the mine floor area, facing south.

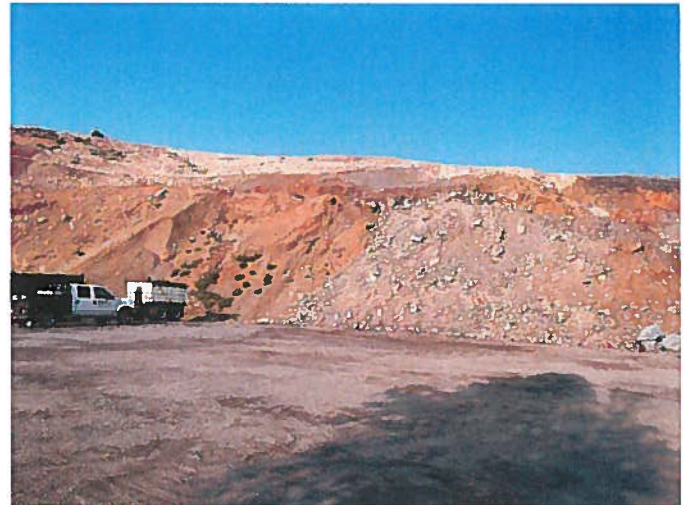
Figure 4: View from the mine floor area, facing southwest.

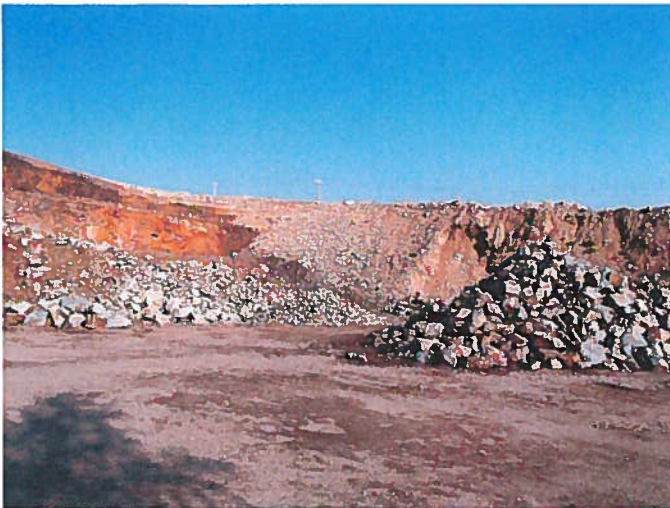
Figure 5: View from the mine floor area, facing west toward the active mine face.

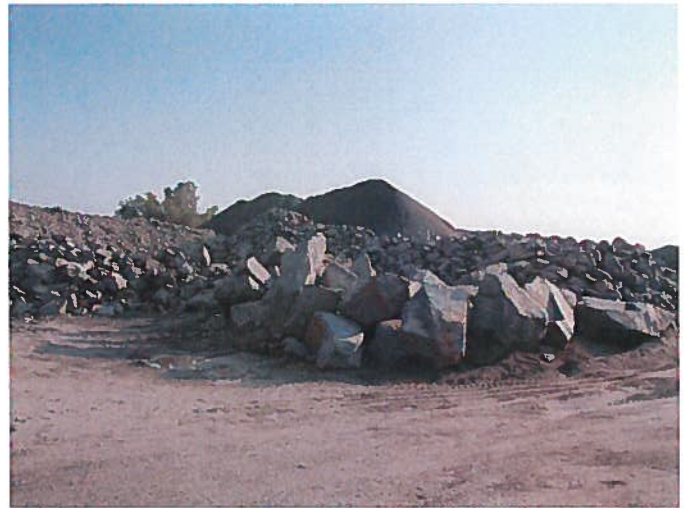
Figure 6: View from the mine floor area, facing north.

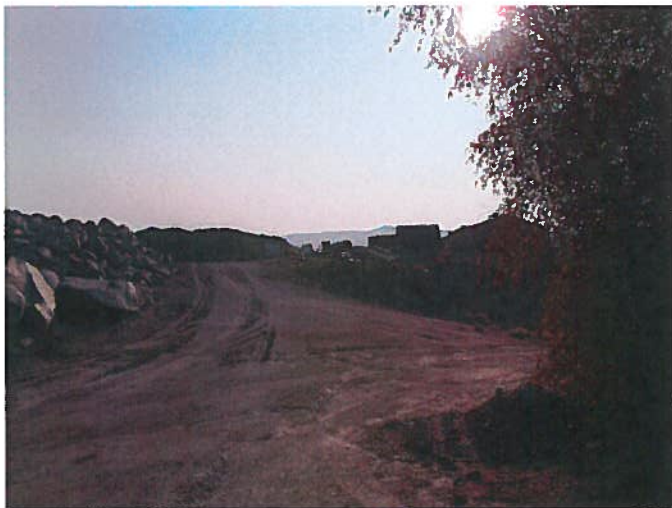
Figure 7: View of refuse storage area at the east side of the mine bench.
