COLORADO DIVISION OF RECLAMATION, MINING AND SAFETY
MINERALS PROGRAM INSPECTION REPORT
PHONE: (303) 866-3567

MINE NAME: Revenue Mine	MINE/PROSPECTING ID#: M-2012-032	MINERAL: Lead, silver and gold	COUNTY: Ouray
INSPECTION TYPE: Monitoring	INSPECTOR(S): Bob Oswald	INSP. DATE: July 25, 2012	INSP. TIME: 10:30
OPERATOR: Star Mine Operations, LLC	OPERATOR REPRESENTATIVE: James Williams	TYPE OF OPERATION: 112d-1 - Designated Mining Operation

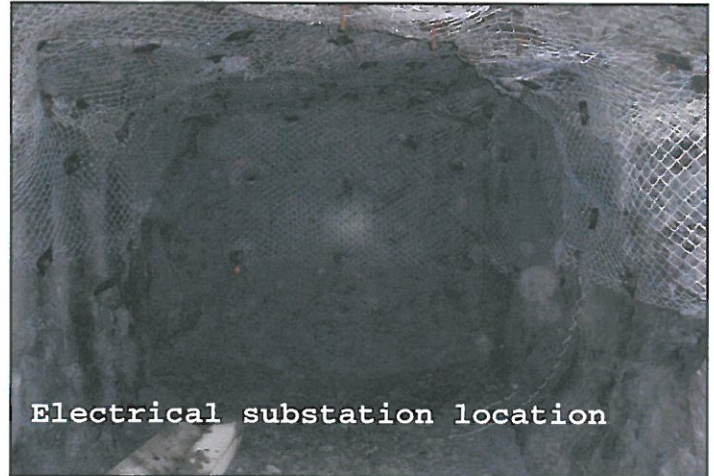
Many new areas for proposed activities will be constructed underground, for better visual quality of the site and for durability against weather and avalanches. The inspection party walked into the Revenue Tunnel to inspect recent changes. A new electric substation will be installed in a small bay that has been created a short distance in by the portal. The substation space has been meshed and rock bolted, and will be shotcreted. New, quieter ventilation fans have been installed, and with the new brattice cloth, air is directed to the headings and work areas. Drillers were active in the tunnel, and a slusher and mucker were set up to remove blasted development rock. About 550 feet in by is the intersection of the Revenue Tunnel and the Yellow Rose Vein Drift, where the group stopped. At this intersection there are two of the groundwater sampling locations, since both branches of the mine here make water. Other improvements that were observed underground include: better underground drainage control, new brattice cloth for ventilation, new cabling and pipe, new rail, new ties (wood and steel), The existing Revenue Tunnel dimensions (8' x 14') do not need to be enlarged for this new operation.

Electrical substation location

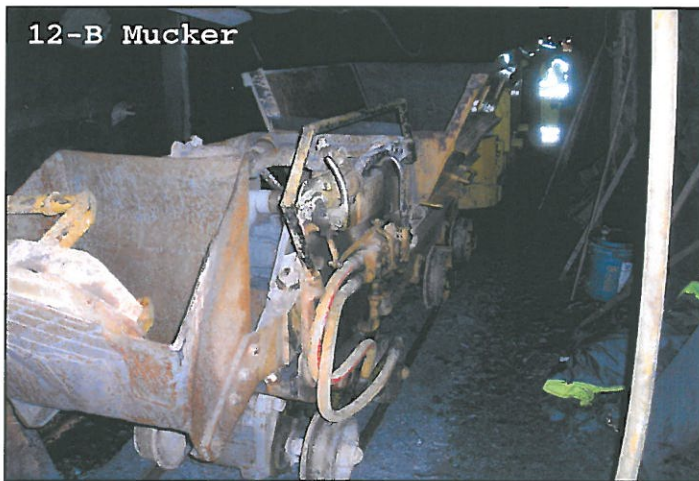
12-B Mucker

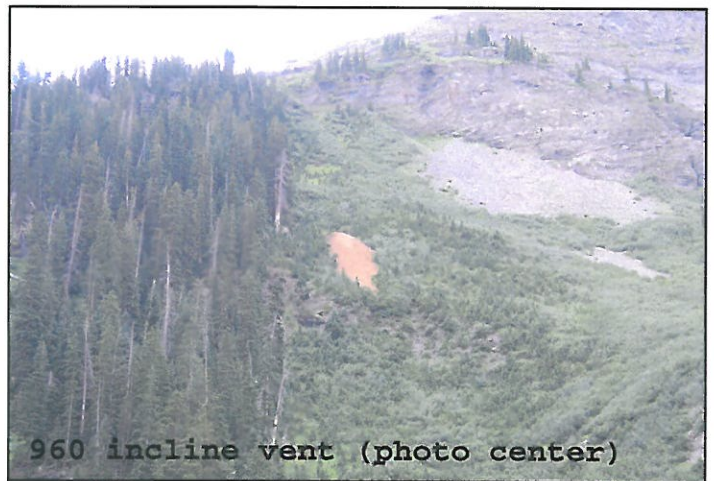
960 incline vent (photo center)

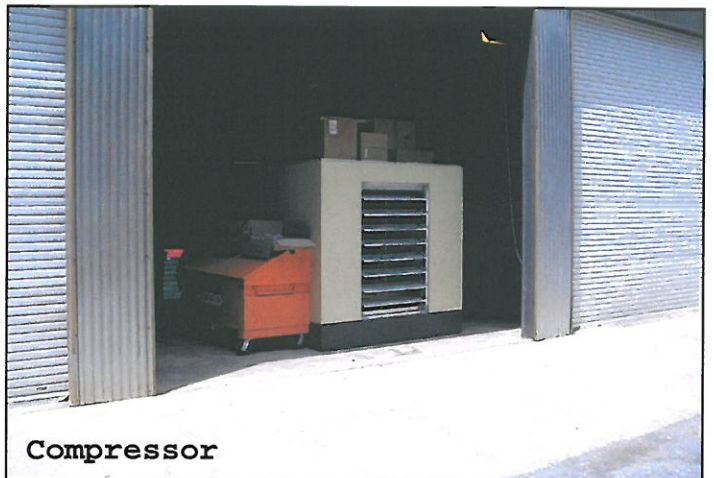
Compressor
