COLORADO DIVISION OF RECLAMATION, MINING AND SAFETY
MINERALS PROGRAM INSPECTION REPORT
PHONE: (303) 866-3567

MINE NAME: Brown Derby Mine	MINE/PROSPECTING ID#: M-1999-074	MINERAL: Gems, lepidolite	COUNTY: Gunnison
INSPECTION TYPE: Monitoring	INSPECTOR(S): Dustin M. Czapla	INSP. DATE: August 16, 2012	INSP. TIME: 09:30
OPERATOR: Precious Offerings Minerals Exchange, Inc.	OPERATOR REPRESENTATIVE: Jake Wilkinson	TYPE OF OPERATION: 110(2) - Hard Rock Limited Impact

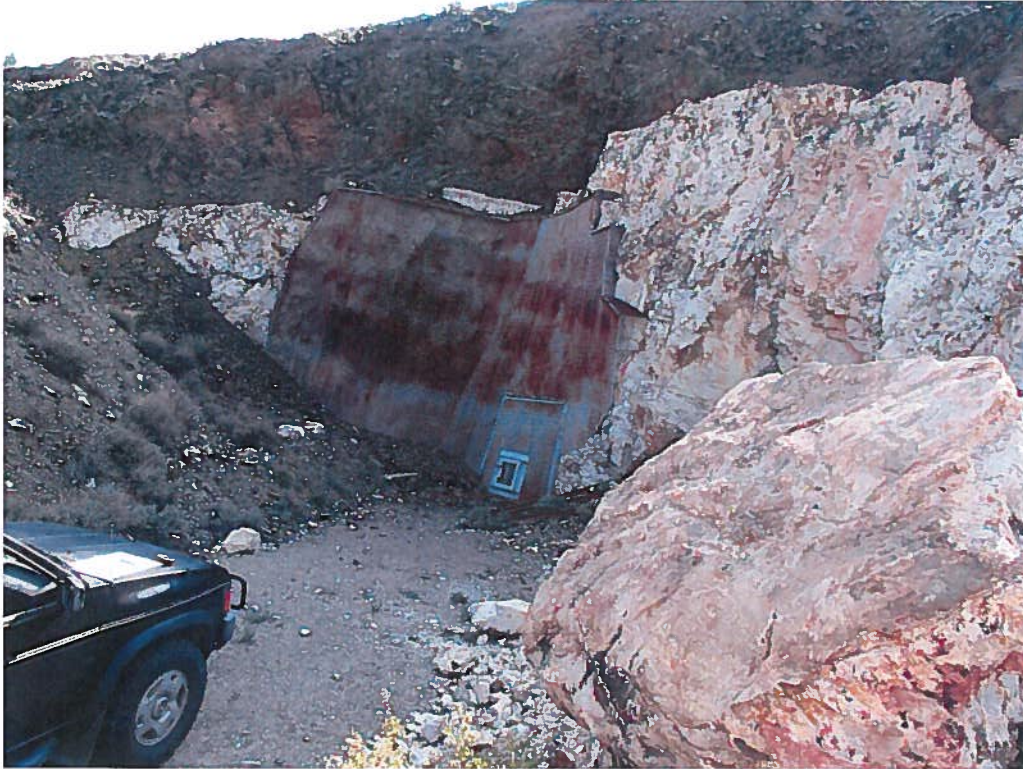
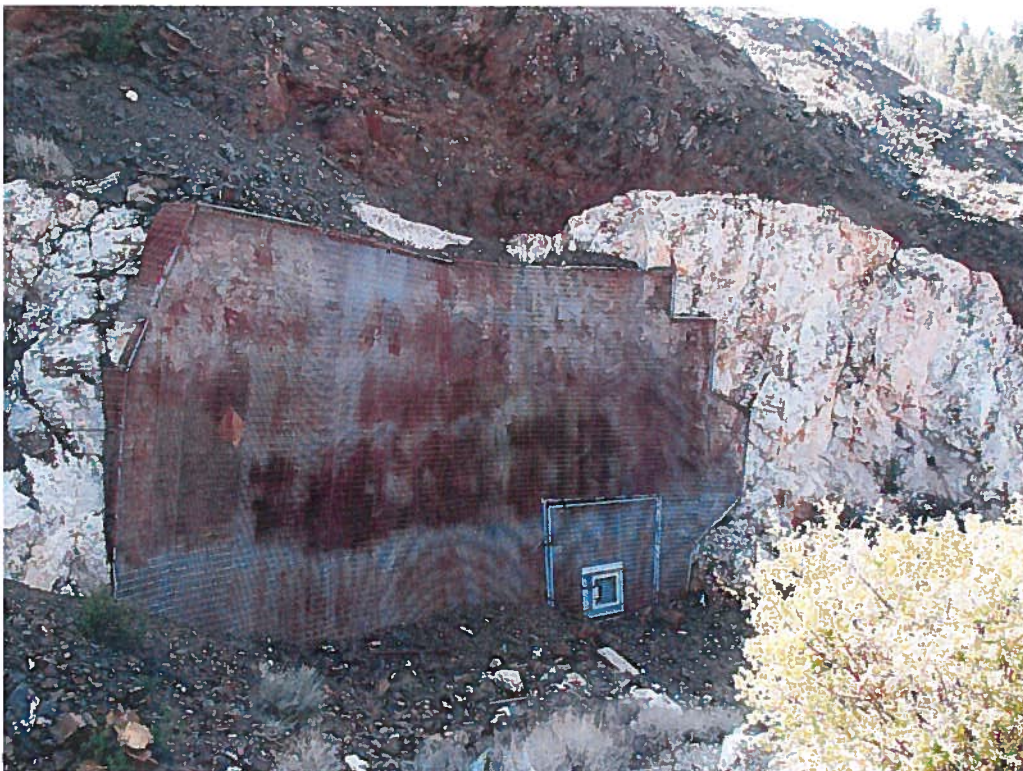
The site consists of a headwall cut into the west slope of the hill, where a grated portal is located. A flat bench area is located just outside the portal.

No stability, erosion or sedimentation concerns were noted. Overall, the site appears to be in good order.
