COLORADO DIVISION OF RECLAMATION, MINING AND SAFETY
MINERALS PROGRAM INSPECTION REPORT
PHONE: (303) 866-3567

MINE NAME: Gold Links Mine	MINE/PROSPECTING ID#: M-1987-143	MINERAL: Silver and gold	COUNTY: Gunnison
INSPECTION TYPE: Monitoring	INSPECTOR(S): Dustin M. Czapla	INSP. DATE: August 16, 2012	INSP. TIME: 11:00
OPERATOR: CRG Mining, LLC	OPERATOR REPRESENTATIVE: Jake Wilkinson	TYPE OF OPERATION: 110(2) - Hard Rock Limited Impact

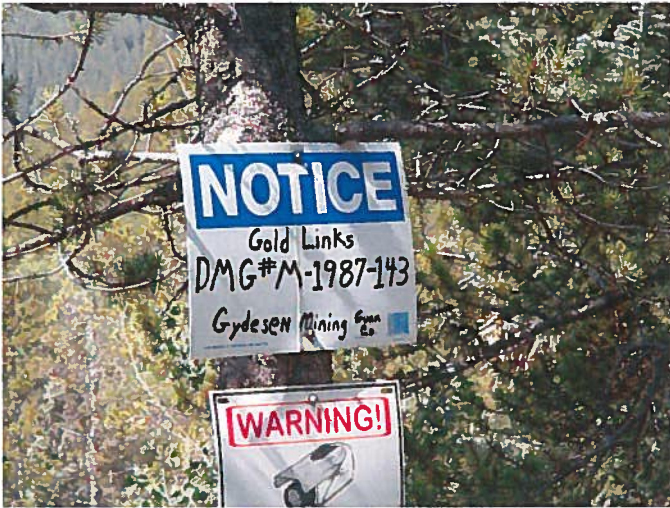
Adequate mine identification signage was noted at the entrance to the site.

Figure 1: Mine I.D. sign located at site entrance.

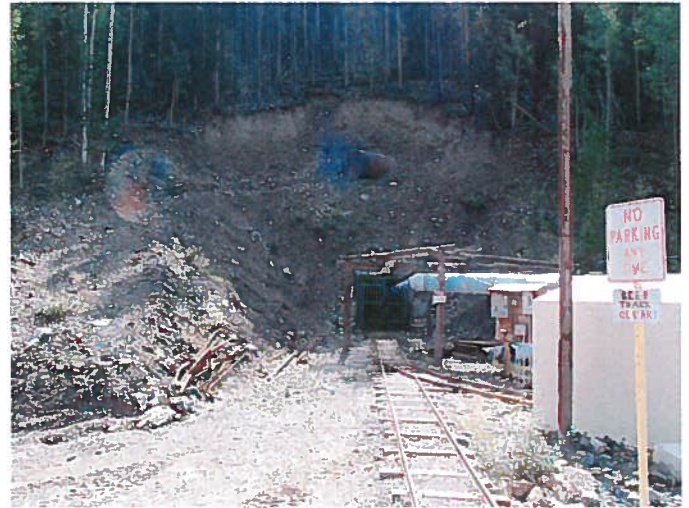
The portal appeared stable, with locking steel gates to prevent unauthorized entry. An escapeway had been installed on the bench directly above the portal.

Figure 2: Portal and escapeway.

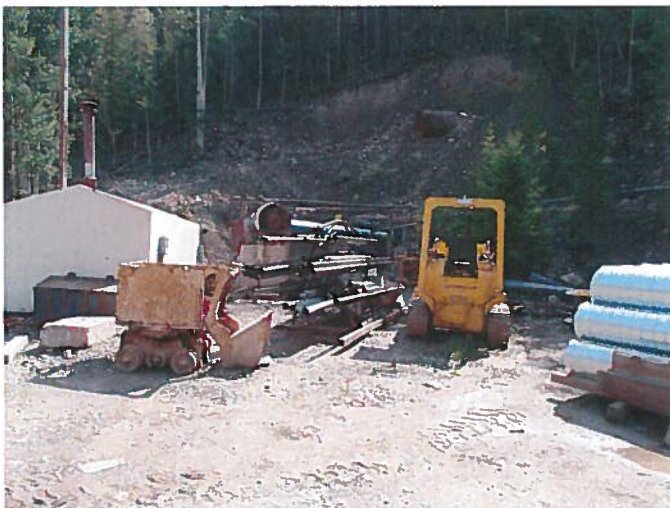
Figure 3: Area outside portal – generator building and ventilation system.

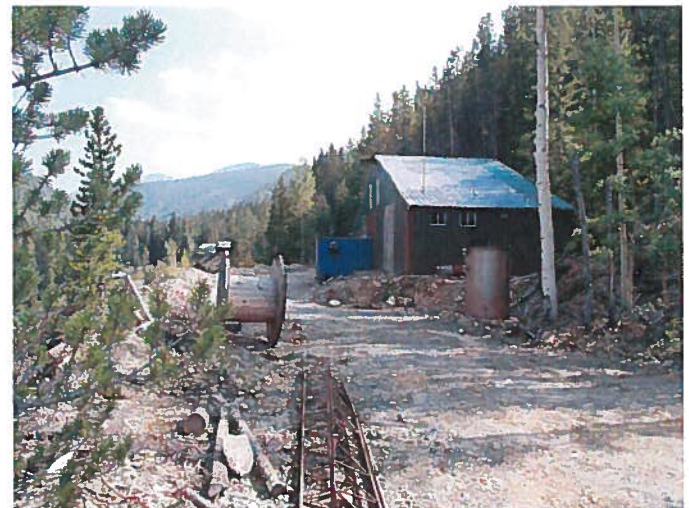
Figure 4: Crushing building located in the south permit area.

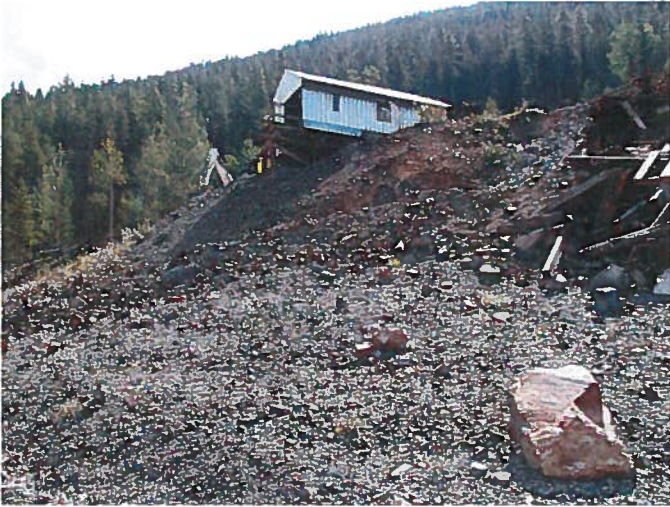
Figure 5: Old load out area.

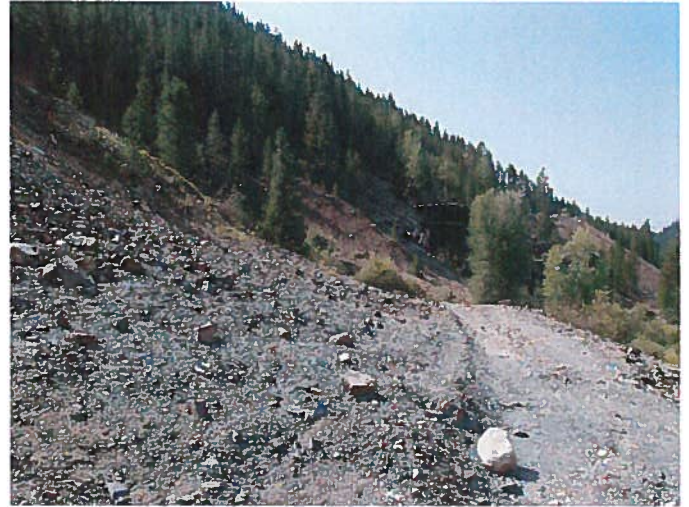
Figure 6: View south toward old mill area.

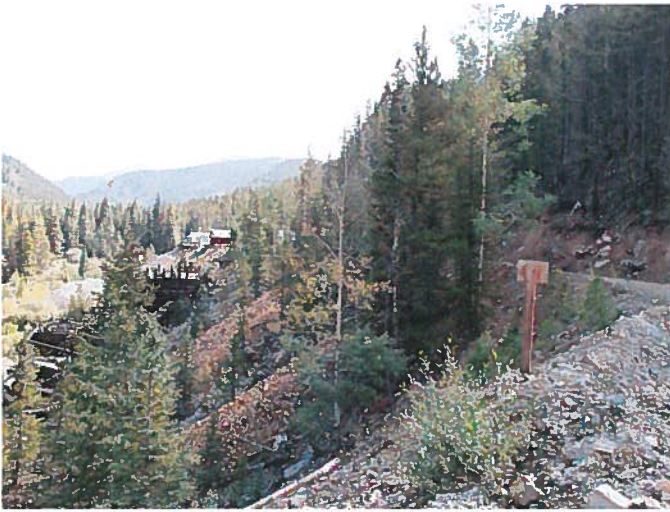
Figure 7: View north from south end of permit area.
