File Code: 2810

Date: August 24, 2012

**Greyhound Mine drilling post inspection notes and followup work to close up project for 2012.**

**Liz Mauch, Ouray Ranger District, August 23, 2012 inspection**

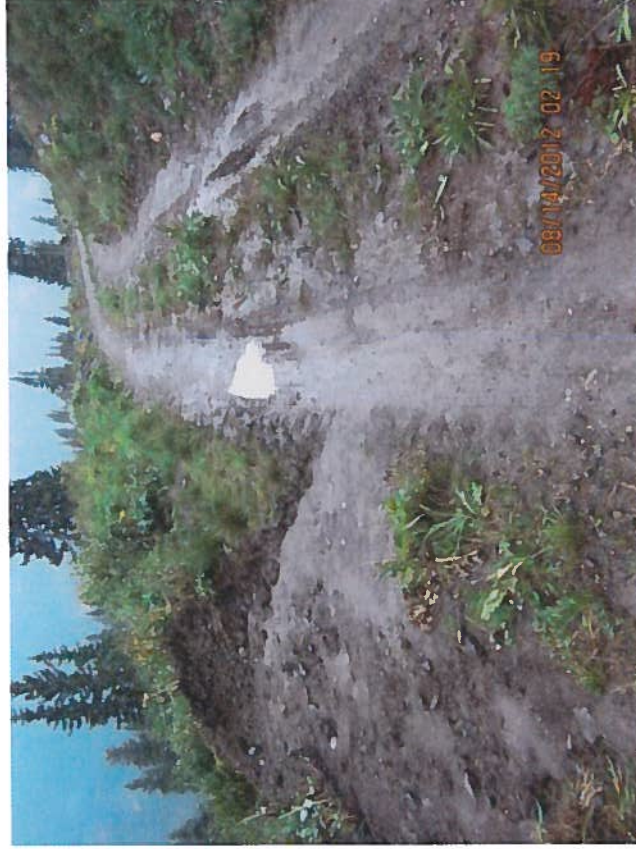
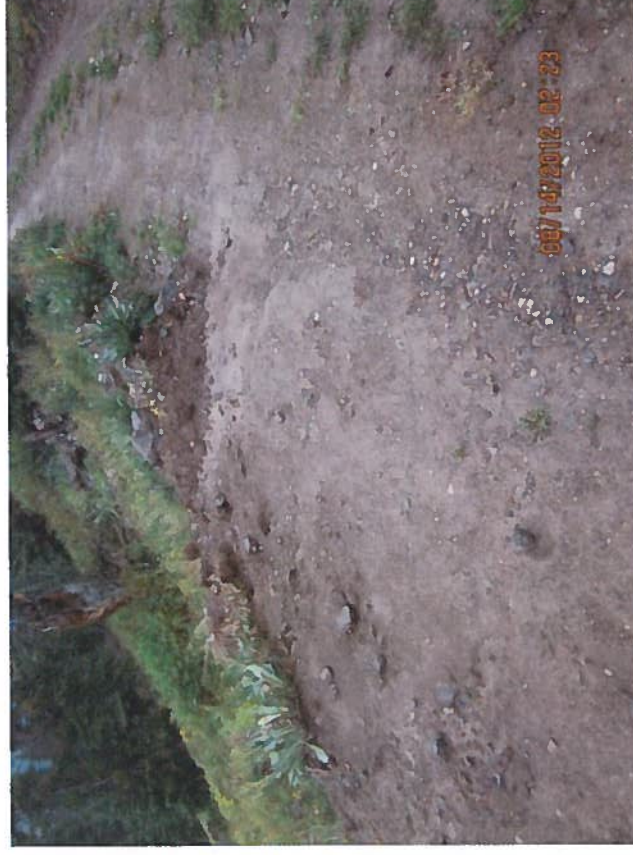
several spots have been bladed to create an opening for water to drain, but are too flat and water doesn't drain. Need to use a shovel to better define the drainage to get it to drain off the road.

Apply seed in areas where the blade has scraped off several square feet of vegetation, as illustrated in these photos.

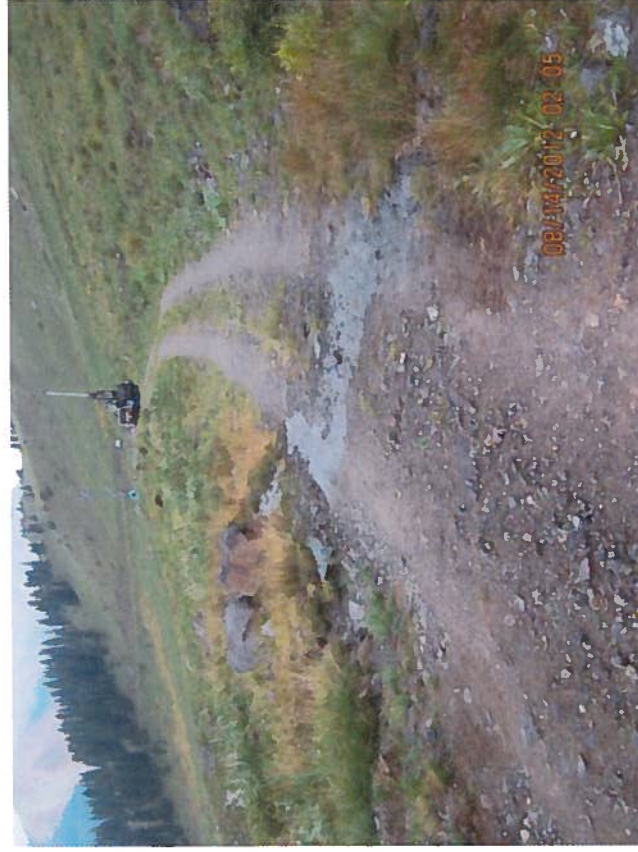
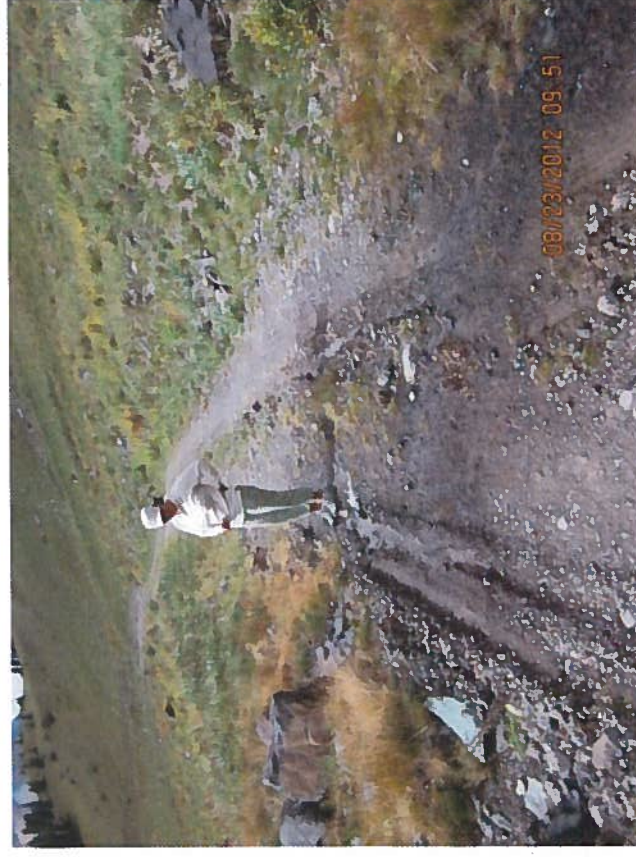
Audit drainage over the road on switchback below the mine and just above the drillhole:

Comparison of Aug 14 and Aug 23 shows ruts are dispersing water and not allowing it to run across the road.

Suggest re-grading the road, or at least use a shovel to define drainage across the road.

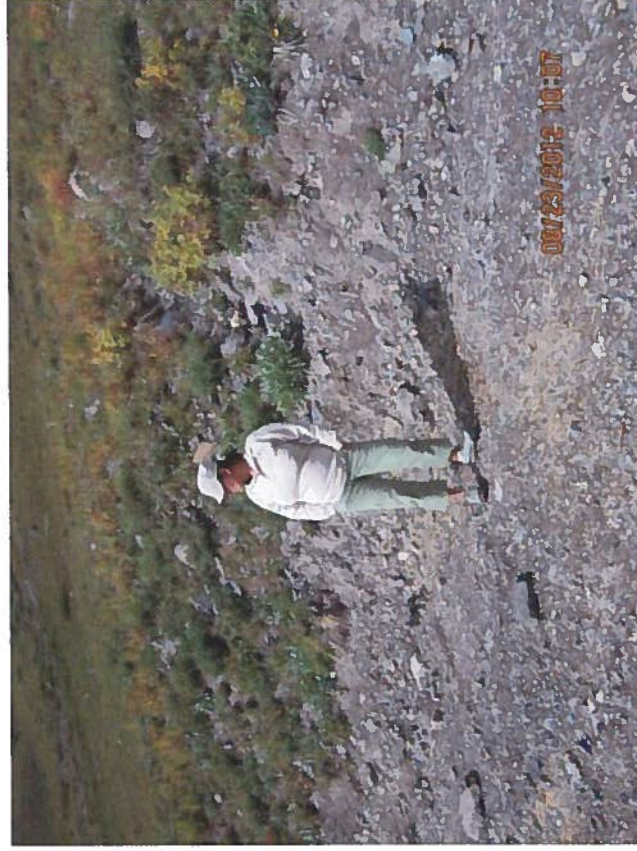
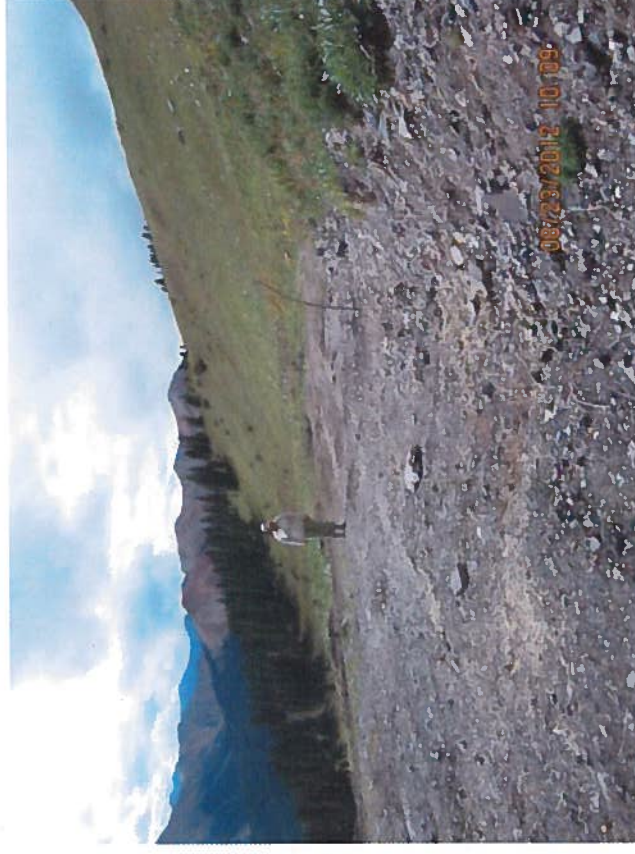
Drainage immediately uphill of the drillhole. Left picture shows the drainage with no defined place to go once it hits the road. There is no inslope drainage, and no rolling dip. Suggest a diagonal rolling dip, heading down between the old and new drillholes where person is standing.

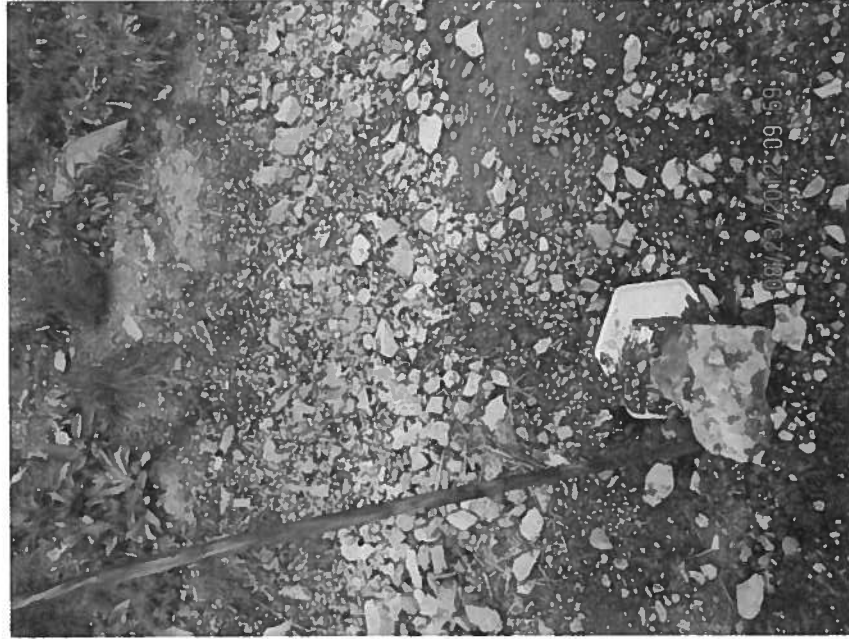
New drillhole: Remove pipe and fill top with dirt.

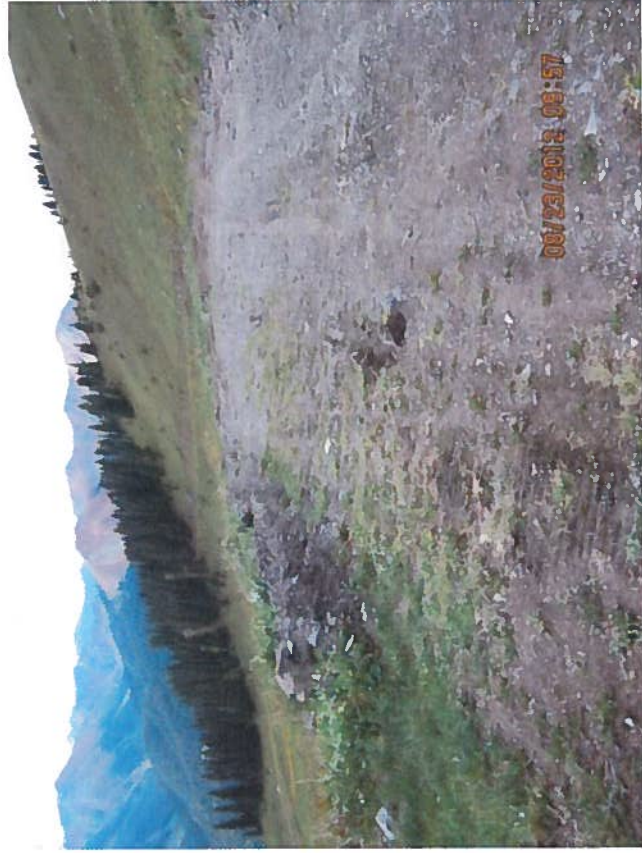
### Drillhole location.

Left: new berm was built. Pull it back onto the road, then re-seed.

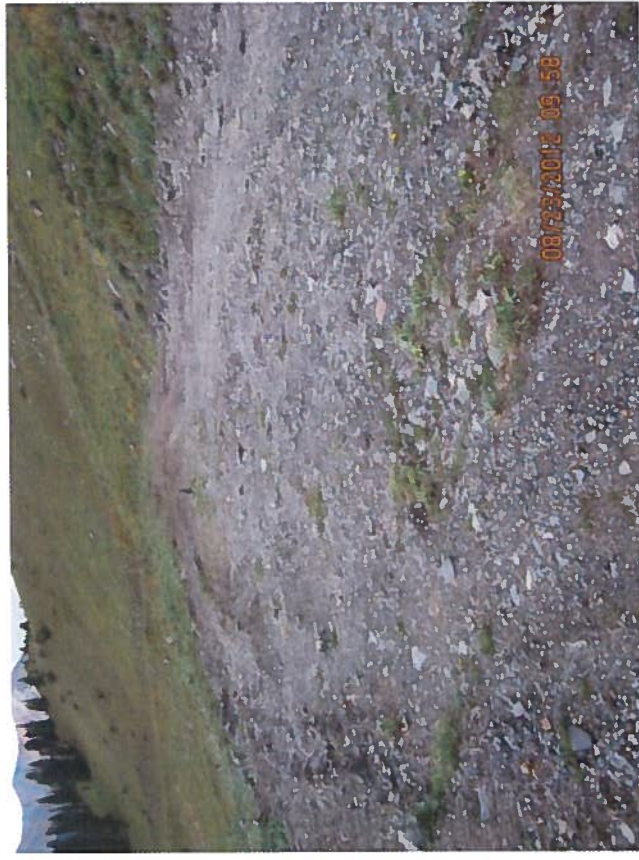
Right: re-seed widened spot on road to re-establish a single travel surface (i.e., re-seed the road going around the old well)

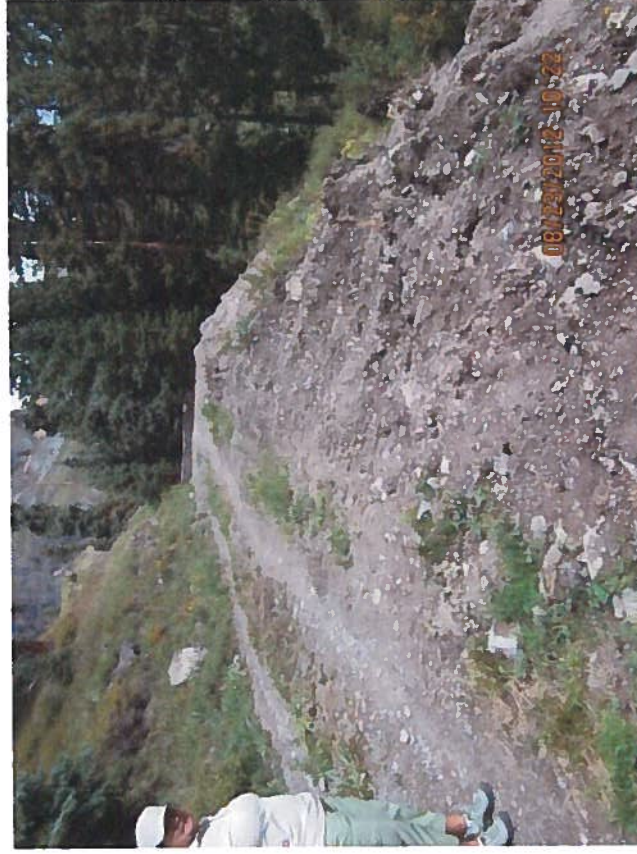
Left: One example photo for Area 4 and 5 sloughed areas. The drainage dips in this section need to be defined better, focus especially on getting water off the road ABOVE the sloughs. Re-seed the barren soil on outside of road surface throughout this area.

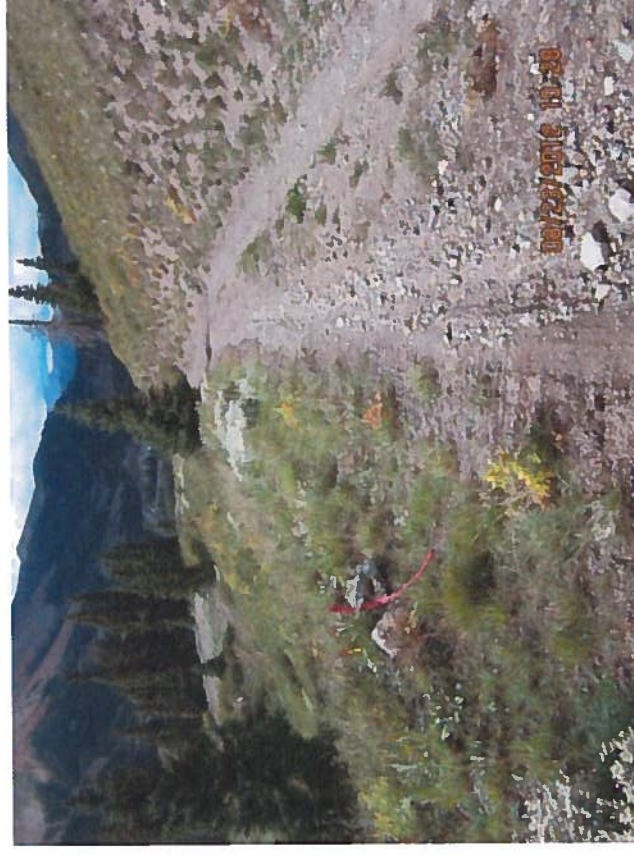
Right: Area 8 (conifer in meadow area). Road is rutted along this switchback. I placed additional flagging and a couple of rocks where we had placed flagging before to install a rolling dip. This section could really use 2 rolling dips because the ruts continue all the way to the bottom of the switchback.

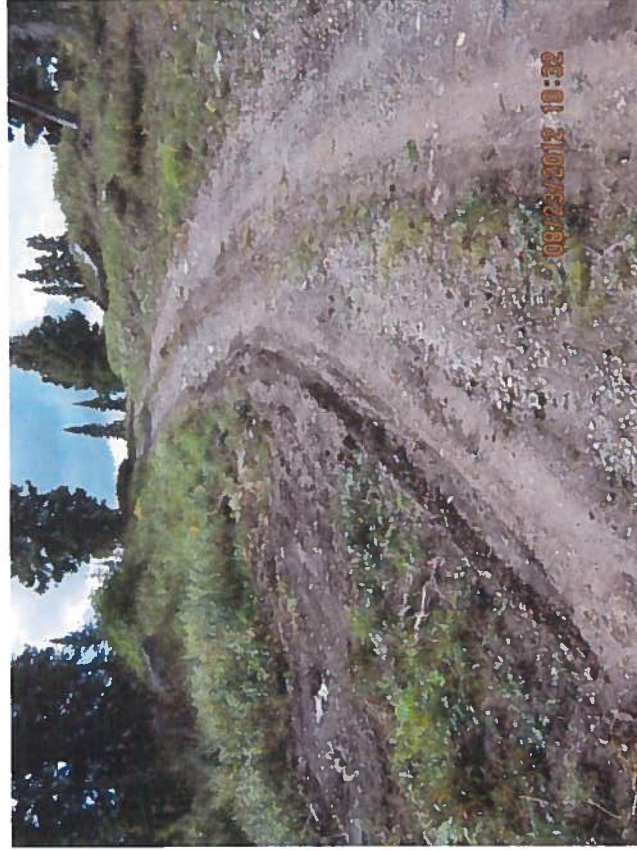
Area 9. Drainage feature constructed below Area 8 conifer/meadow site: is ineffective. Blading did not establish a place to direct water off the road. Fix it, and re-seed. (Note: road has the worst rutting below this site, so it is important to get this area fixed)

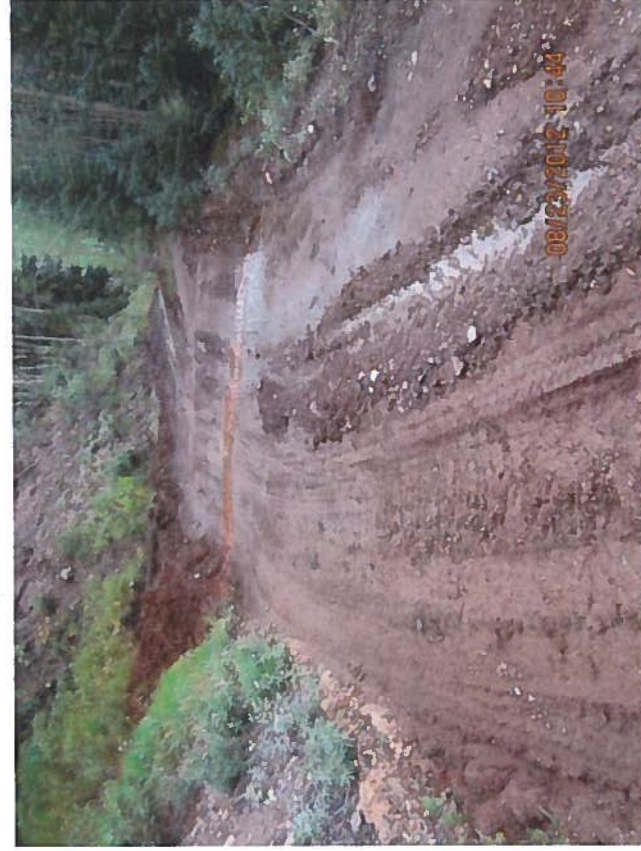
Area 23, upper adit. Left: above the adit, really need another cross drainage to get water off road and to dry out this area. Could wait to do that until next year. Adit drainage is acceptable.

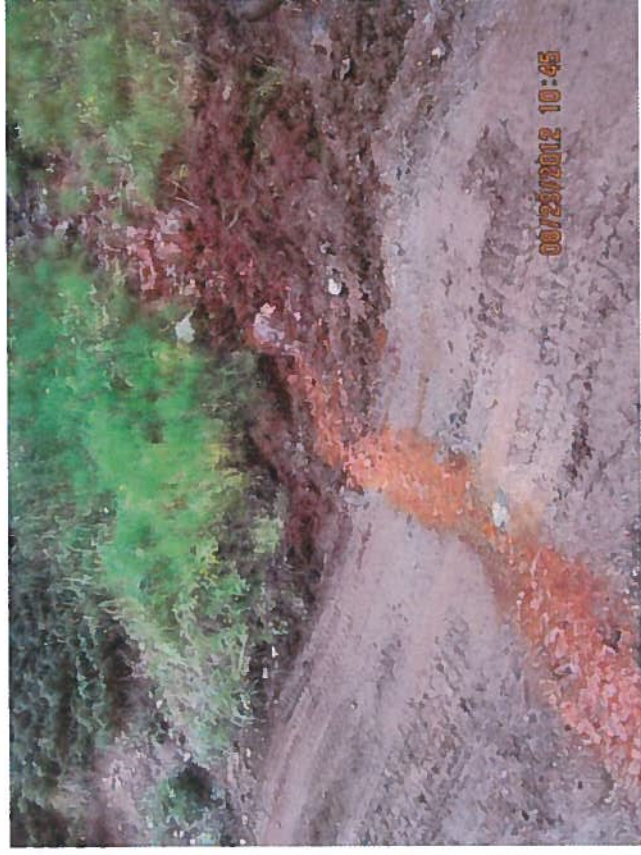
Right: Re-seed disturbed areas.

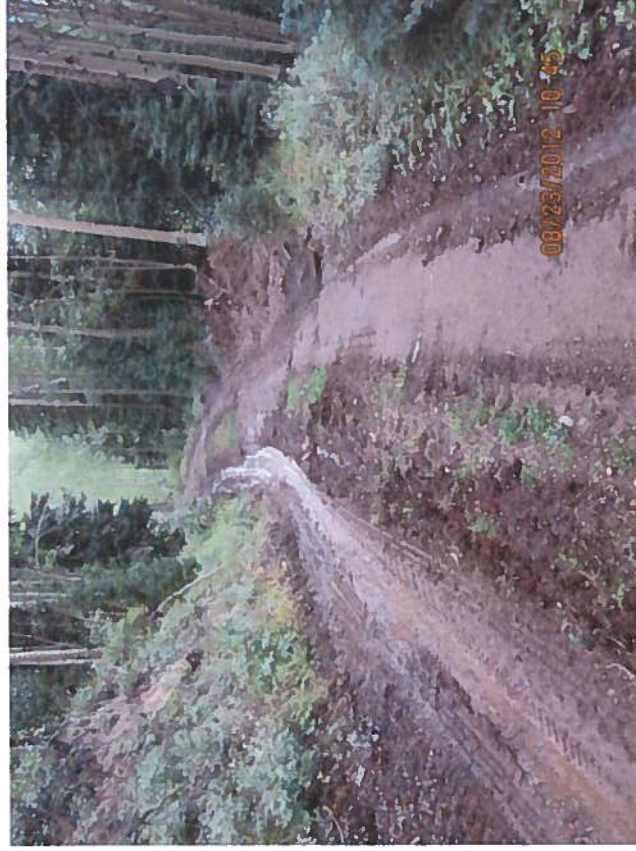
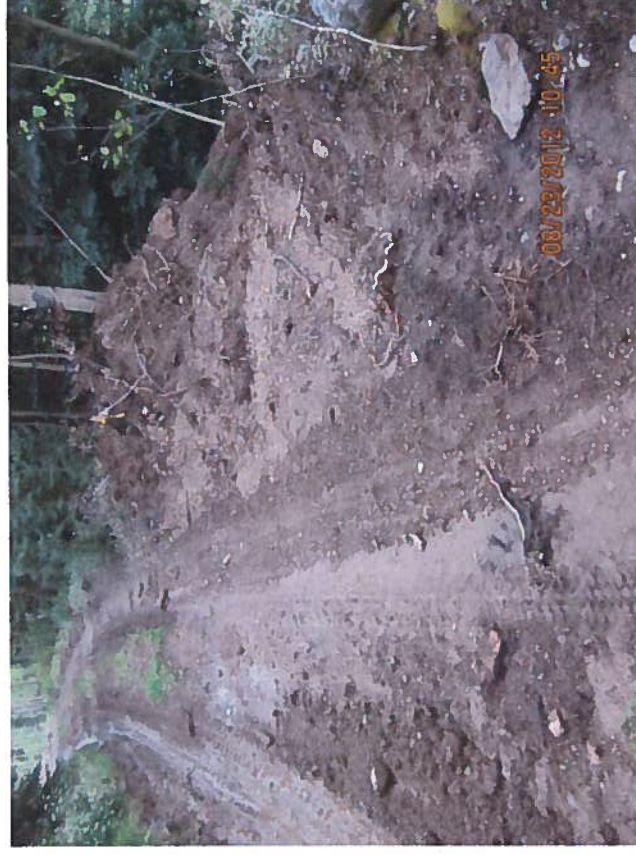
Area 24, below upper adit. Newly installed drainage is not effective. Left photo shows water continuing to run down the road and not being routed off the road at the intended drainage area.

Need to fix it and then re-seed disturbed ground.

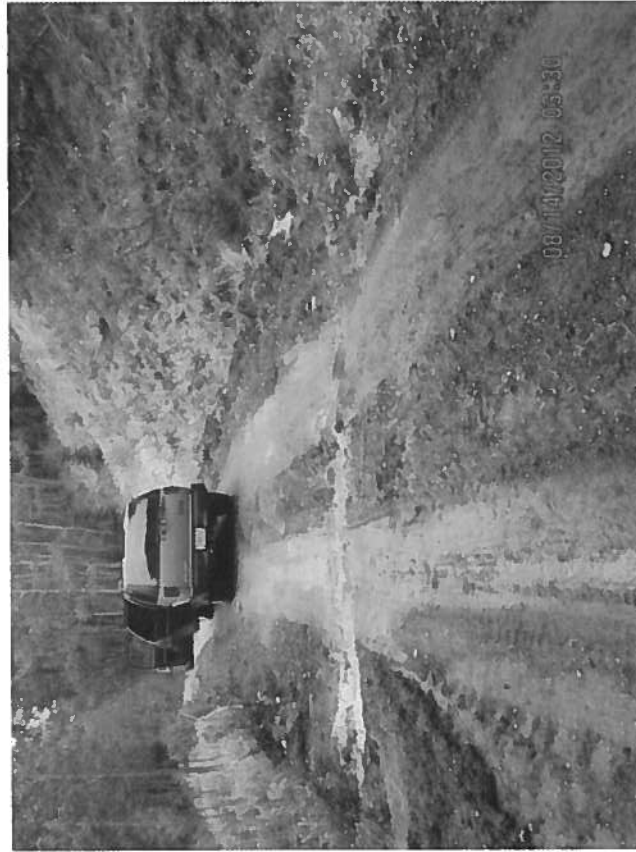
Area 25, middle adit. Work is satisfactory.

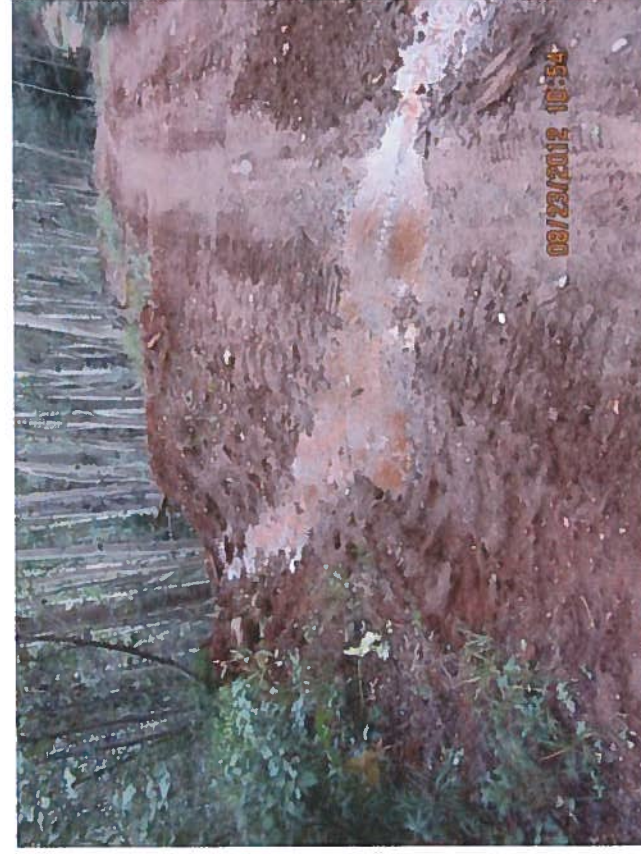
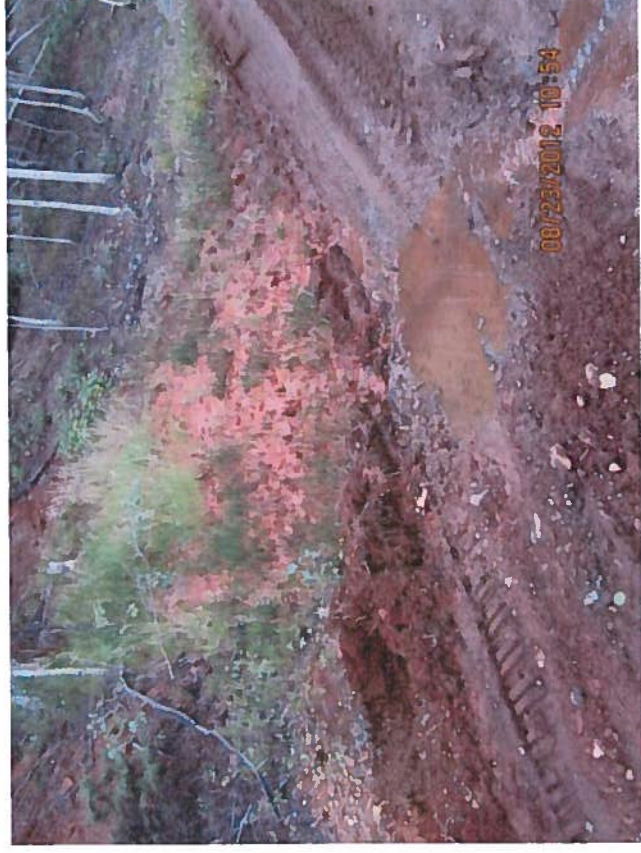
Area 34, lower adit. Rolling dip has been improved and will work for now. Re- seed disturbed areas on both sides of road. Harden downslope side with cobbles.
