COLORADO DIVISION OF RECLAMATION, MINING AND SAFETY
MINERALS PROGRAM INSPECTION REPORT
PHONE: (303) 866-3567

MINE NAME: Ready Mix Pit	MINE/PROSPECTING ID#: M-1977-023	MINERAL: Sand and gravel	COUNTY: Gunnison
INSPECTION TYPE: Monitoring	INSPECTOR(S): Dustin M. Czapl	INSP. DATE: August 15, 2012	INSP. TIME: 10:00
OPERATOR: Oldcastle SW Group, Inc. dba United Companies of Mesa County	OPERATOR REPRESENTATIVE: Jason Burkey	TYPE OF OPERATION: 112c - Construction Regular Operation

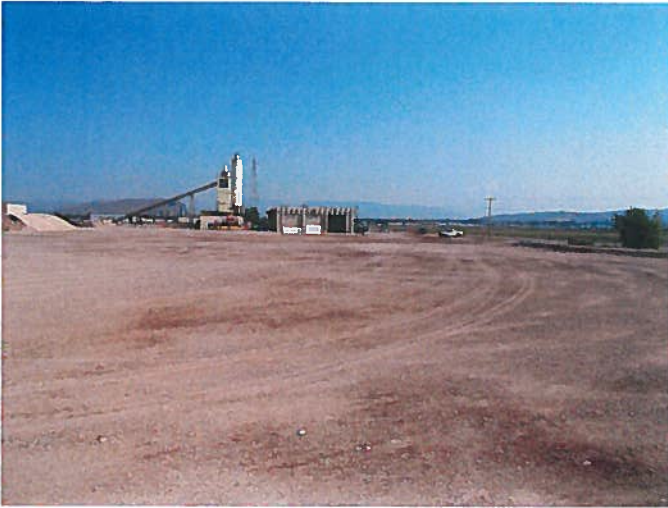
Figure 1: View from the north side of the current mining area, facing north toward the batch plant area.

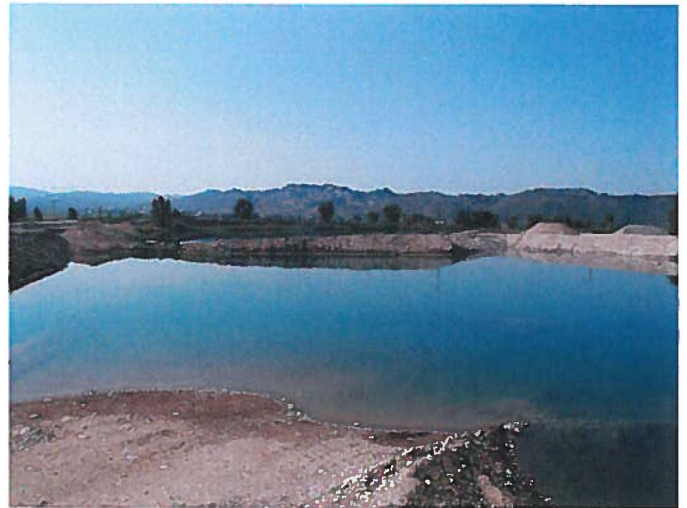
Figure 2: View, facing south, of the current mining area.

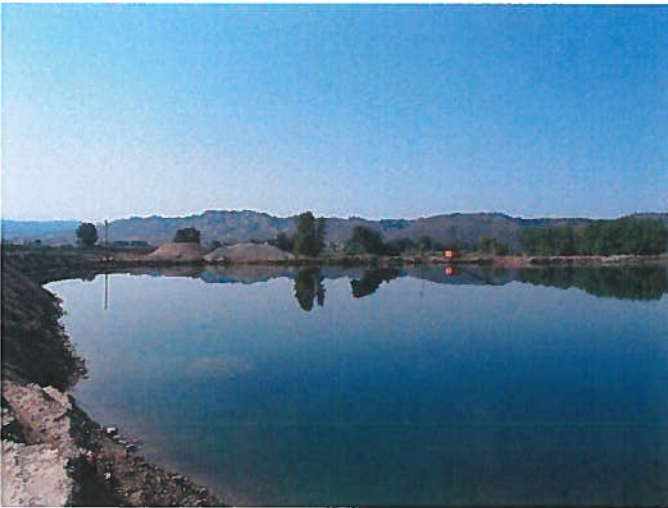
Active mining was not occurring during this inspection. Three mined out ponds, separated by dikes constructed of in-situ material, were located in the south and west part of the permit area. Final grading of the ponds banks was partially complete. Dewatering of the ponds will be necessary in order to remove the dikes and complete reclamation grading. Mining of a fourth pond has begun in the east part of the permit area. The remainder of the permit area is relatively flat and graveled. Most of the materials stockpiles are located in the area west of the batch plant. A topsoil stockpile was noted northwest of the ponds.

Figure 3: View, facing southwest, of the mined out southwest permit area.

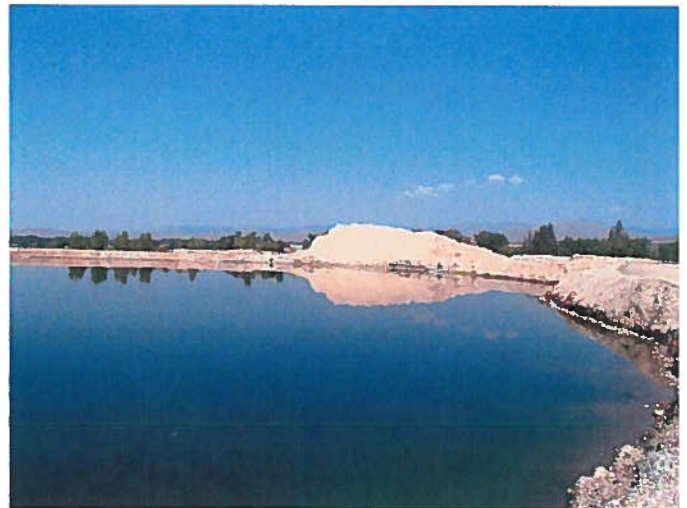
Figure 4: Topsoil stockpile located on the northwest side of the ponds.

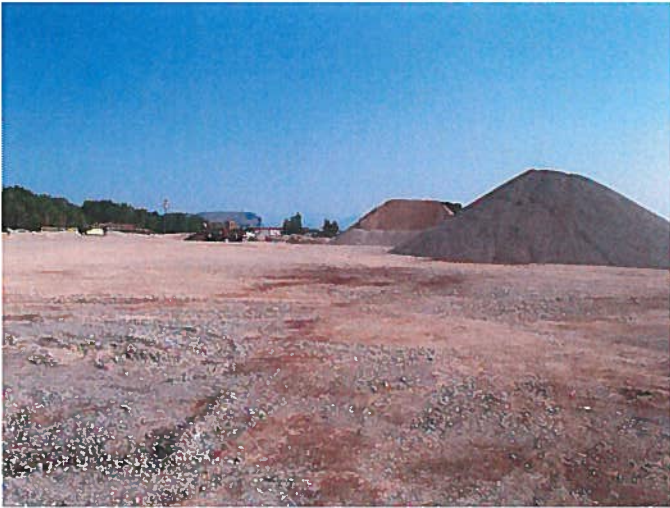
Figure 5: View, facing north, of the stockpile area west of the batch plant.

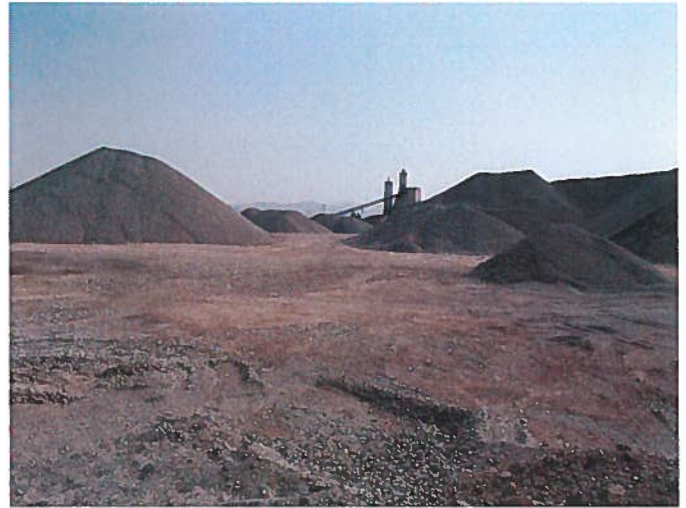
Figure 6: View, facing north, of the stockpile area west of the batch plant.

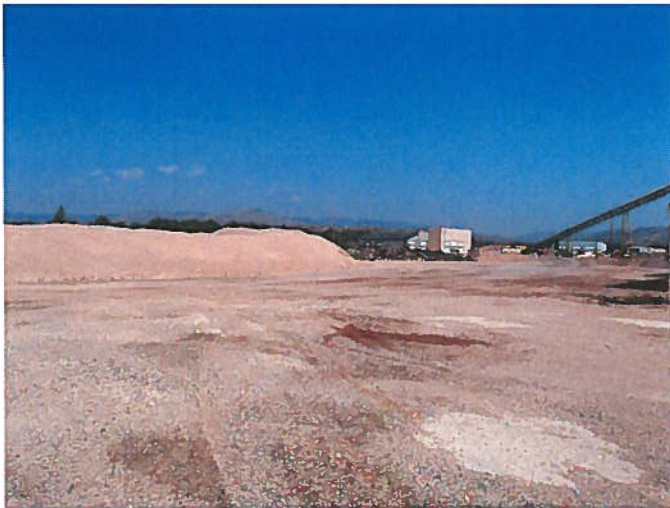
Figure 7: View, facing north, of the stockpile area west of the batch plant.

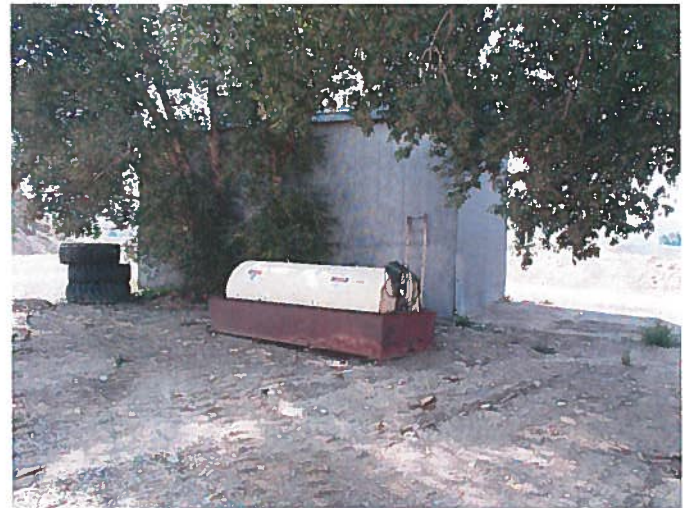
Figure 8: Shed located north of the ponds.
