**COLORADO DIVISION OF RECLAMATION, MINING AND SAFETY**  
**MINERALS PROGRAM INSPECTION REPORT**  
**PHONE: (303) 866-3567**

<b>MINE NAME:</b> Vader Pit	<b>MINE/PROSPECTING ID#:</b> M-1978-287	<b>MINERAL:</b> Sand and gravel	<b>COUNTY:</b> Gunnison
<b>INSPECTION TYPE:</b> Monitoring	<b>INSPECTOR(S):</b> Dustin M. Czapla	<b>INSP. DATE:</b> August 15, 2012	<b>INSP. TIME:</b> 11:30
<b>OPERATOR:</b> Oldcastle SW Group, Inc. dba United Companies of Mesa County	<b>OPERATOR REPRESENTATIVE:</b> Jason Burkey	<b>TYPE OF OPERATION:</b> 112c - Construction Regular Operation

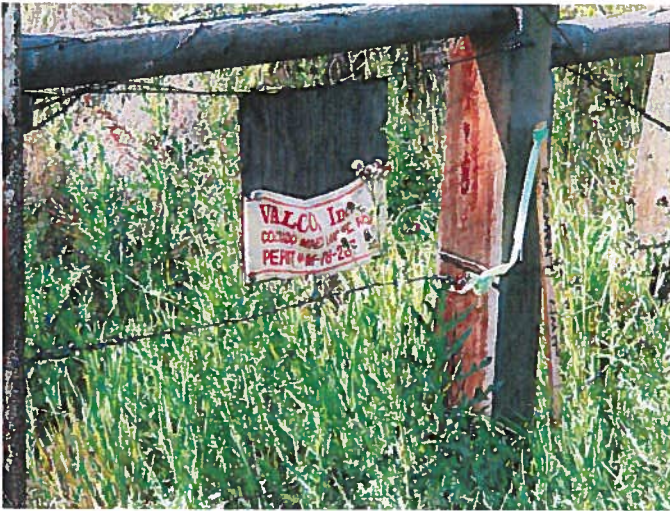
Adequate mine identification signage was noted at the northeast entrance to the site.

Figure 1: Mine identification sign located at northeast entrance to site.

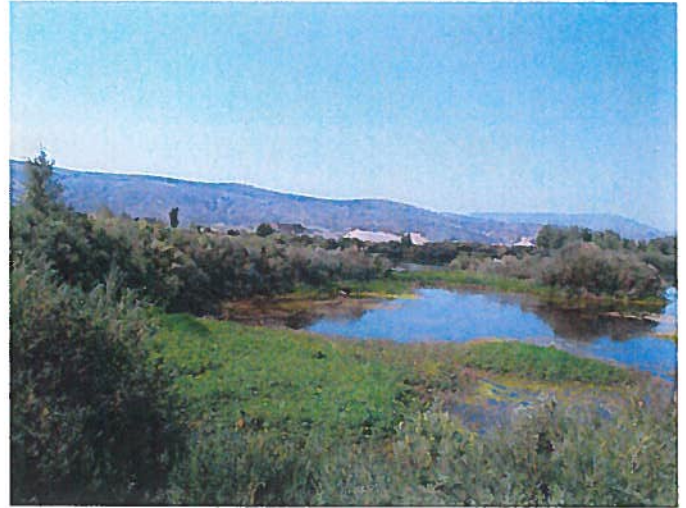
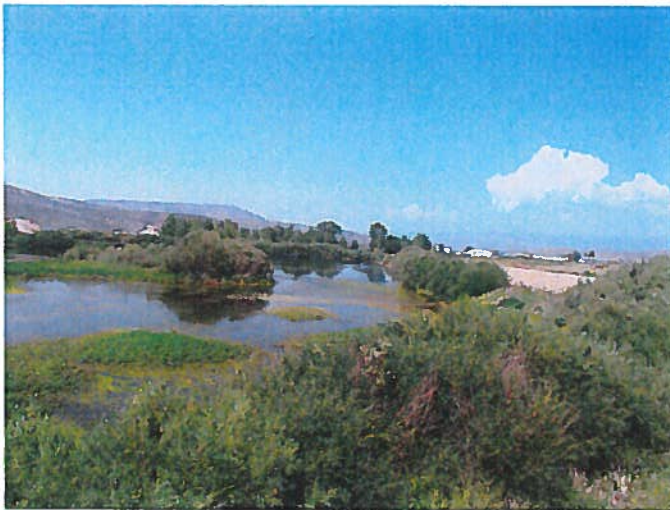
Figure 2: Reclaimed pond in northwest part of permit area.

Figure 3: Reclaimed pond in northwest part of permit area.

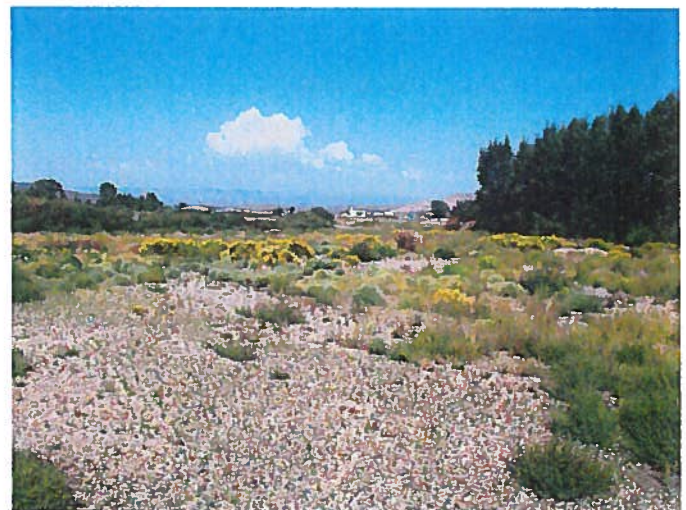
**PROBLEM/POSSIBLE VIOLATION:** There are state-listed noxious weeds present on site. This is a problem for failure to employ weed control methods for state listed noxious weed species within the permitted area, and to reduce the spread of weeds to nearby areas as required by Section 3.1.10 (6) of the rule.

Past mining, in the area north of Tomichi Creek, has created a pond in the northwest part of the permit area. The banks of the pond were well vegetated and appeared stable. The area immediately east of the pond appeared to have been used in the past for stockpiling and/or processing. This area did not appear to have been seeded yet as part of reclamation, although there was considerable volunteer native vegetation becoming established in this area. It did not appear that topsoil has been applied in this area during past reclamation efforts. A significant noxious weed infestation was noted in this area, including plumeless and/or bull thistle and halogeton.

Figure 4: Area east of pond. Noxious weeds were noted in this area.

**CORRECTIVE ACTIONS:** Implement approved weed control plan and provide proof to the Division that this has been done. If a weed control plan is not already in place, the operator shall develop a weed control and management plan in accordance with Section 3.1.10 (6) of the Rule. This plan should be developed in

consultation with the county extension agency, or weed control district office and should include specific control measures to be applied, a schedule for when control measures will be applied and a post-treatment monitoring plan. This weed control plan shall be submitted to the Division as a Technical Revision to the approved plan with the appropriate Technical Revision fee of \$216.00 by the corrective action date.

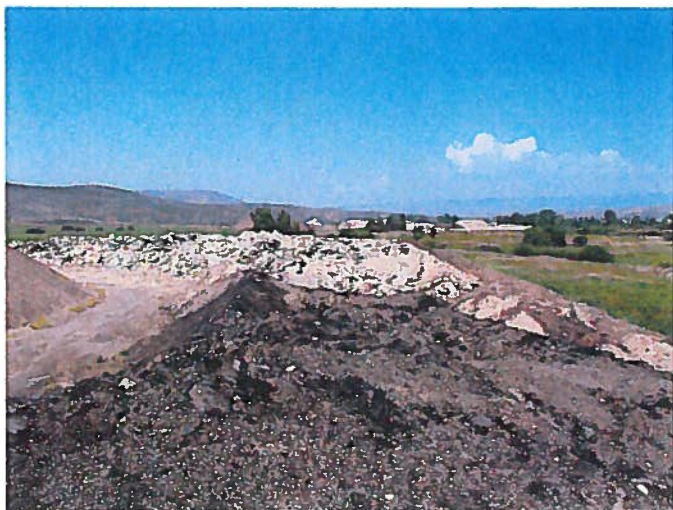
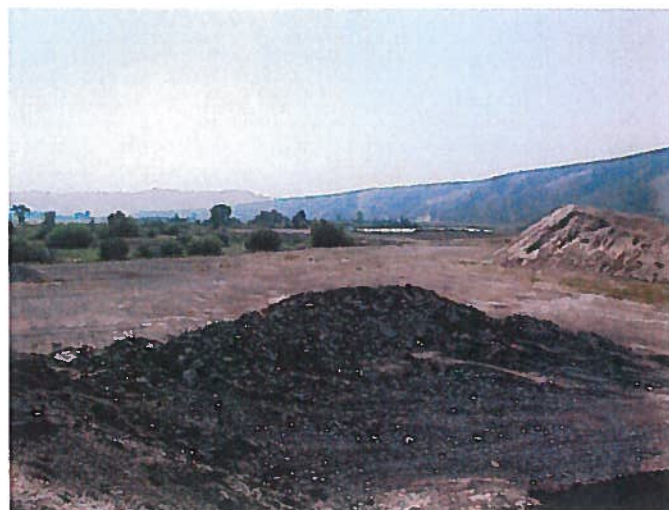
The area south of Tomichi Creek is primarily used by the Operator for stockpiling materials. Active mining or processing was not occurring in this area. Noxious weeds were not noted in this area.

Figure 5: Stockpile area south of Tomichi Creek.

Figure 6: Stockpile area south of Tomichi Creek.
