**COLORADO DIVISION OF RECLAMATION, MINING AND SAFETY**  
**MINERALS PROGRAM INSPECTION REPORT**  
**PHONE: (303) 866-3567**

<b>MINE NAME:</b> Sea Horse Ranch West Gravel Pit	<b>MINE/PROSPECTING ID#:</b> M-2001-113	<b>MINERAL:</b> Sand and Gravel	<b>COUNTY:</b> Gunnison
<b>INSPECTION TYPE:</b> Monitoring	<b>INSPECTOR(S):</b> Dustin M. Czapla	<b>INSP. DATE:</b> September 15, 2012	<b>INSP. TIME:</b> 11:00
<b>OPERATOR:</b> Varra Companies, Inc.	<b>OPERATOR REPRESENTATIVE:</b> Jason Burkey	<b>TYPE OF OPERATION:</b> 112c - Construction Regular Operation

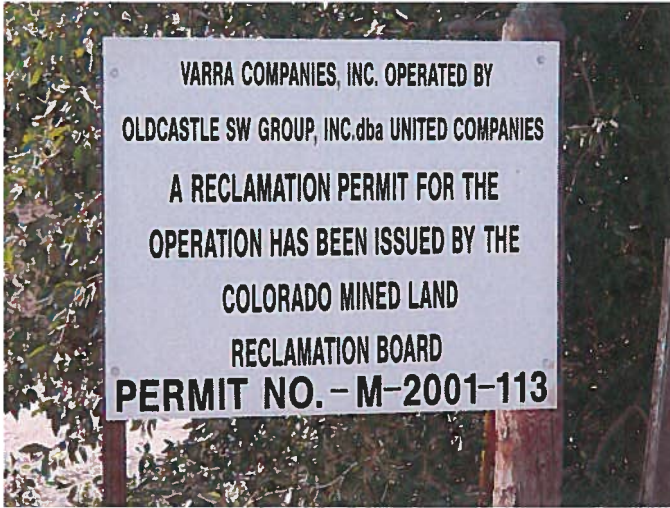
Adequate mine identification signage was noted at the entrance to the site.

Figure 1: Mine identification sign located at northwest entrance to site.

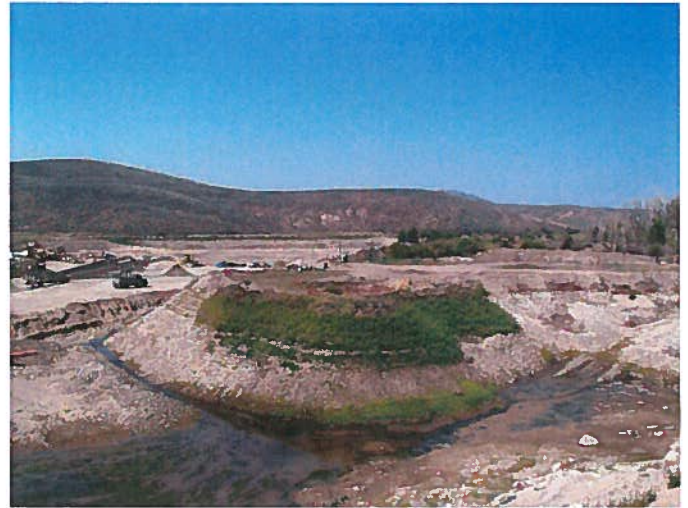
Figure 2: View from north-central part of site, facing west.

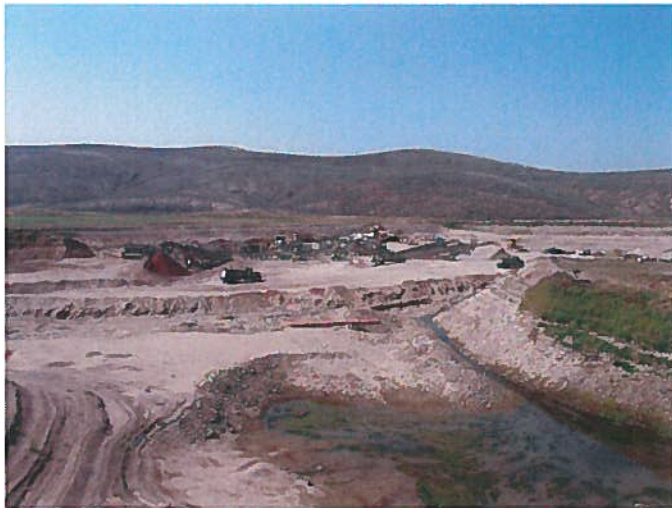
Figure 3: View from north-central part of site, facing southwest.

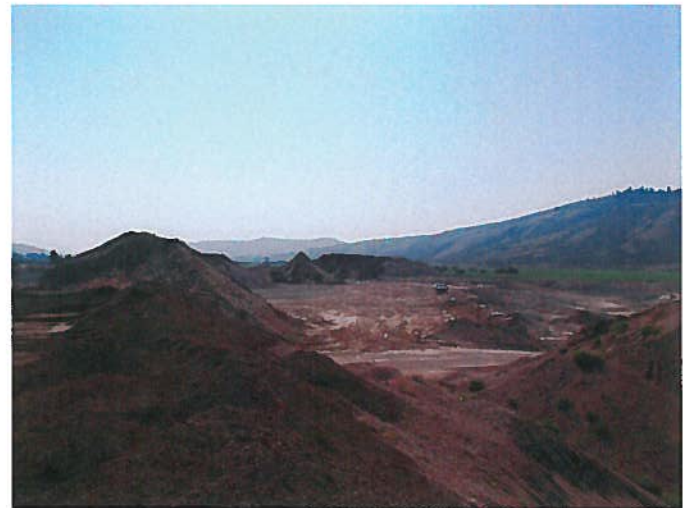
Figure 4: View from north-central part of site, facing east.
