COLORADO DIVISION OF RECLAMATION, MINING AND SAFETY
MINERALS PROGRAM INSPECTION REPORT
PHONE: (303) 866-3567

MINE NAME: Dallas Gravel Pit	MINE/PROSPECTING ID#: M-1978-268	MINERAL: Gravel	COUNTY: Ouray
INSPECTION TYPE: Monitoring	INSPECTOR(S): Wallace H. Erickson	INSP. DATE: August 29, 2012	INSP. TIME: 16:00
OPERATOR: Ouray County	OPERATOR REPRESENTATIVE: Chris Miller, Dan Fossey	TYPE OF OPERATION: 112c - Construction Regular Operation

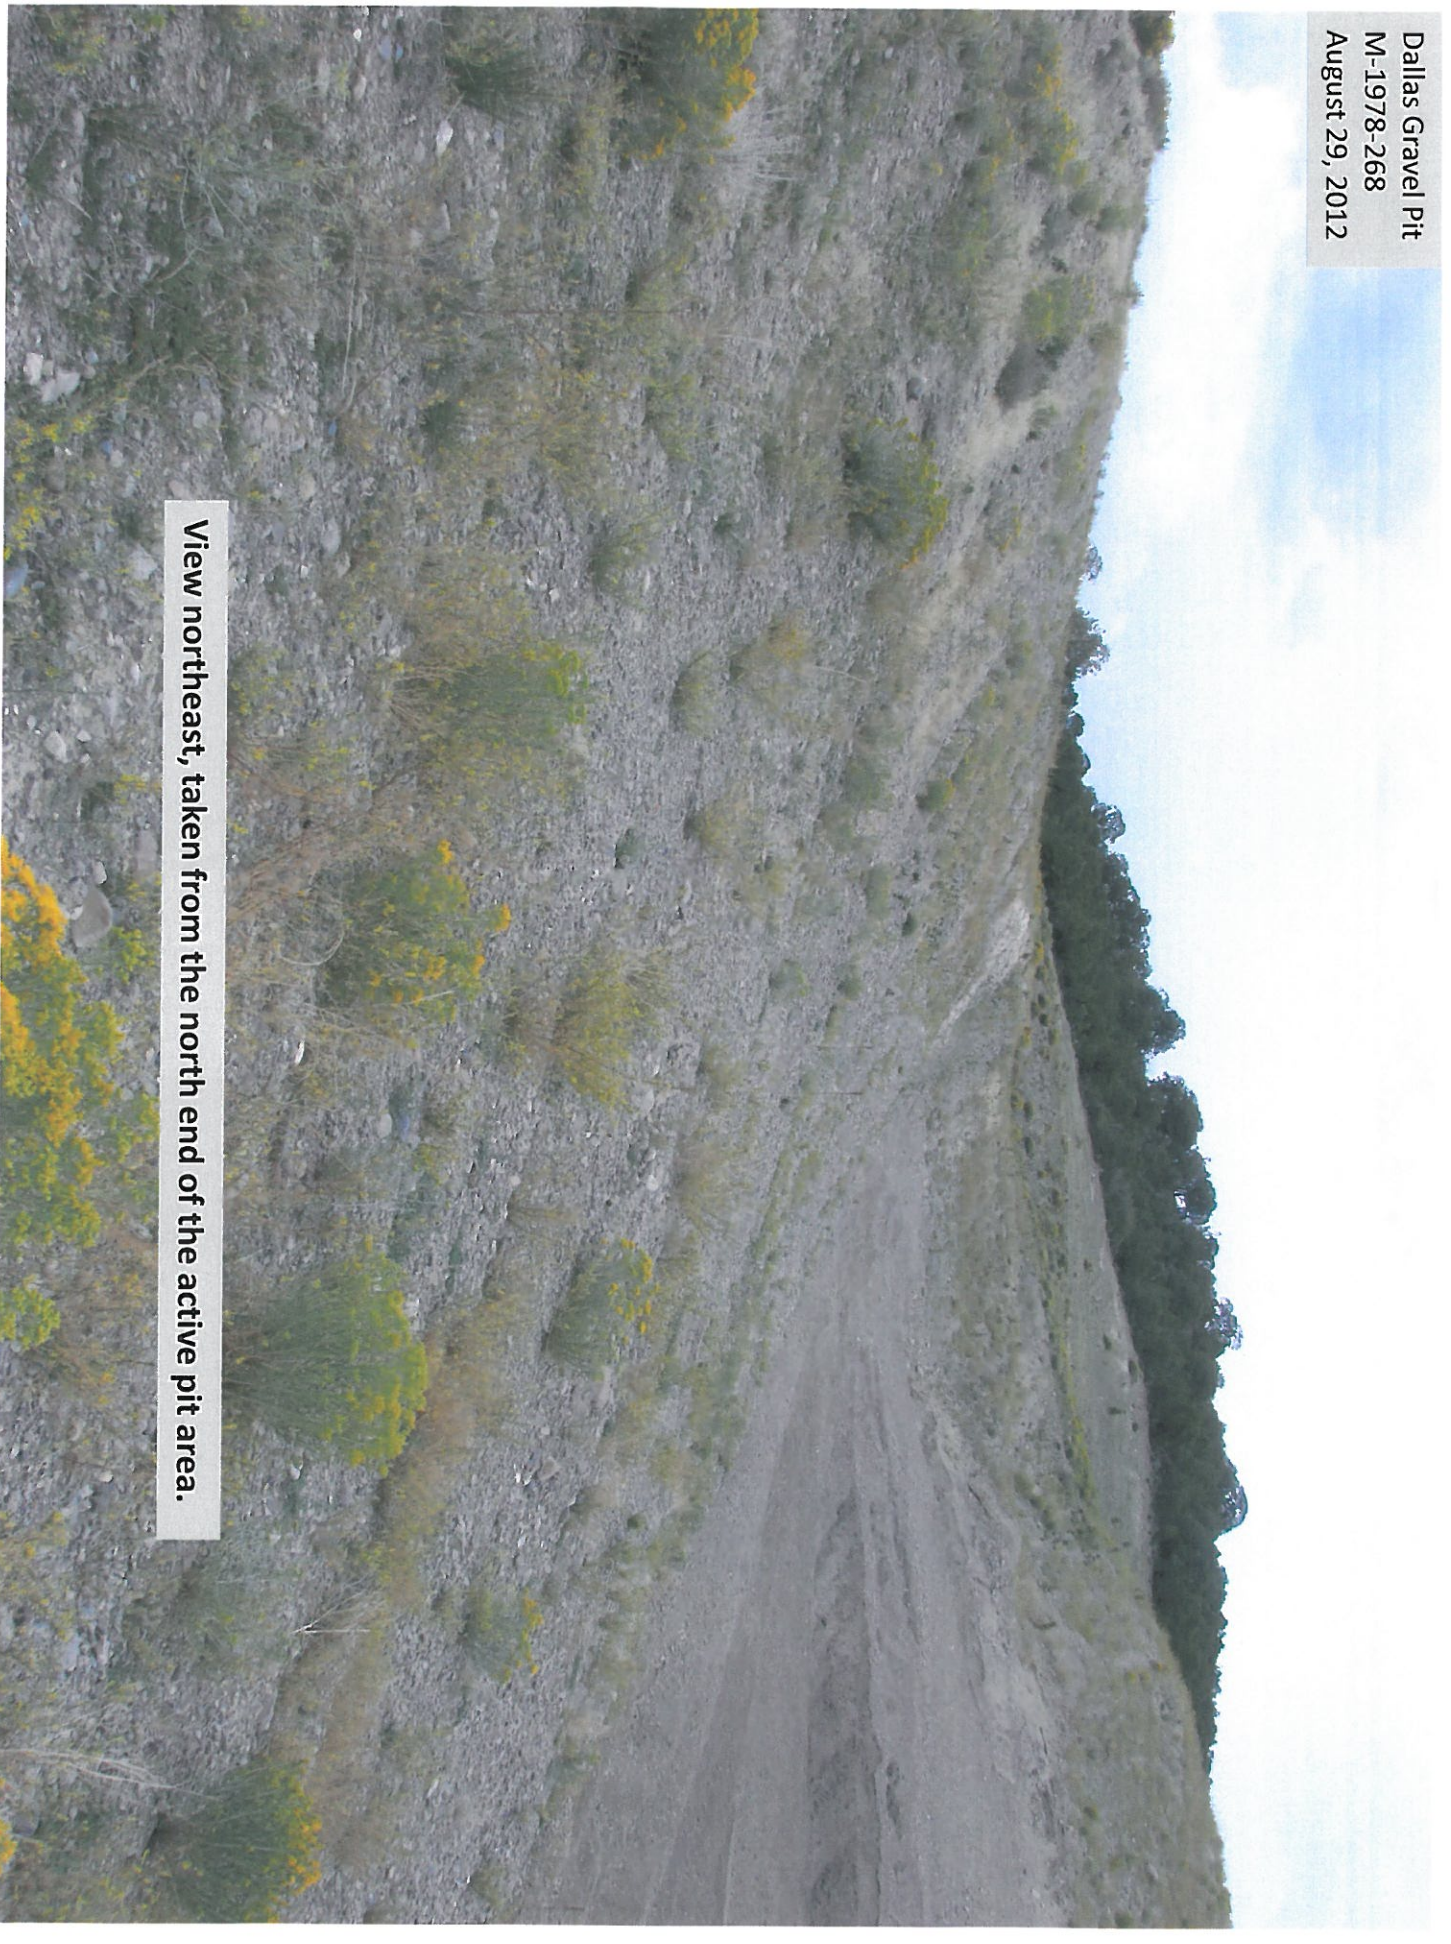
Dallas Gravel Pit
M-1978-268
August 29, 2012

View northeast, taken from the north end of the active pit area.

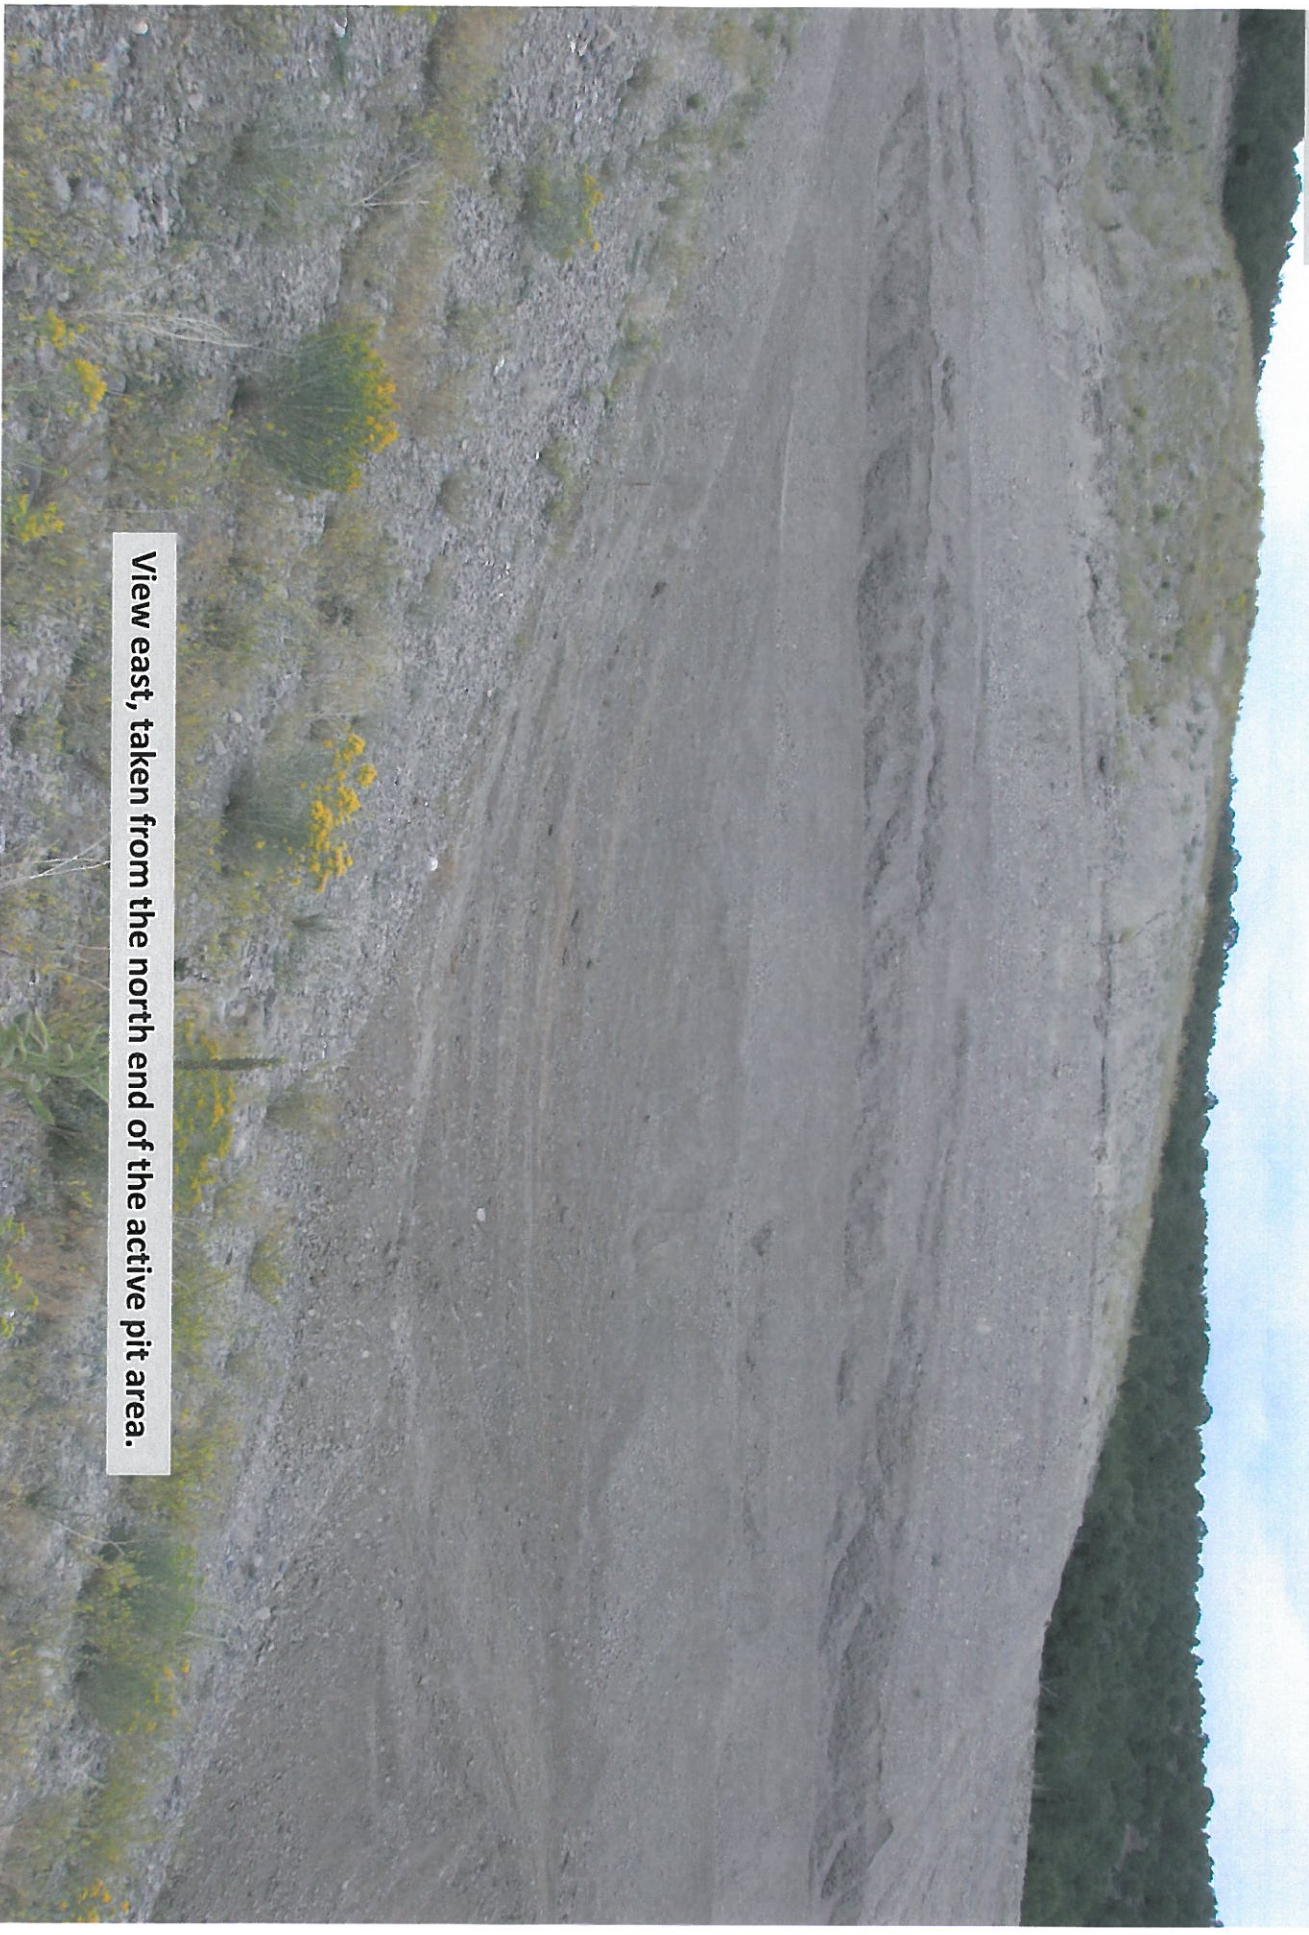
Dallas Gravel Pit
M-1978-268
August 29, 2012

View east, taken from the north end of the active pit area.

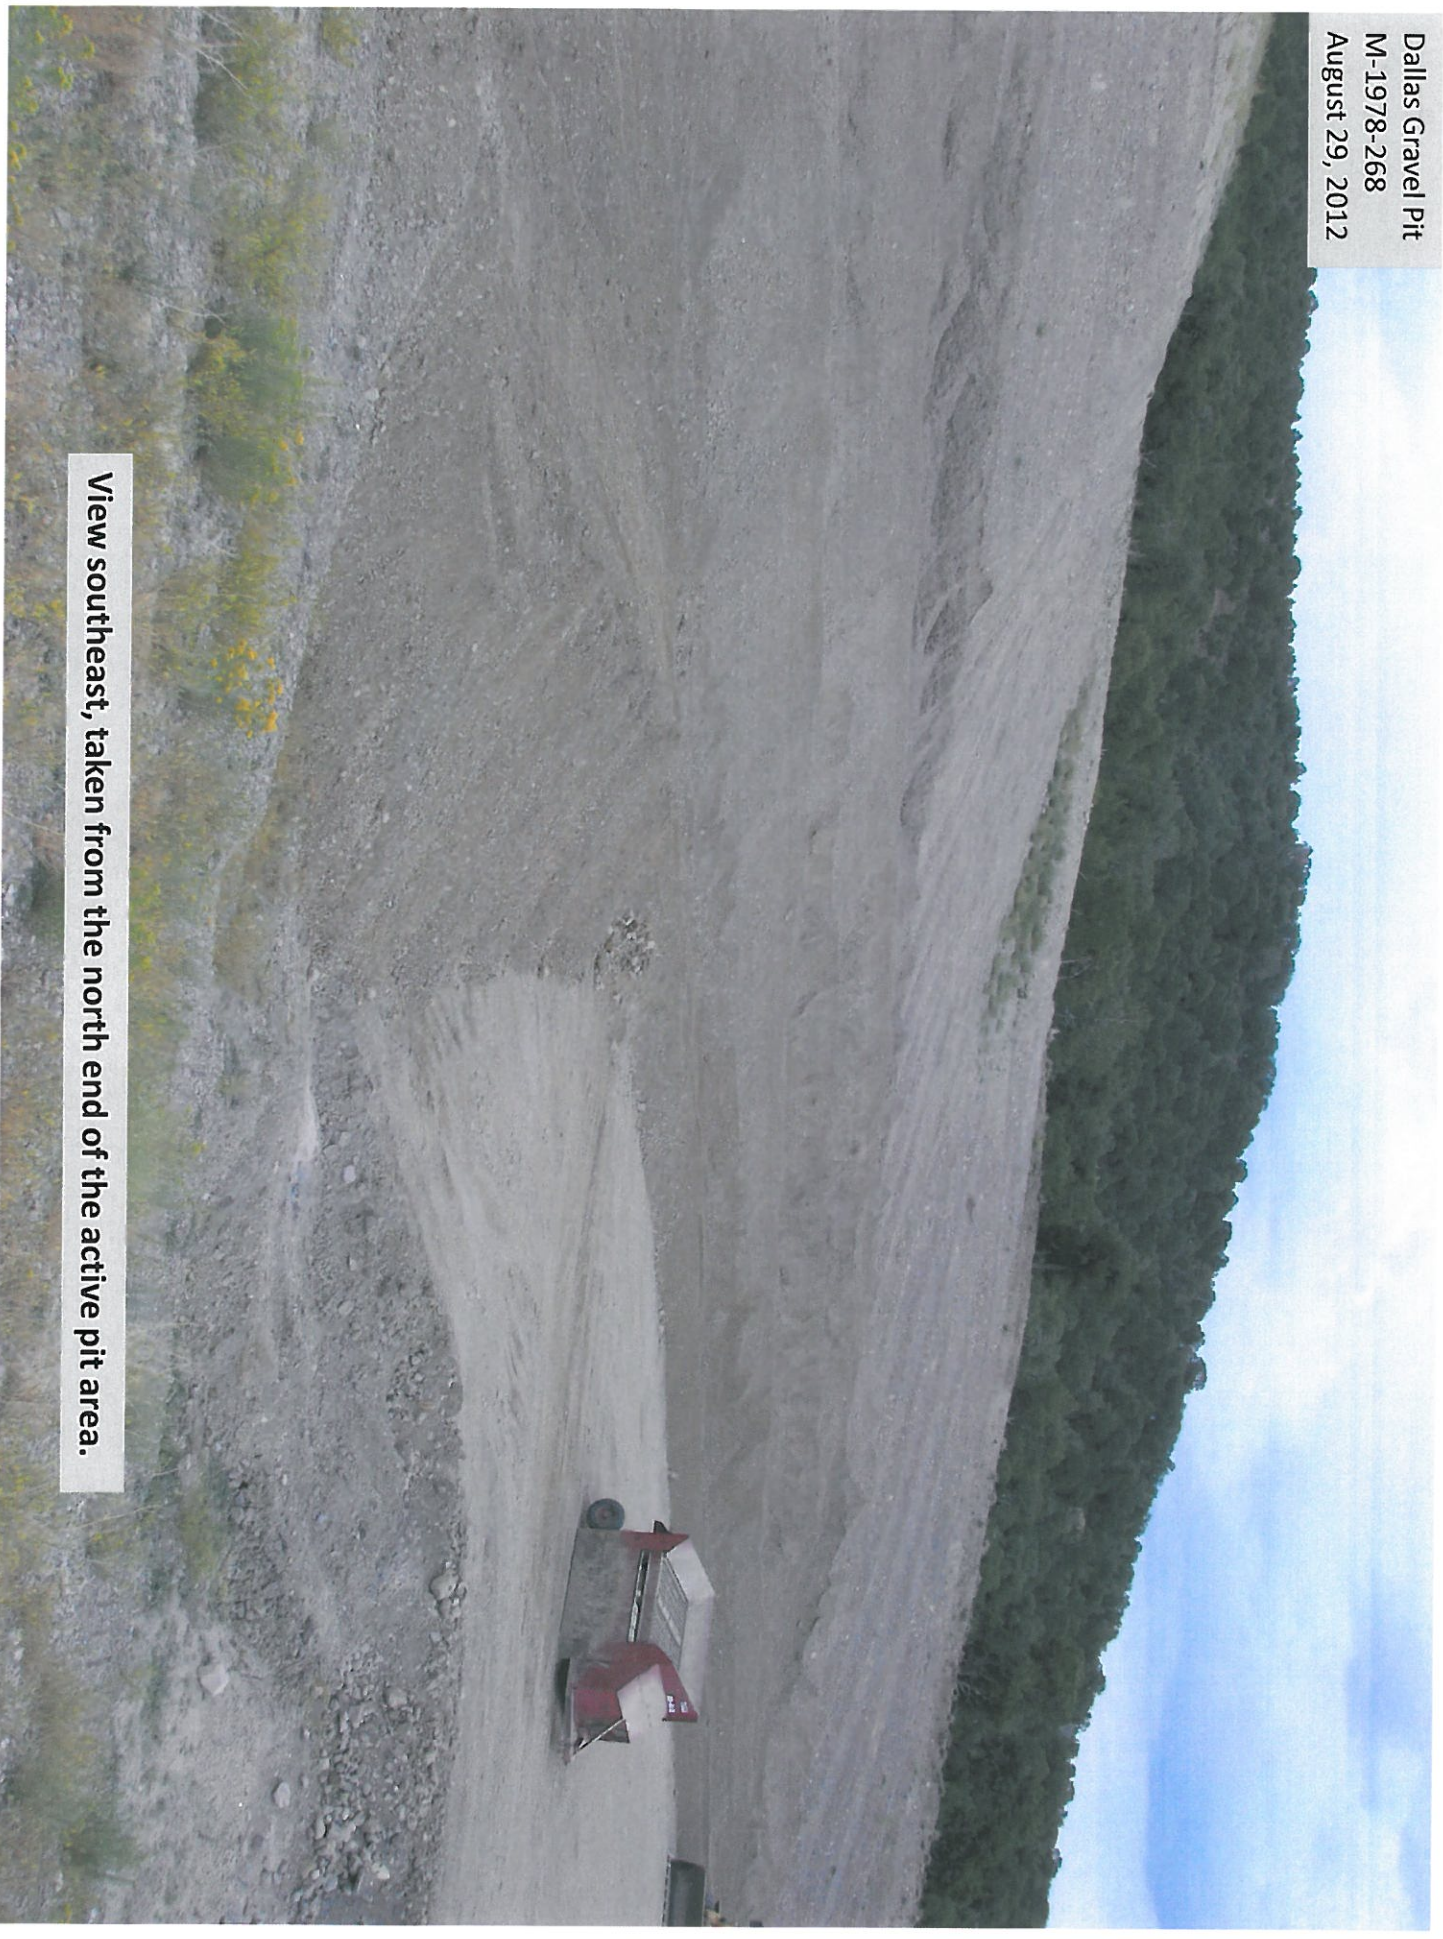
Dallas Gravel Pit
M-1978-268
August 29, 2012

View southeast, taken from the north end of the active pit area.

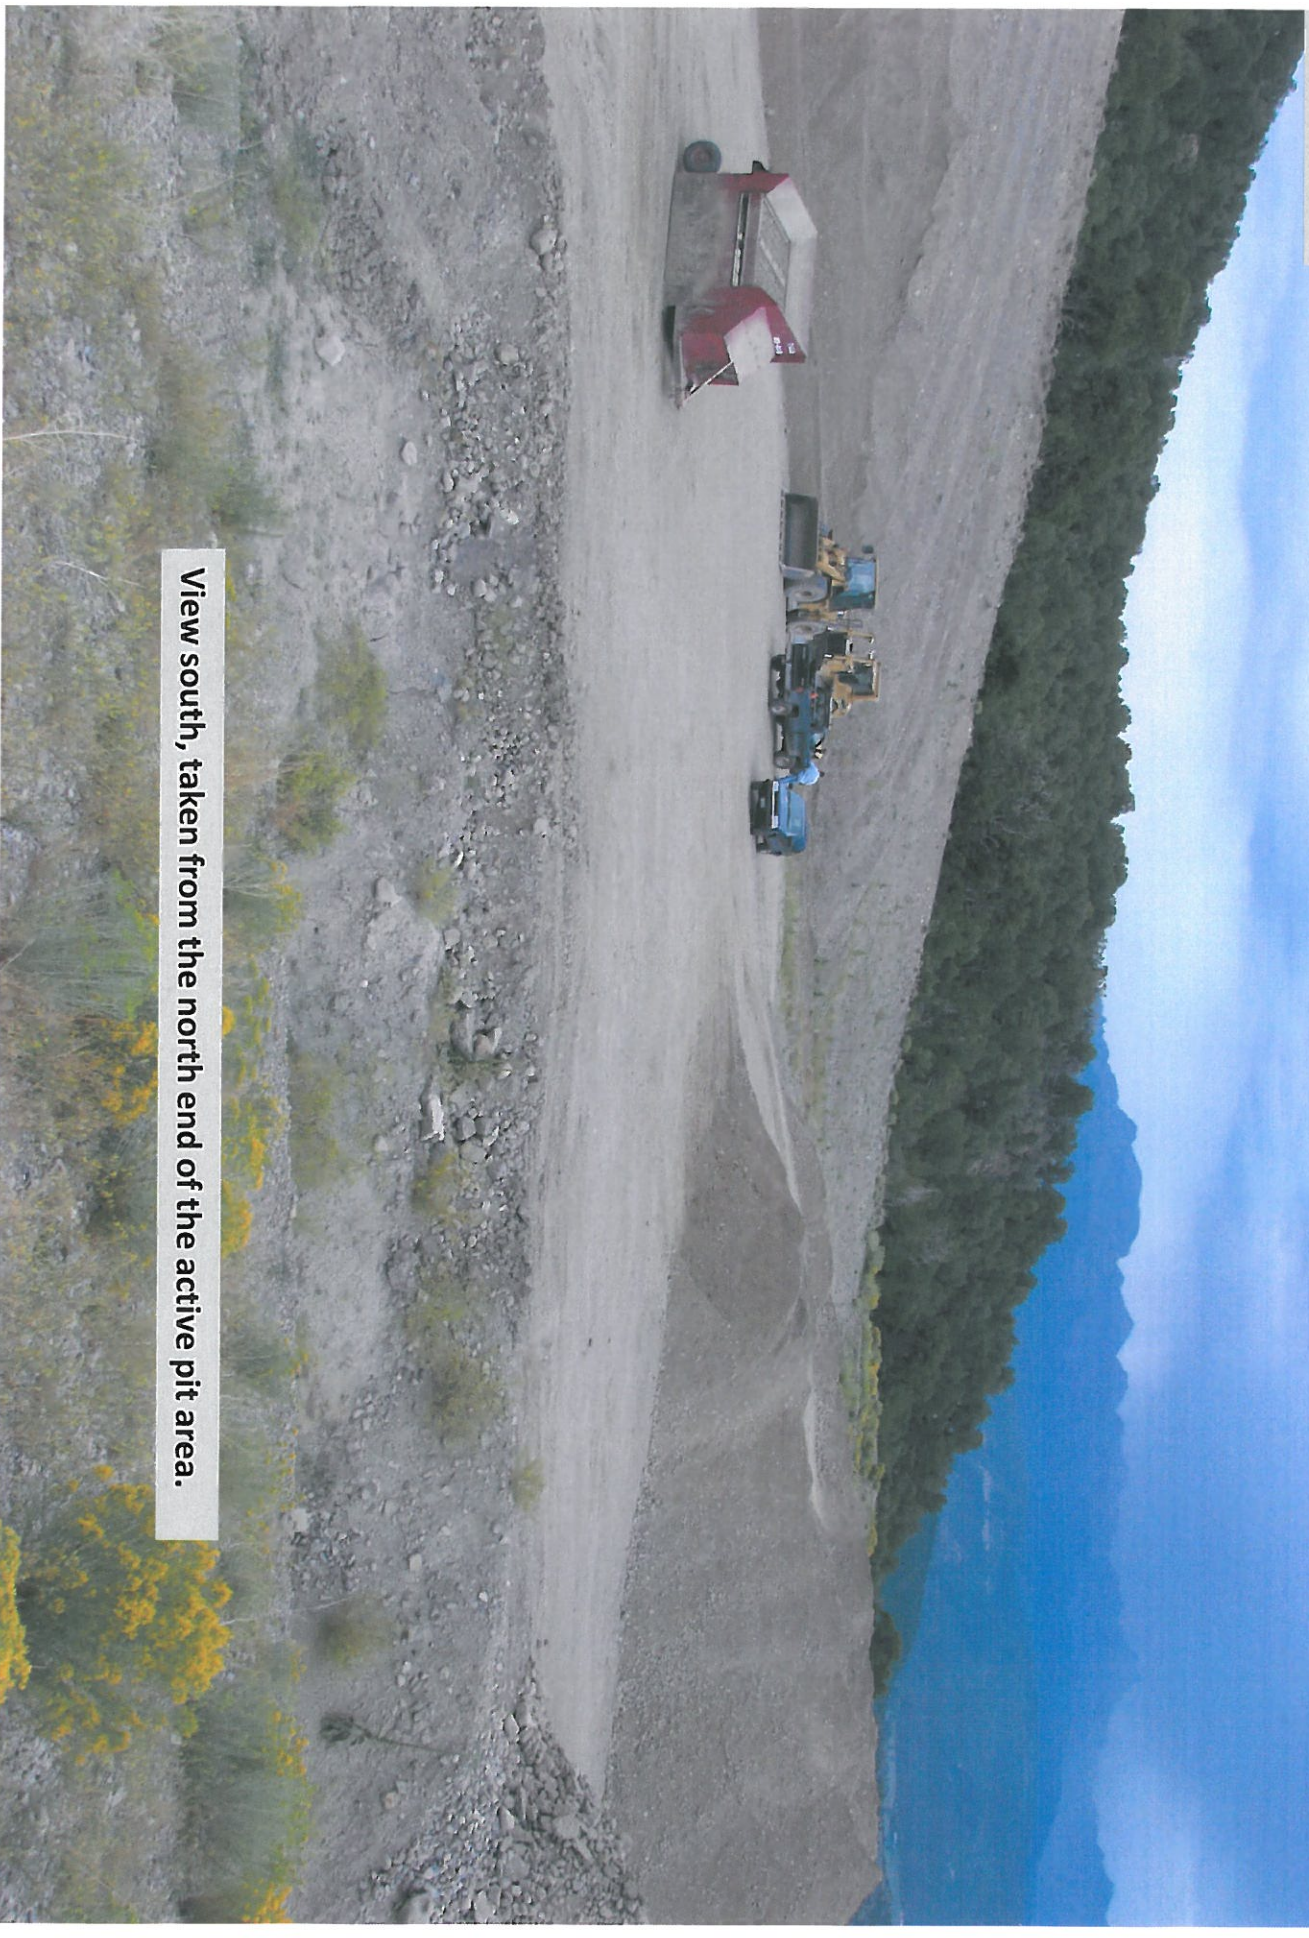
Dallas Gravel Pit
M-1978-268
August 29, 2012

View south, taken from the north end of the active pit area.

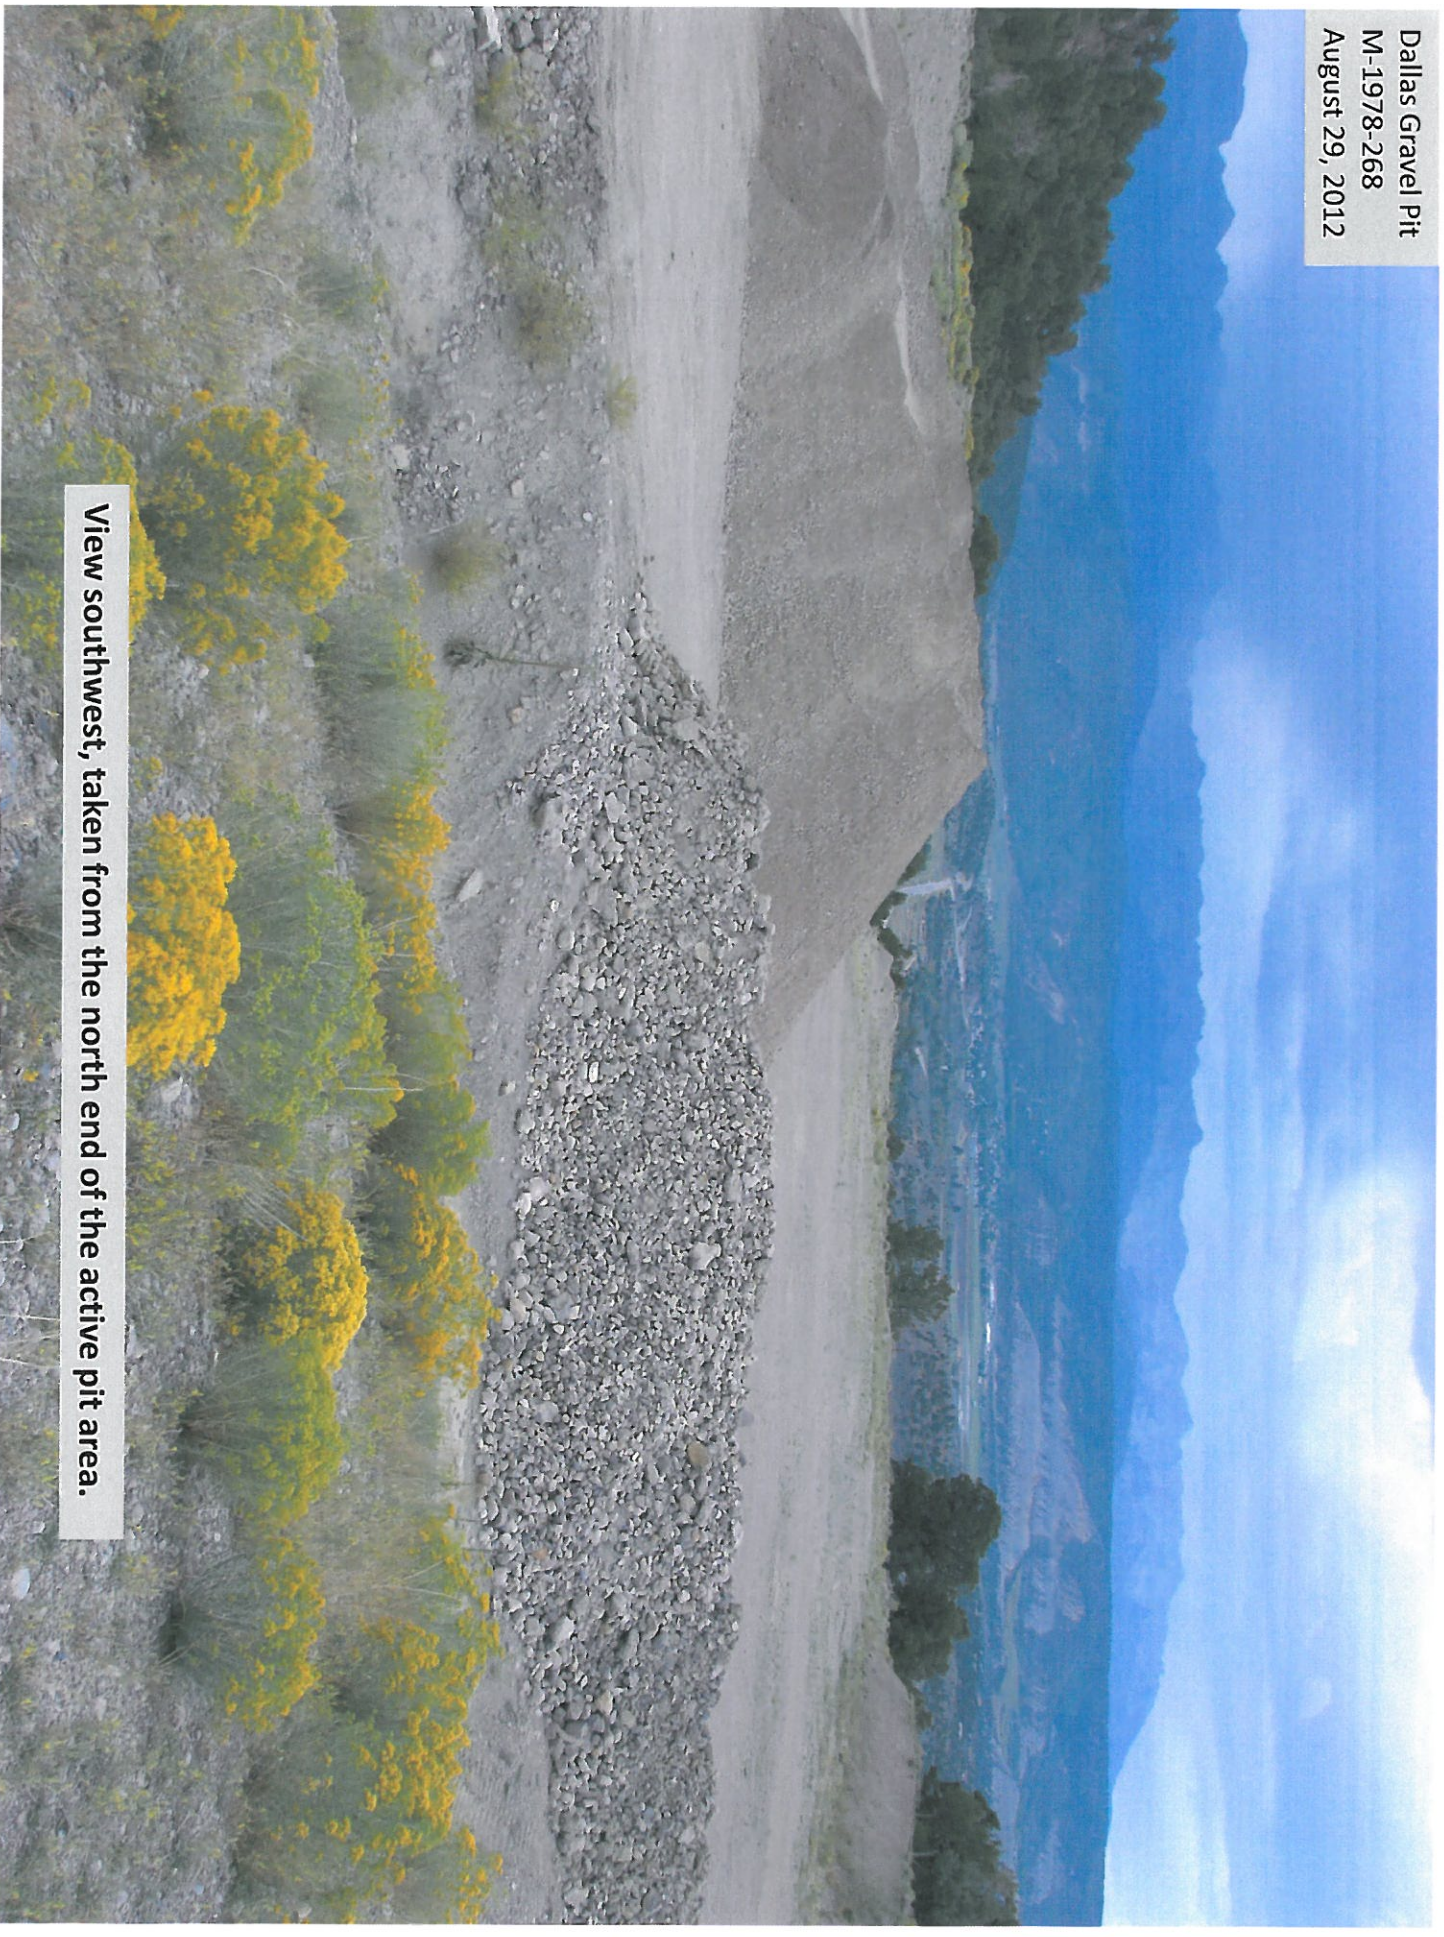
Dallas Gravel Pit
M-1978-268
August 29, 2012

View southwest, taken from the north end of the active pit area.

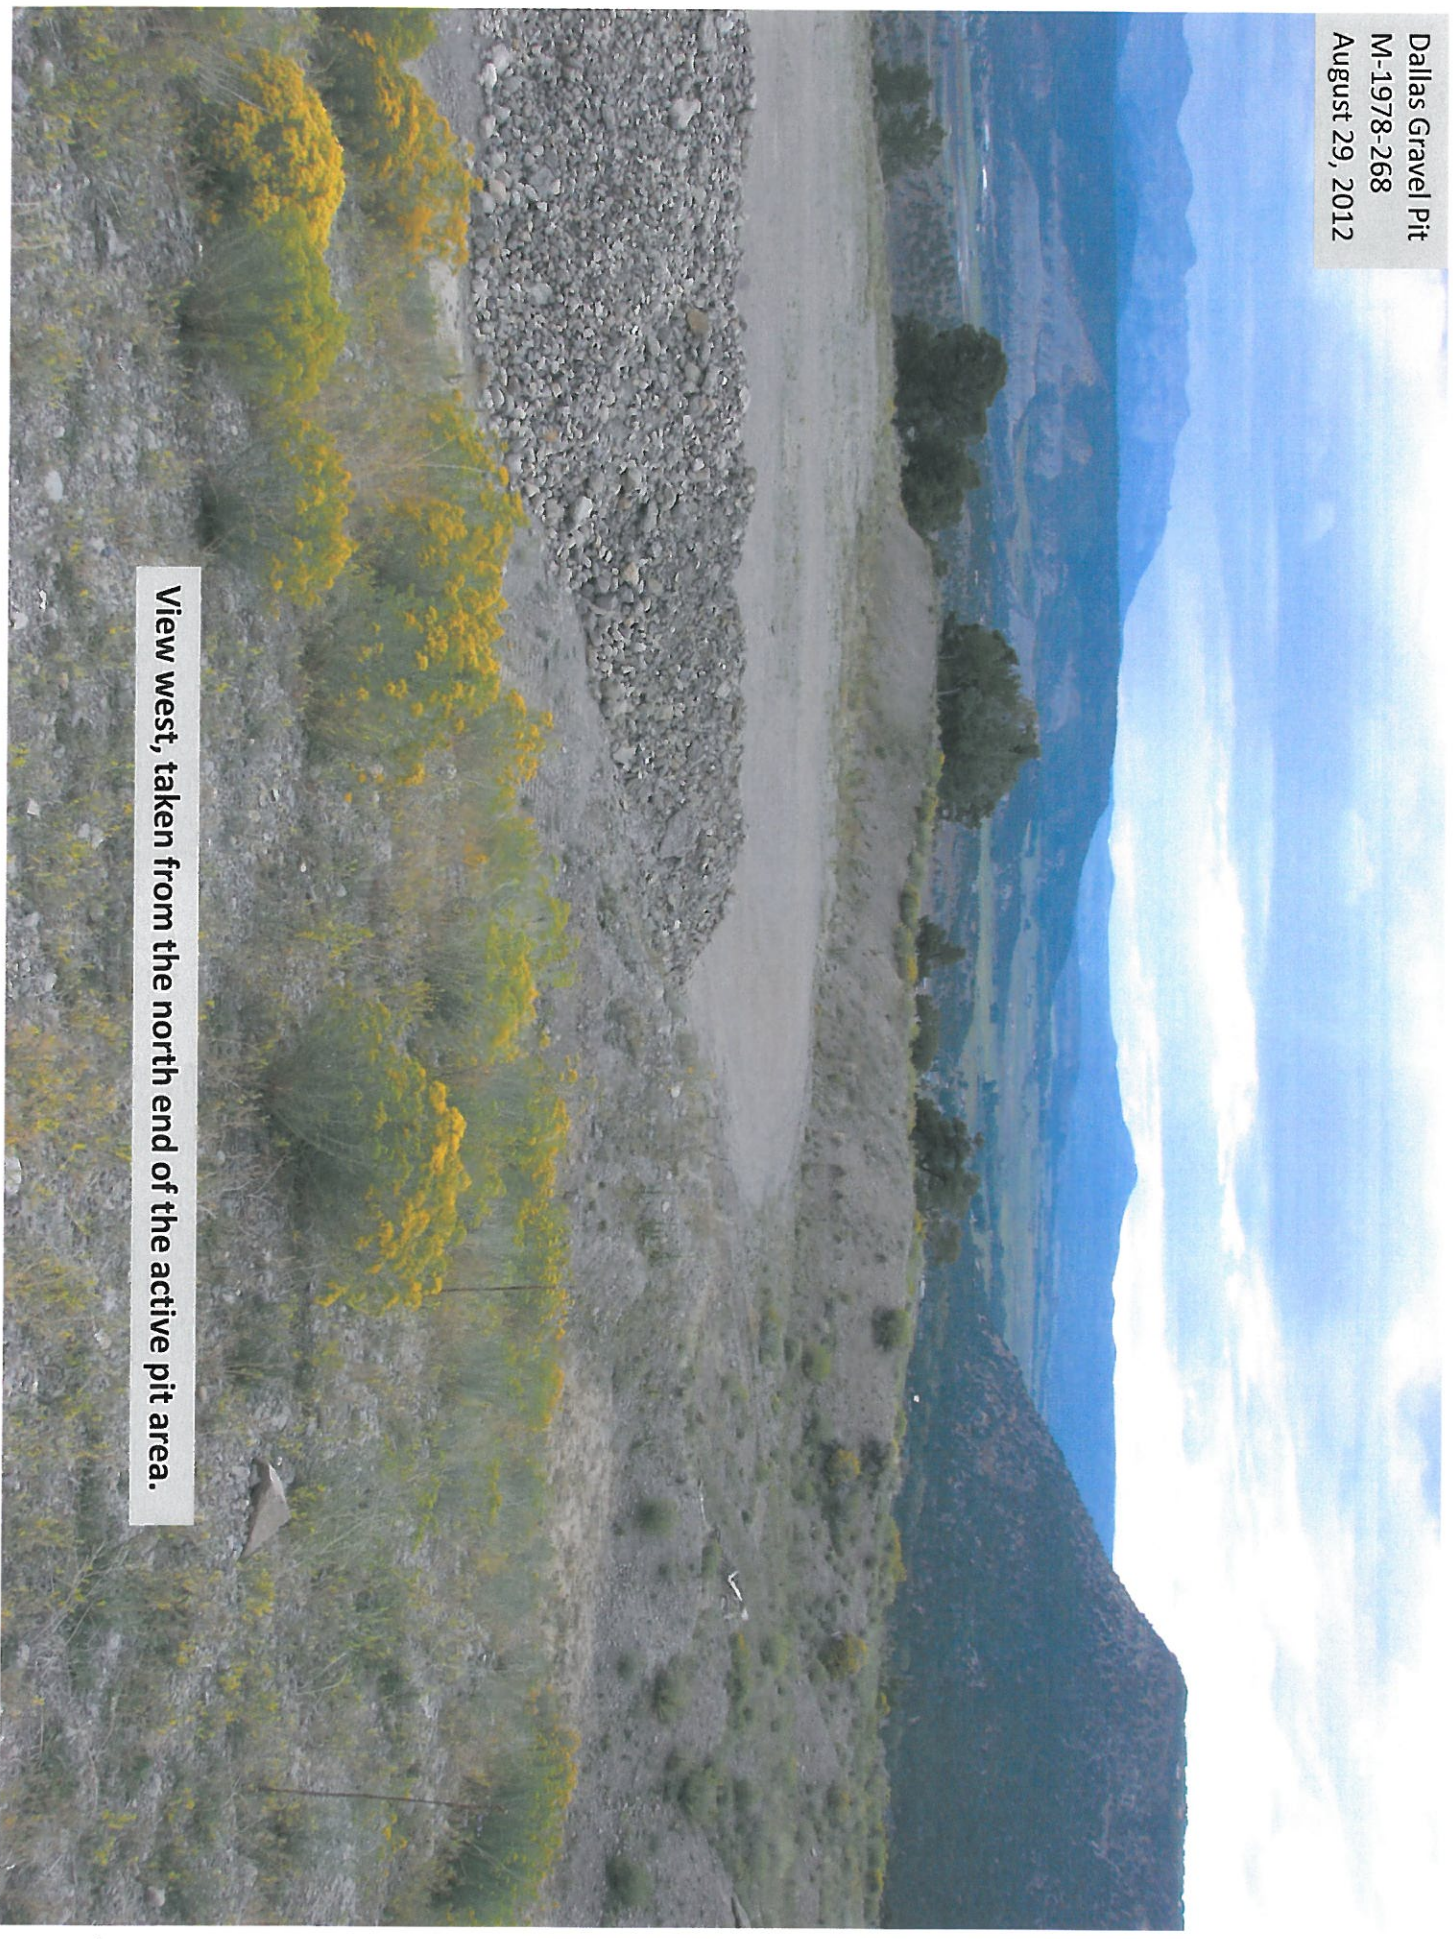
Dallas Gravel Pit
M-1978-268
August 29, 2012

View west, taken from the north end of the active pit area.
