**COLORADO DIVISION OF RECLAMATION, MINING AND SAFETY**  
**MINERALS PROGRAM INSPECTION REPORT**  
**PHONE: (303) 866-3567**

<b>MINE NAME:</b> Gloria Z Mine	<b>MINE/PROSPECTING ID#:</b> M-1984-094	<b>MINERAL:</b> Sand and gravel	<b>COUNTY:</b> Park
<b>INSPECTION TYPE:</b> Monitoring	<b>INSPECTOR(S):</b> Michael A. Cunningham	<b>INSP. DATE:</b> August 30, 2012	<b>INSP. TIME:</b> 09:30
<b>OPERATOR:</b> Sanborn Sand and Gravel/dba Golden Cross Aggregate	<b>OPERATOR REPRESENTATIVE:</b> Mike Pfister	<b>TYPE OF OPERATION:</b> 112c - Construction Regular Operation

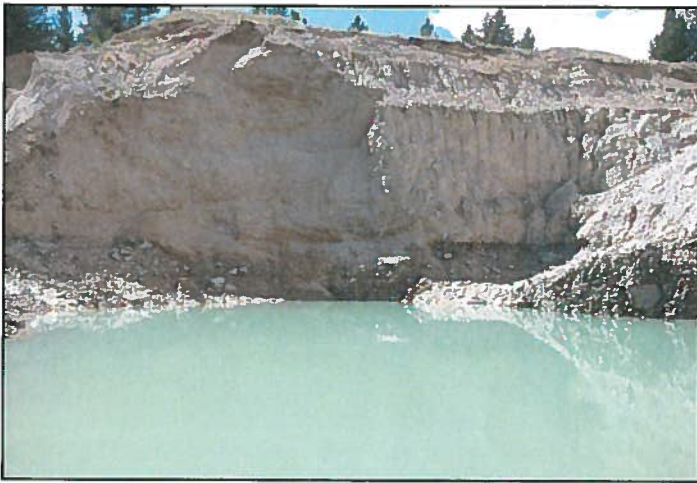
Following the previous inspection, the Operator was instructed to backfill the area of exposed groundwater located along the southern perimeter of the mine site to two feet above the static groundwater level or submit documentation demonstrating a legal right to expose groundwater. On August 23, 2012, the Operator submitted photographic documentation demonstrating the exposure of groundwater had been eliminated through backfilling. Upon arriving at the site the Division found that the Operator had re-exposed groundwater in the same location as was previously documented; the area of exposed groundwater was substantially larger than it was during the previous inspection. The area of exposed groundwater had increased from approximately 75 square feet to 6,500 square feet. In addition, the Operator had constructed a diversion ditch from the wash pond in the northern portion of the mine site to the area of exposed groundwater. The Operator explained that water from the wash pond was being diverted to the pit with exposed groundwater and the pit was being utilized as a settling pond. Mr. Pfister contended that the water in the pit was not groundwater, but was surface water which had been diverted from the wash pond. The Division disagrees with Mr. Pfister and, based on observations made during the inspection, has concluded the water in the pit is groundwater. No active mining operations were taking place during the inspection and no water was being diverted into the pit. The Operator did not submit a Technical Revision addressing the construction a diversion ditch or the use of the pit as a settling pond. These types of minor revisions require the submittal of a Technical Revision and the changes may not be made until the Division approval is granted.

1. Area of re-exposed groundwater, facing south.

- 1) File a financial warranty that will ensure backfilling of the pit to cover the exposed groundwater to a depth of two feet above the static groundwater level.
- 2) Obtain a court approved augmentation plan prior to exposing groundwater.
- 3) File a financial warranty to cover the cost of installing a clay liner or a slurry wall that meets the Division of Water Resources requirements for preventing groundwater exposure.
- 4) Obtain approval from the Division of Water Resources that acknowledges compliance with the SEO's requirements pursuant to § 37-90-137(11).

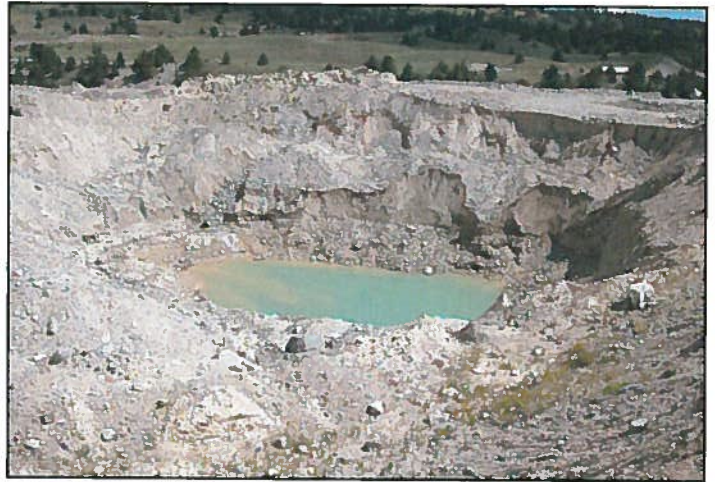
2. Overview of area of re-exposed groundwater, facing northeast.

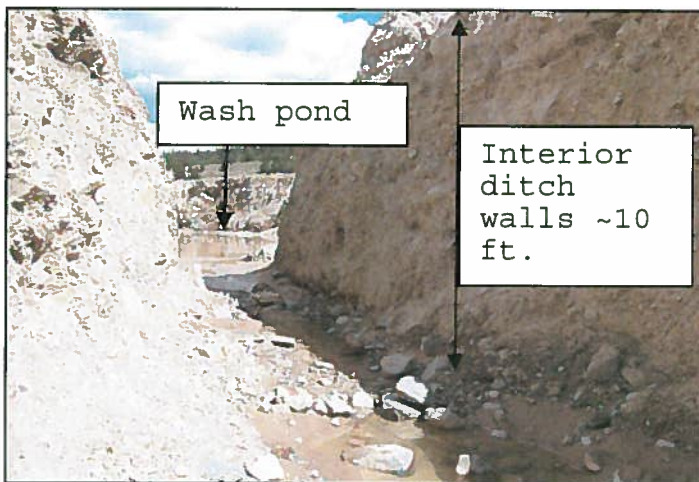
3. Diversion ditch.

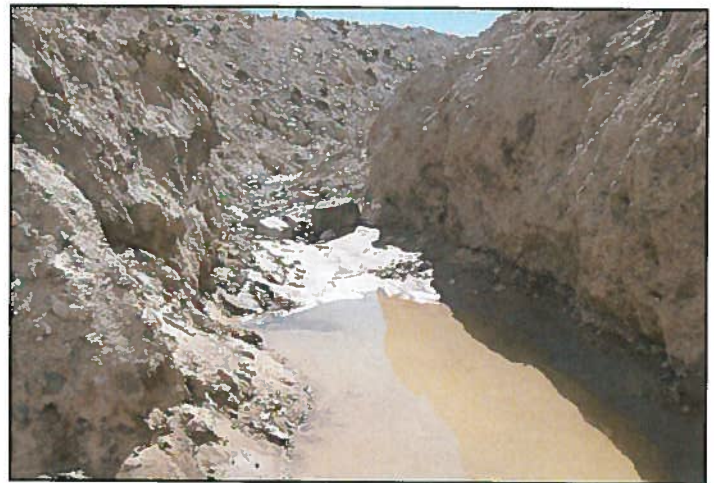
4. Diversion ditch.

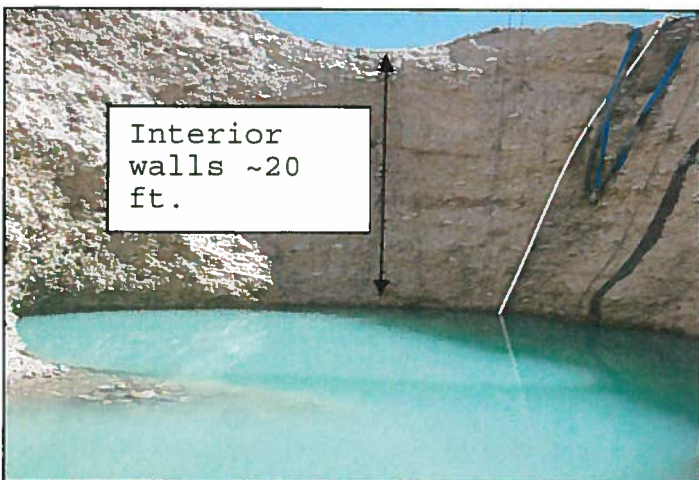
In addition to re-exposing groundwater at the south end of the site, the Operator had exposed a second area of groundwater immediately west of the existing wash pond. The second area of exposed groundwater was approximately 300 square feet in size. According to Mr. Pfister, it was necessary to expose groundwater in this area because he could no longer make use of his water right, which allowed him to divert water from the Sacramento Creek to his wash plant. The Operator had set up a pump to move water from the pit up to the trommel located on the south side of the wash pond. The second area of exposed groundwater had vertical highwalls on three sides which were approximately 20 ft. in height. According to Mr. Pfister, the water was being leased and the evaporative depletions were covered under an existing augmentation plan. Mr. Pfister has not provided the Division with documentation demonstrating that he is in compliance with Colorado water laws and regulations governing injury to existing water rights. In addition, the Operator did not receive Division approval through a technical revision to expose a second area of groundwater. The approved Mining Plan for the Gloria Z clearly states that groundwater will not be exposed during mining operations.

5. Second area of exposed groundwater, west of wash pond.

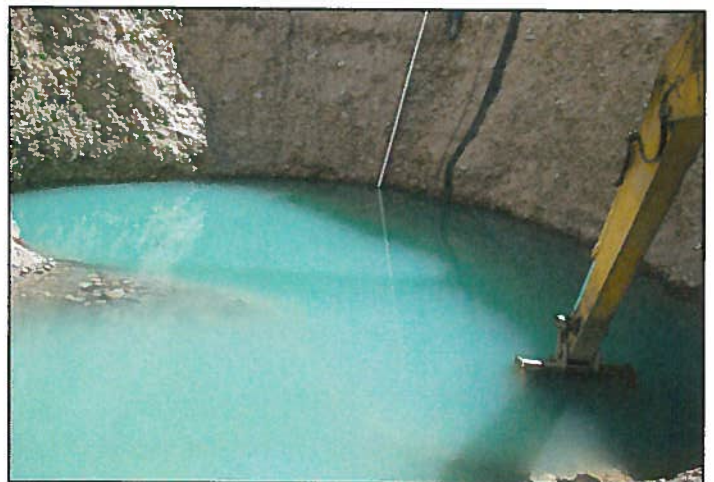
Second area of exposed groundwater.
