**COLORADO DIVISION OF RECLAMATION, MINING AND SAFETY**  
**MINERALS PROGRAM INSPECTION REPORT**  
**PHONE: (303) 866-3567**

<b>MINE NAME:</b> Bridalveil Pit	<b>MINE/PROSPECTING ID#:</b> M-2001-054	<b>MINERAL:</b> Gravel	<b>COUNTY:</b> Ouray
<b>INSPECTION TYPE:</b> Multi Person Inspection	<b>INSPECTOR(S):</b> Wallace H. Erickson & G. Russell Means	<b>INSP. DATE:</b> August 29, 2012	<b>INSP. TIME:</b> 10:30
<b>OPERATOR:</b> Bridal Veil Construction	<b>OPERATOR REPRESENTATIVE:</b> Emery Lynn Olin	<b>TYPE OF OPERATION:</b> 110c - Construction Limited Impact	
<b>REASON FOR INSPECTION:</b> Normal I&E Program	<b>BOND CALCULATION TYPE:</b> Complete Bond	<b>BOND AMOUNT:</b> \$4,942.00	
<b>DATE OF COMPLAINT:</b> NA	<b>POST INSP. CONTACTS:</b> None	<b>JOINT INSP. AGENCY:</b> None	
<b>WEATHER:</b> Cloudy	<b>INSPECTOR'S SIGNATURE:</b> <i>Wallace H. Erickson</i>	<b>SIGNATURE DATE:</b> September 12, 2012

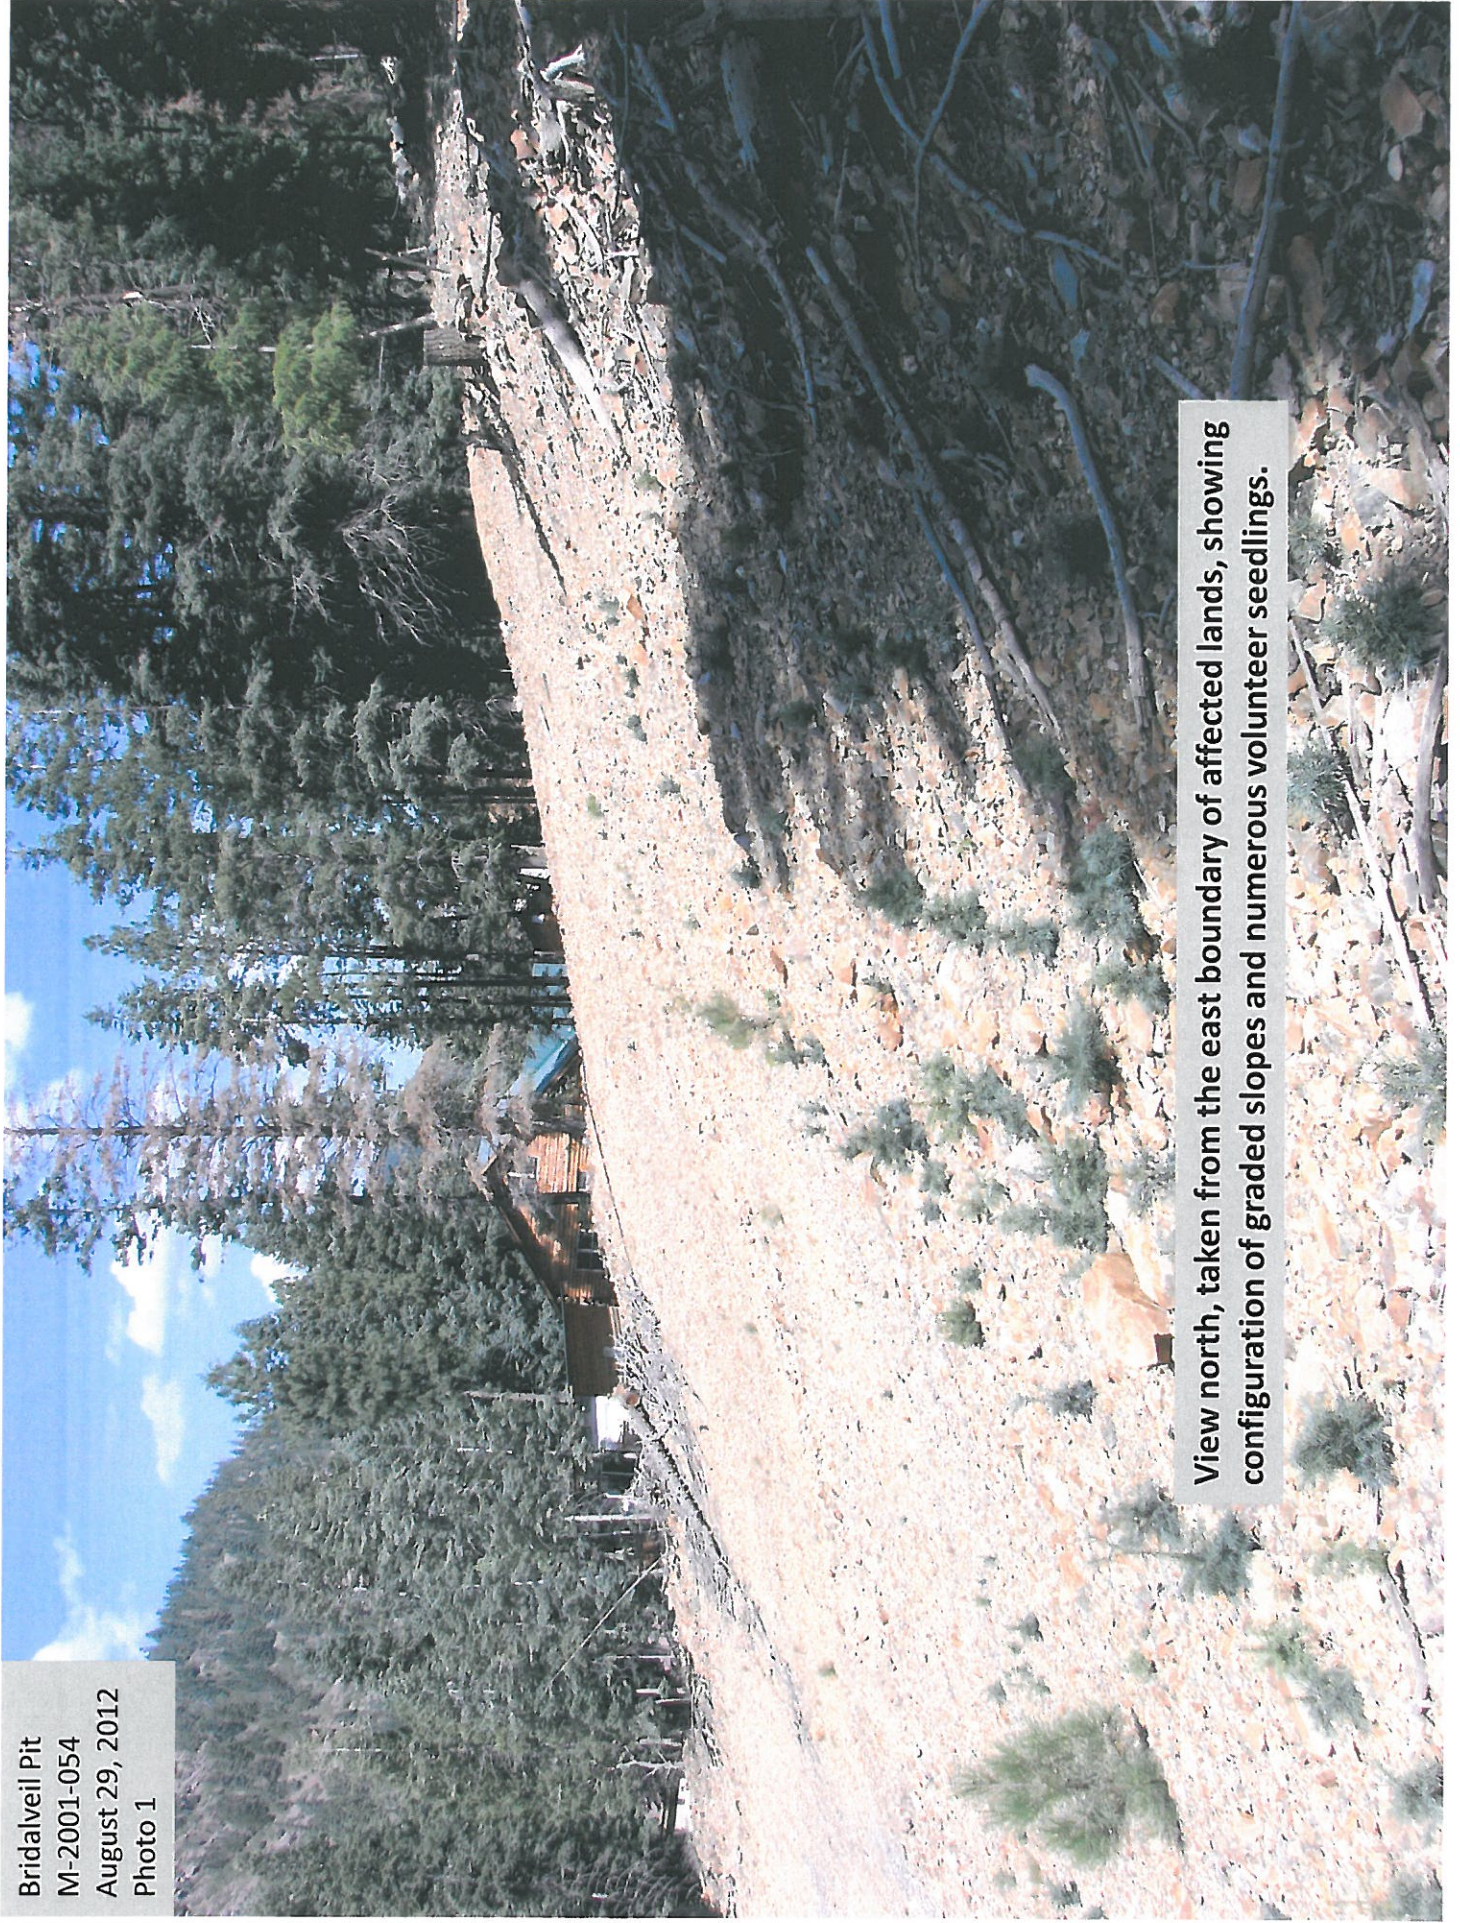
Bridalveil Pit  
M-2001-054  
August 29, 2012  
Photo 1

View north, taken from the east boundary of affected lands, showing configuration of graded slopes and numerous volunteer seedlings.

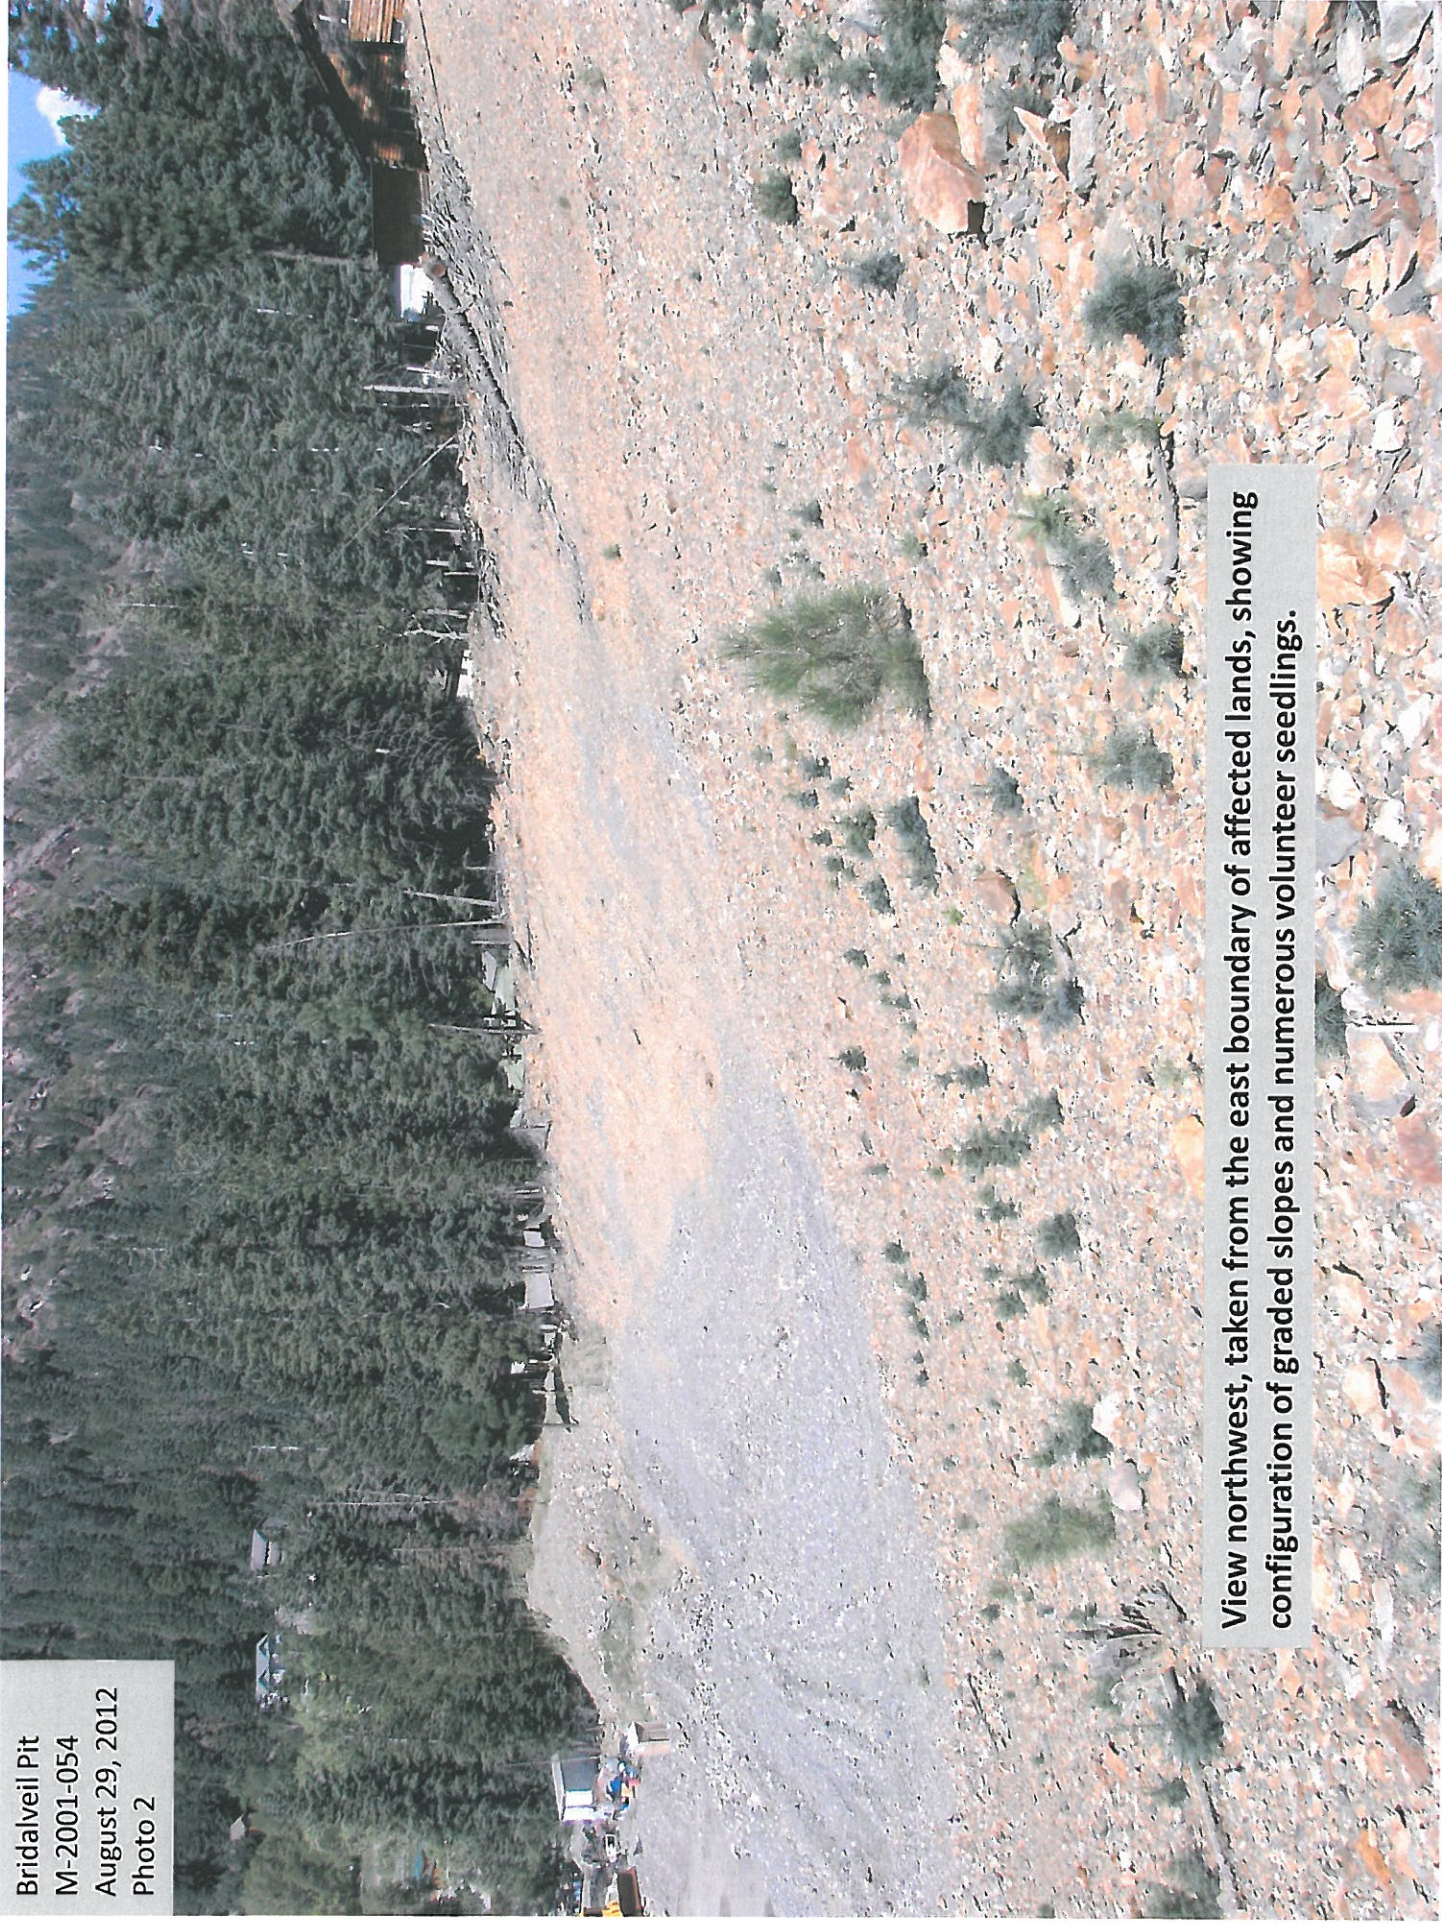
Bridalveil Pit  
M-2001-054  
August 29, 2012  
Photo 2

As shown in photos 2 and 3, earthen materials appear to have been imported from off-site areas and are being utilized as backfill. Permit documents do not indicate importation of materials was intended or that imported materials would be utilized as structural fill. Permit documents do not include the notice from the Operator required under Rule 3.1.5(9), addressing the imported materials. As noted above, the Division has identified the issue as a problem and has imposed a 30-day corrective action deadline whereby the issue must be resolved.

View northwest, taken from the east boundary of affected lands, showing configuration of graded slopes and numerous volunteer seedlings.

**CORRECTIVE ACTIONS:** Within 30 days, due October 12, 2012, the Operator shall provide a notarized affidavit, stating that the fill is, in fact, inert and addressing all requirements of Rule 3.1.5(9), which describes the intended use of inert/off-site fill by the corrective action date.

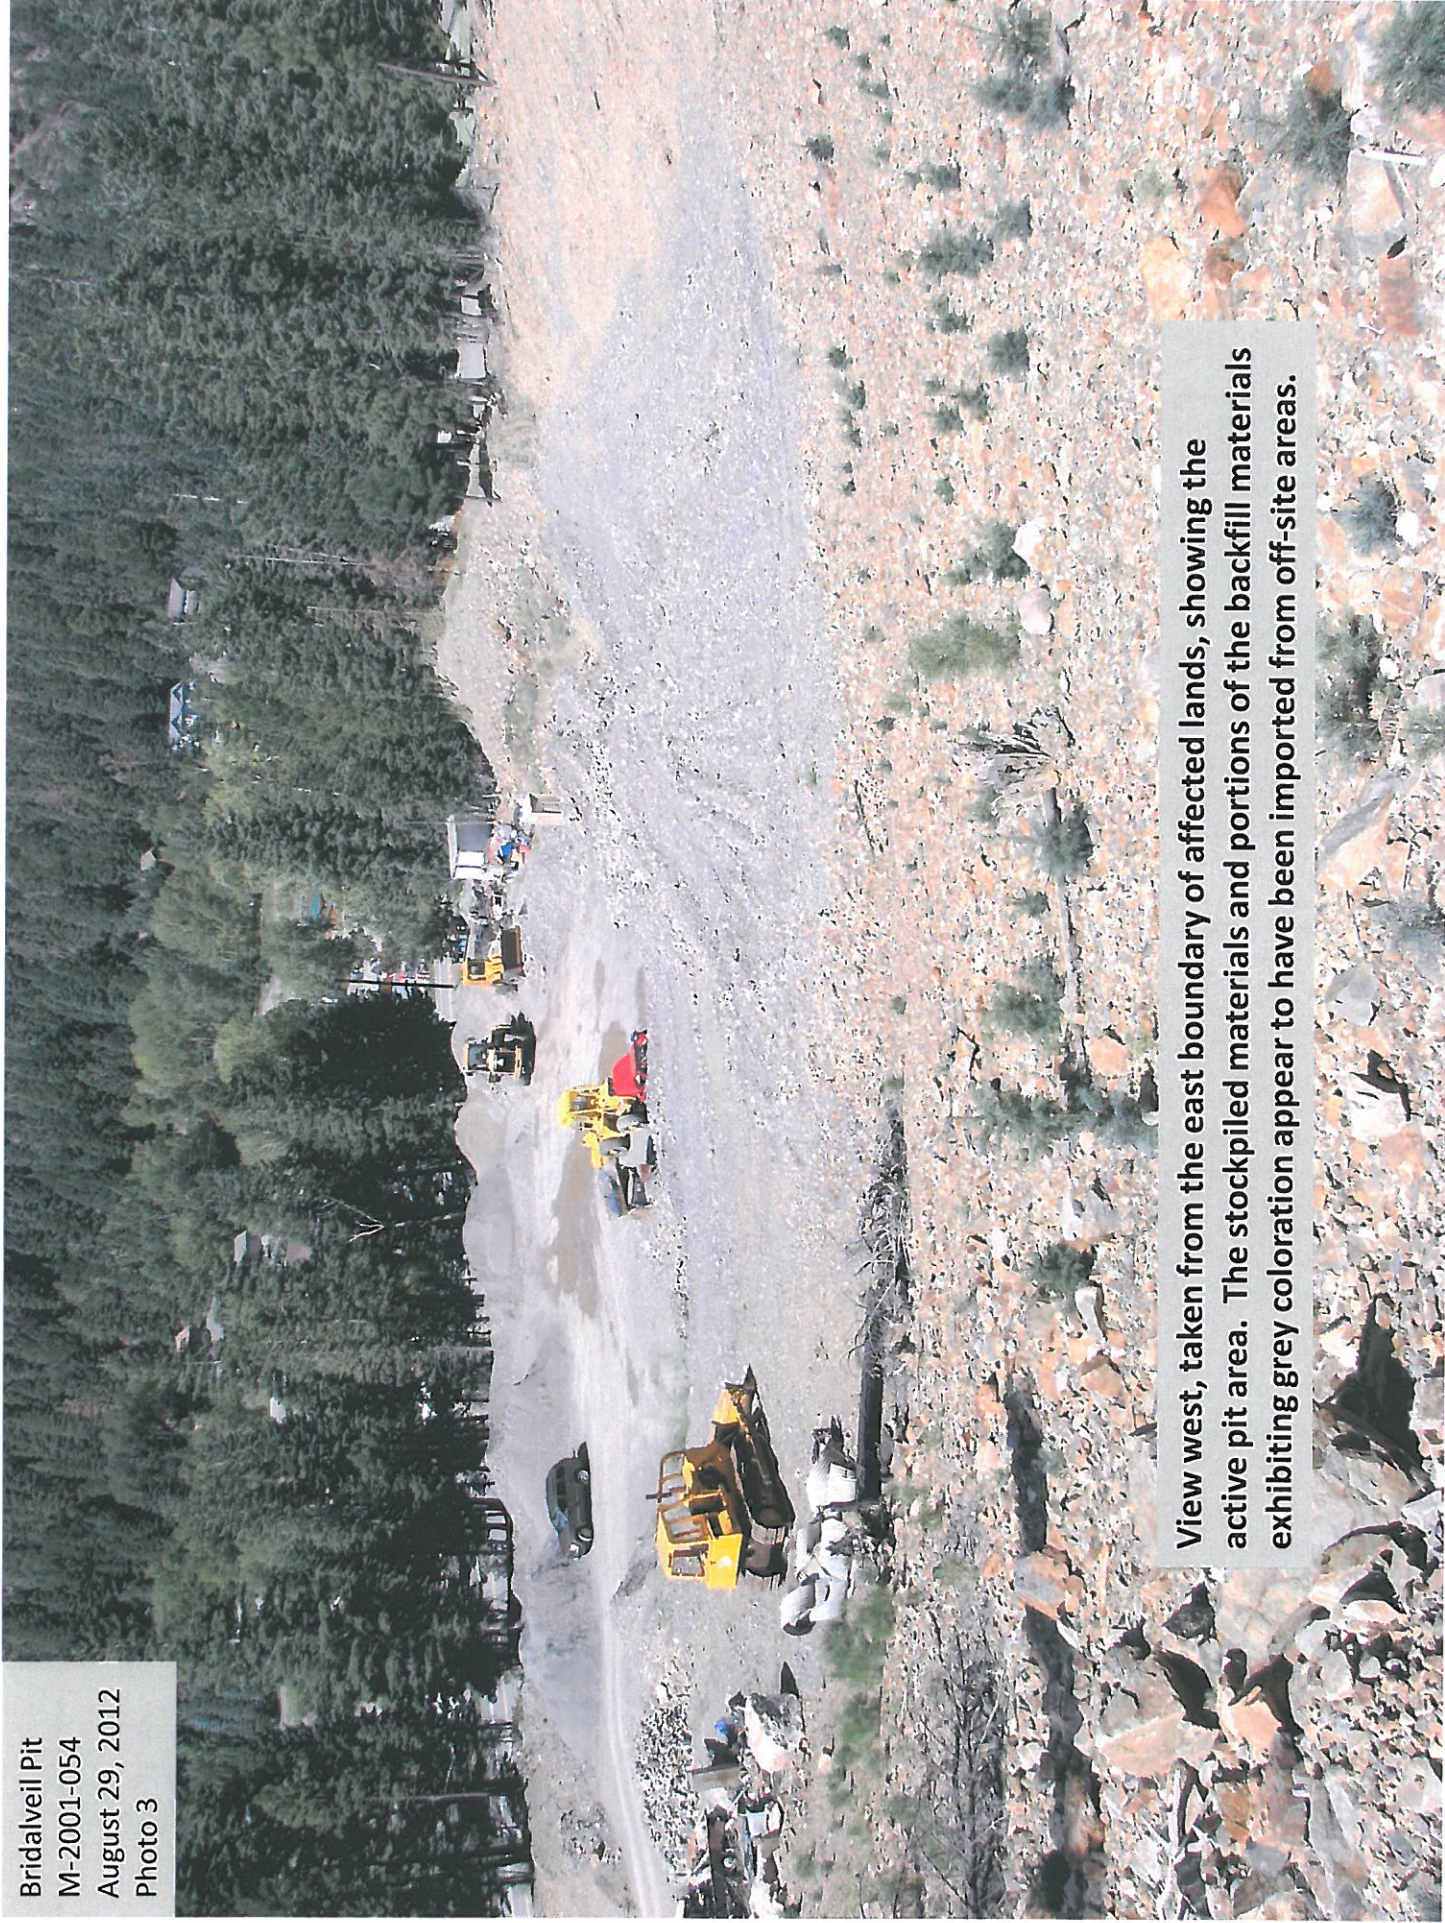
Bridalveil Pit  
M-2001-054  
August 29, 2012  
Photo 3

**PROBLEM/POSSIBLE VIOLATION:** Problem: The site is utilizing off-site fill without prior approval by the Division, per Construction Materials Rule 3.1.5(9).

View west, taken from the east boundary of affected lands, showing the active pit area. The stockpiled materials and portions of the backfill materials exhibiting grey coloration appear to have been imported from off-site areas.

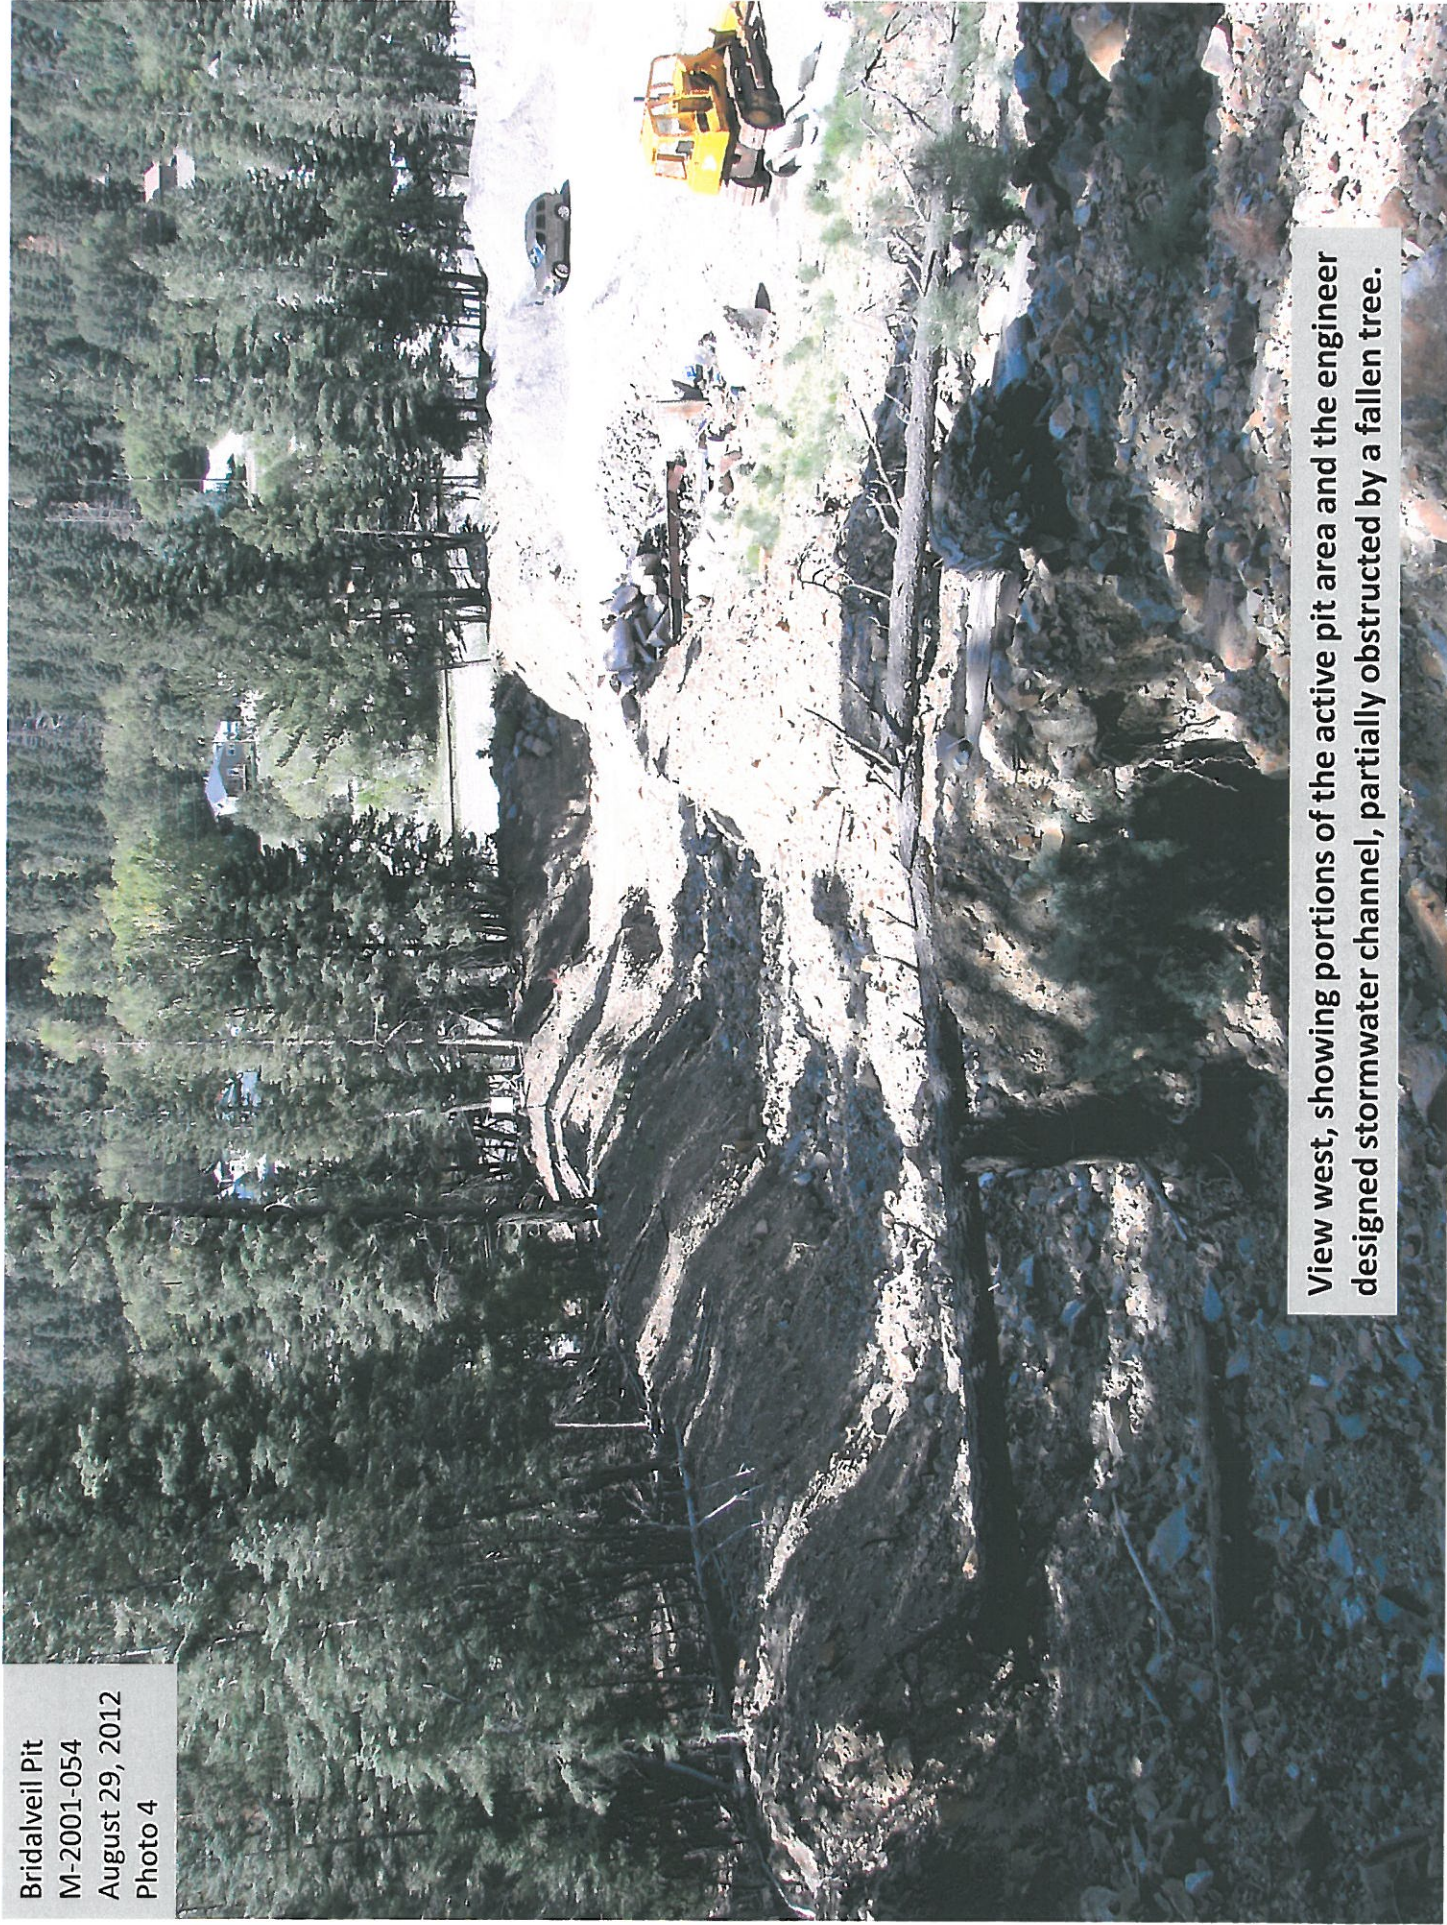
Bridalveil Pit  
M-2001-054  
August 29, 2012  
Photo 4

View west, showing portions of the active pit area and the engineer designed stormwater channel, partially obstructed by a fallen tree.

**CORRECTIVE ACTIONS:** Within 30 days, due October 12, 2012, the Operator shall repair the stormwater control channel and basin to fully comply with the approved plan, control erosion, and protect outside areas from damage. By October 12, 2012, the Operator shall provide photo documentation to the Division verifying the completion of repairs for all portions of the stormwater control structures.

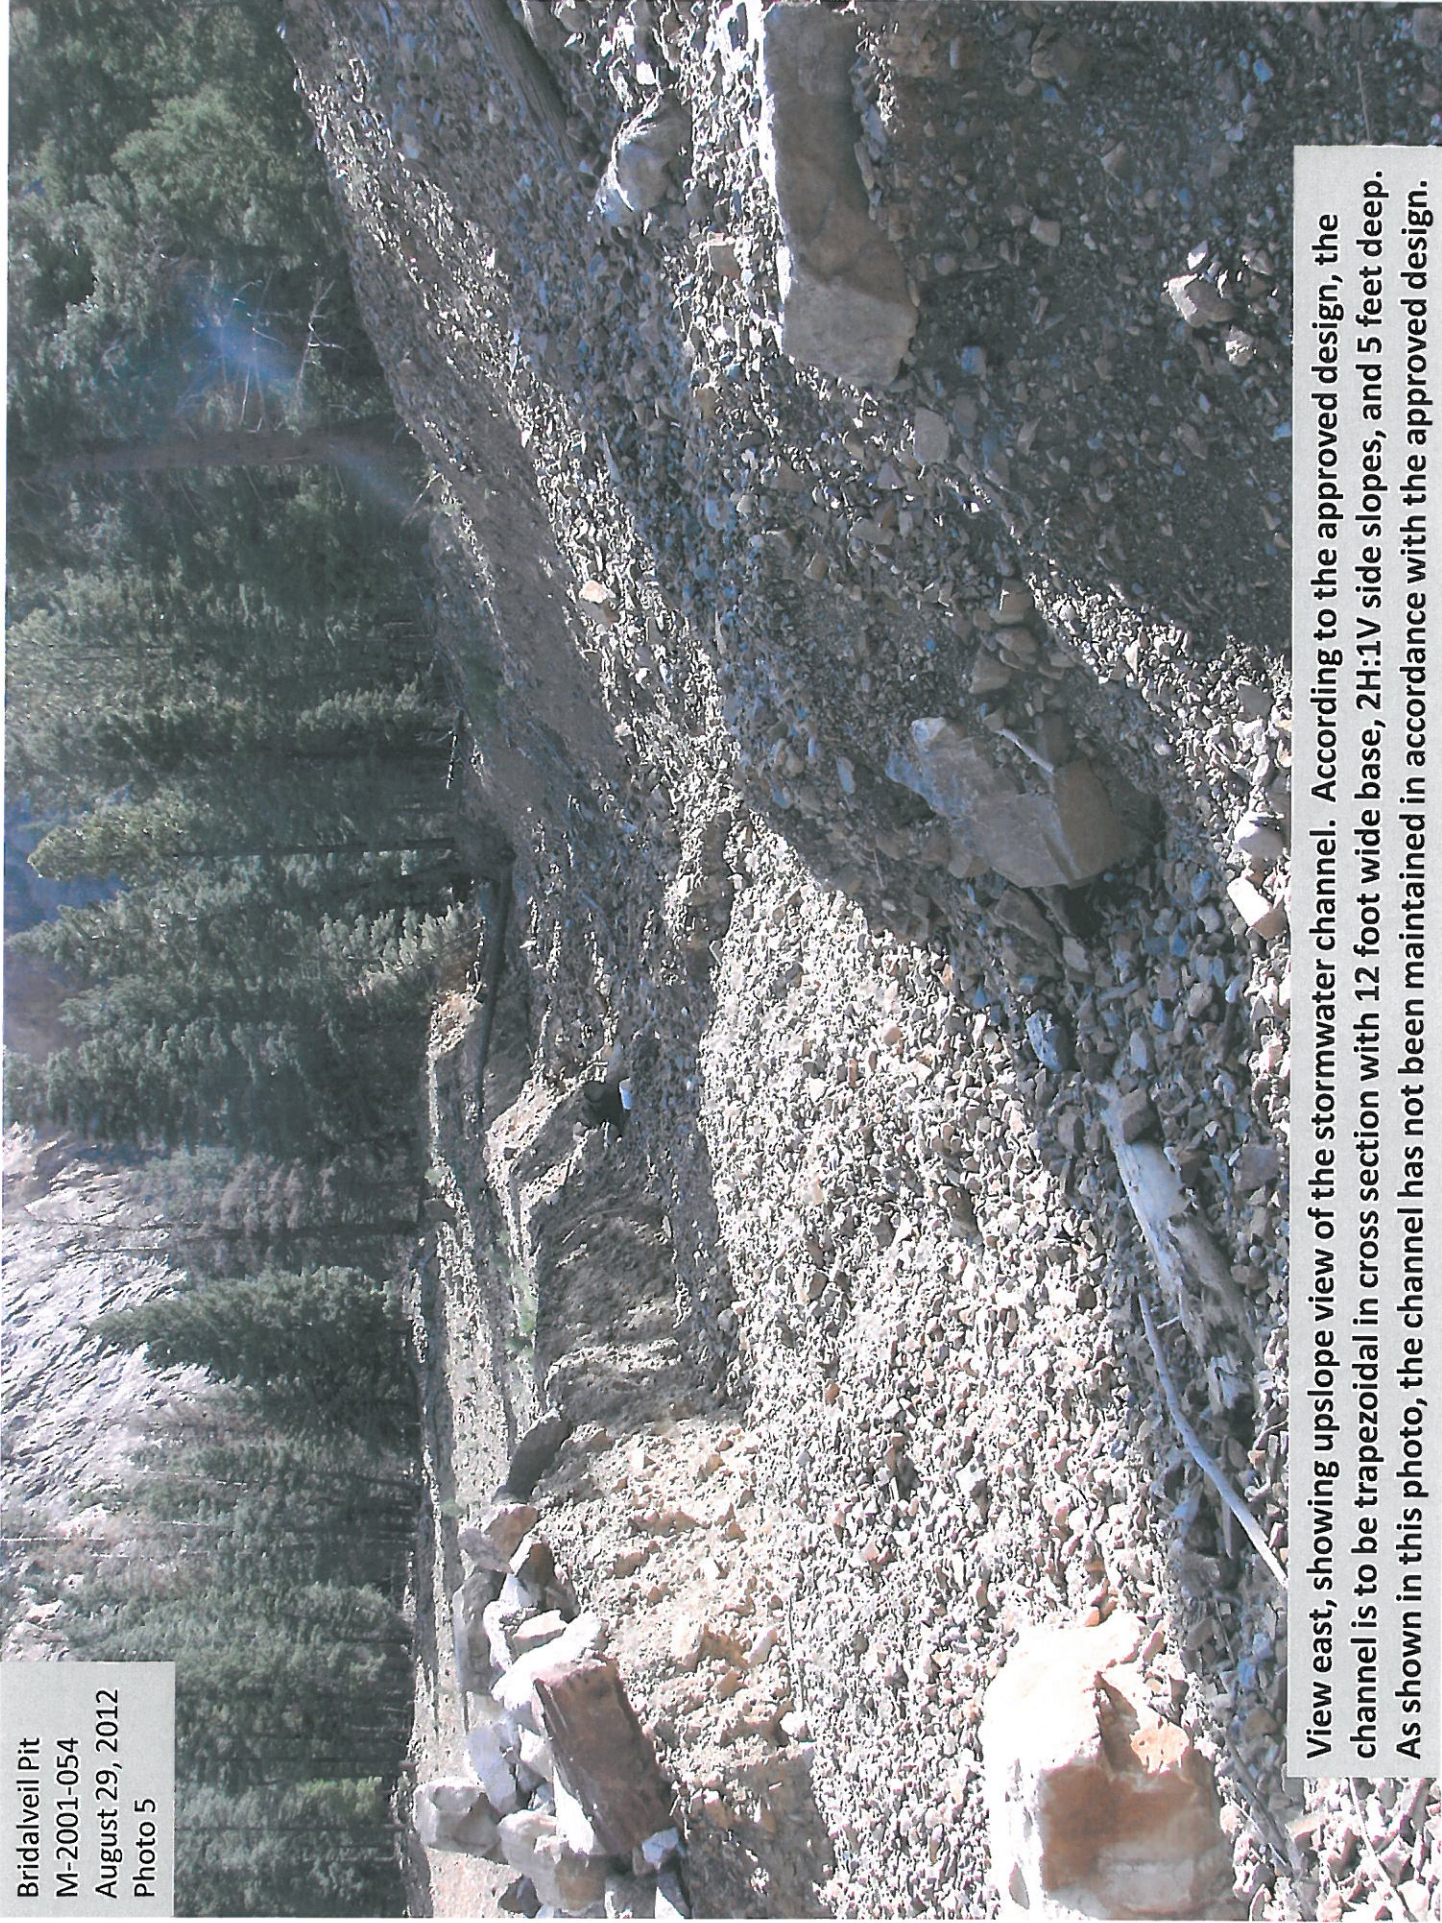
Bridalveil Pit  
M-2001-054  
August 29, 2012  
Photo 5

**PROBLEM/POSSIBLE VIOLATION:** Problem: The Operator is not maintaining the stormwater control channel or its associated sediment basin in accordance with the approved plan. The approved plan was designed and certified by a licensed professional engineer. Evidence of excessive erosion and sedimentation were observed. Pursuant to C.R.S. 34-32.5-116(4)(i) and (j), the Operator is required to stabilize affected lands so as to effectively control erosion and protect outside areas from damage.

View east, showing upslope view of the stormwater channel. According to the approved design, the channel is to be trapezoidal in cross section with 12 foot wide base, 2H:1V side slopes, and 5 feet deep. As shown in this photo, the channel has not been maintained in accordance with the approved design.

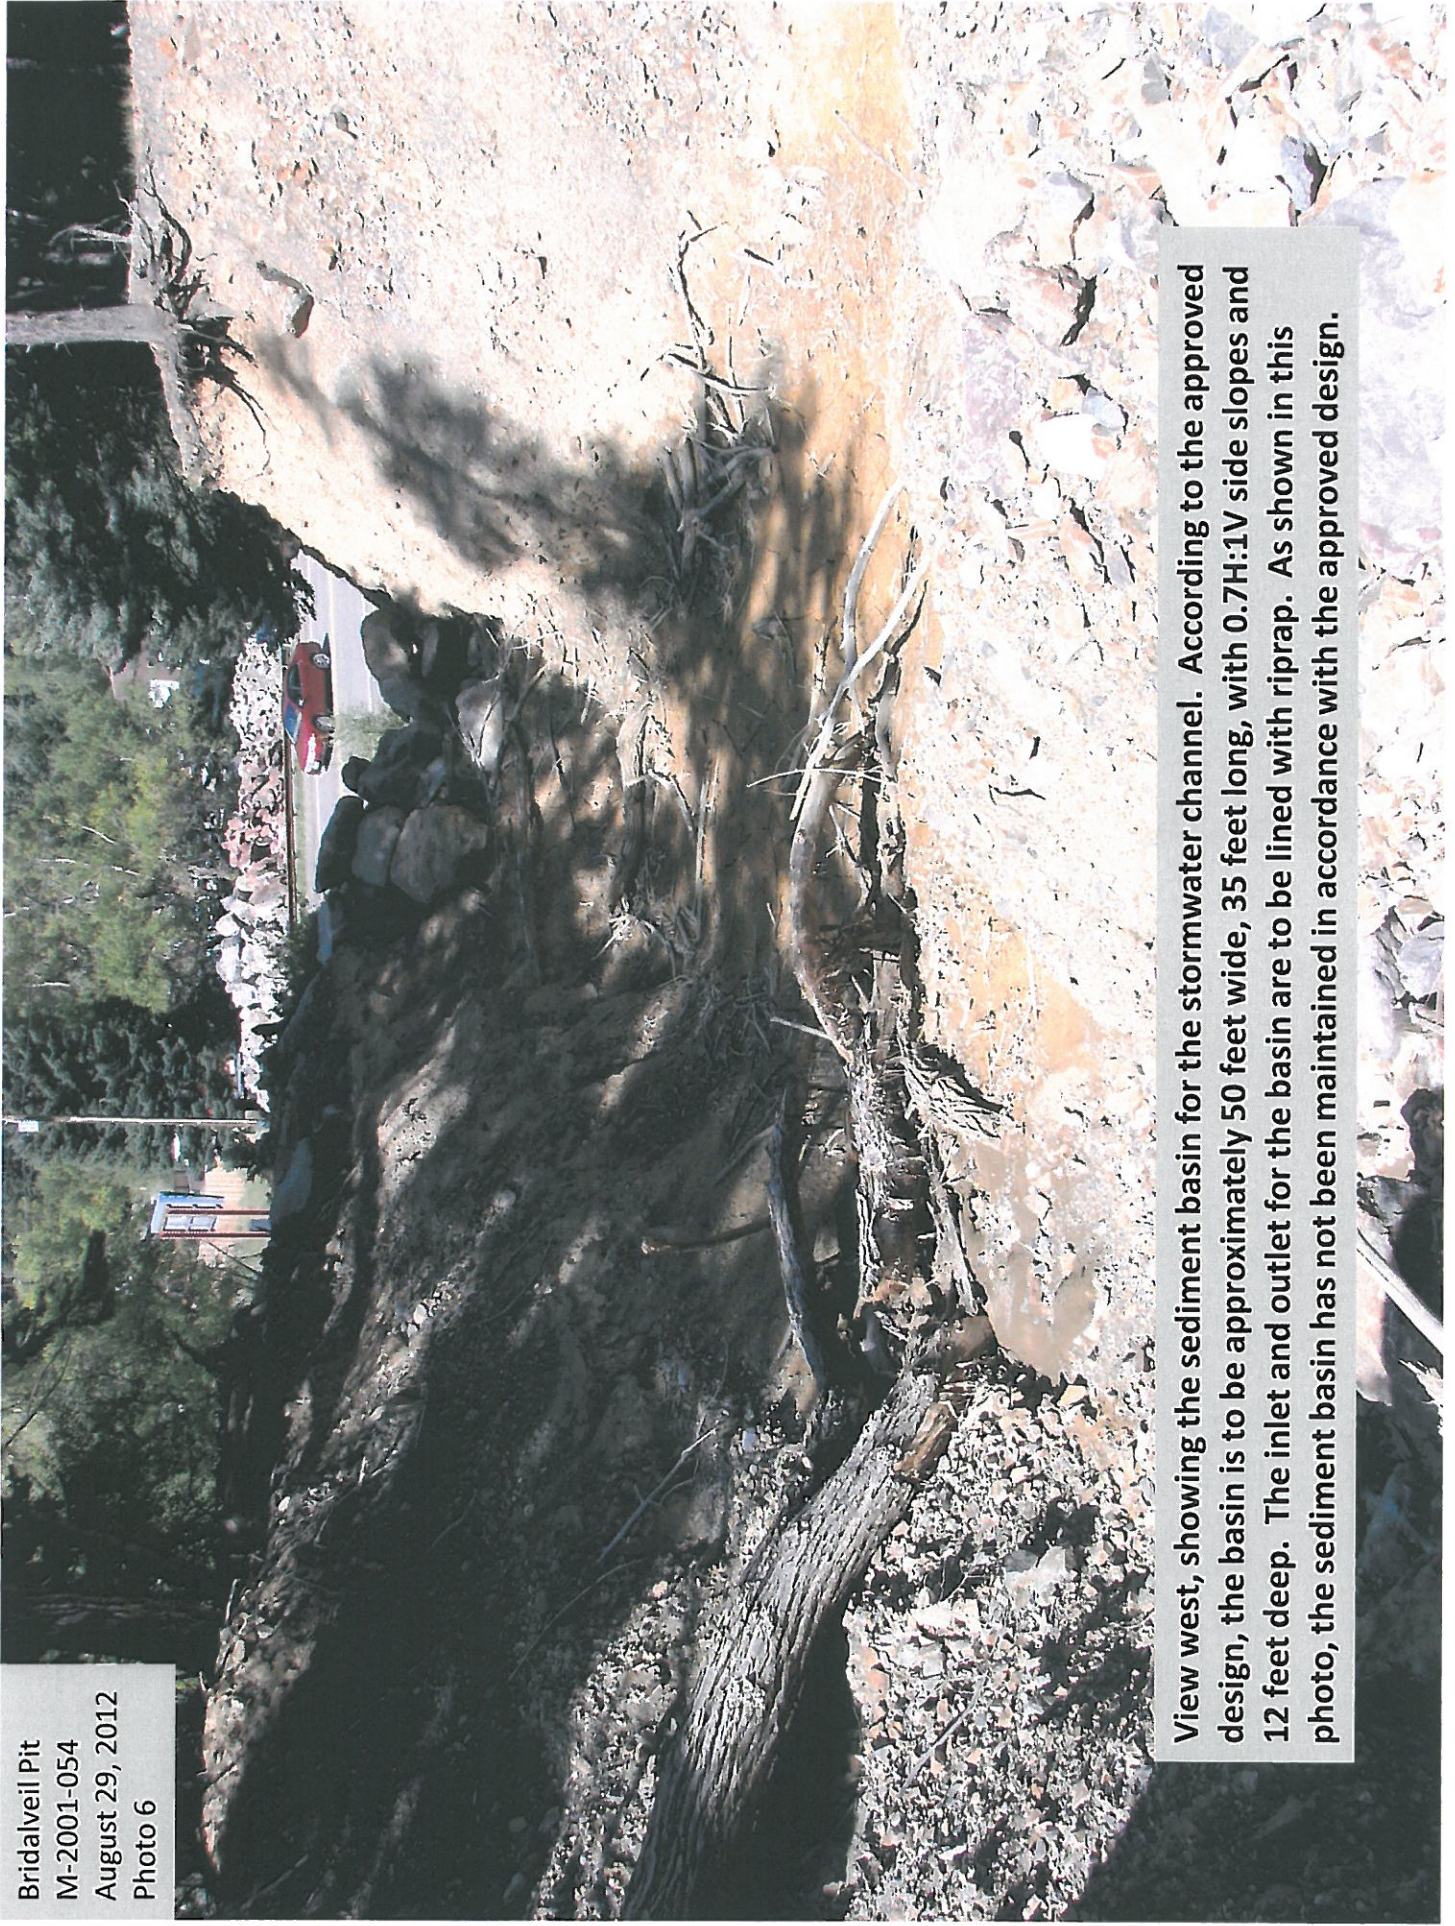
Bridalveil Pit  
M-2001-054  
August 29, 2012  
Photo 6

day corrective action deadline whereby the stormwater structures must be repaired and maintained in accordance with the approved designs. The approved designs provide critical dimensions, minimum capacities, and specify riprap lining for the inlet and outlet of the sediment basin. The approved riprap lining is composed of 12-inch diameter rock, a minimum of 2-feet deep, 12-feet wide and extending 20 feet upstream and 20 feet downstream of the inlet and outlet of the basin.

View west, showing the sediment basin for the stormwater channel. According to the approved design, the basin is to be approximately 50 feet wide, 35 feet long, with 0.7H:1V side slopes and 12 feet deep. The inlet and outlet for the basin are to be lined with riprap. As shown in this photo, the sediment basin has not been maintained in accordance with the approved design.

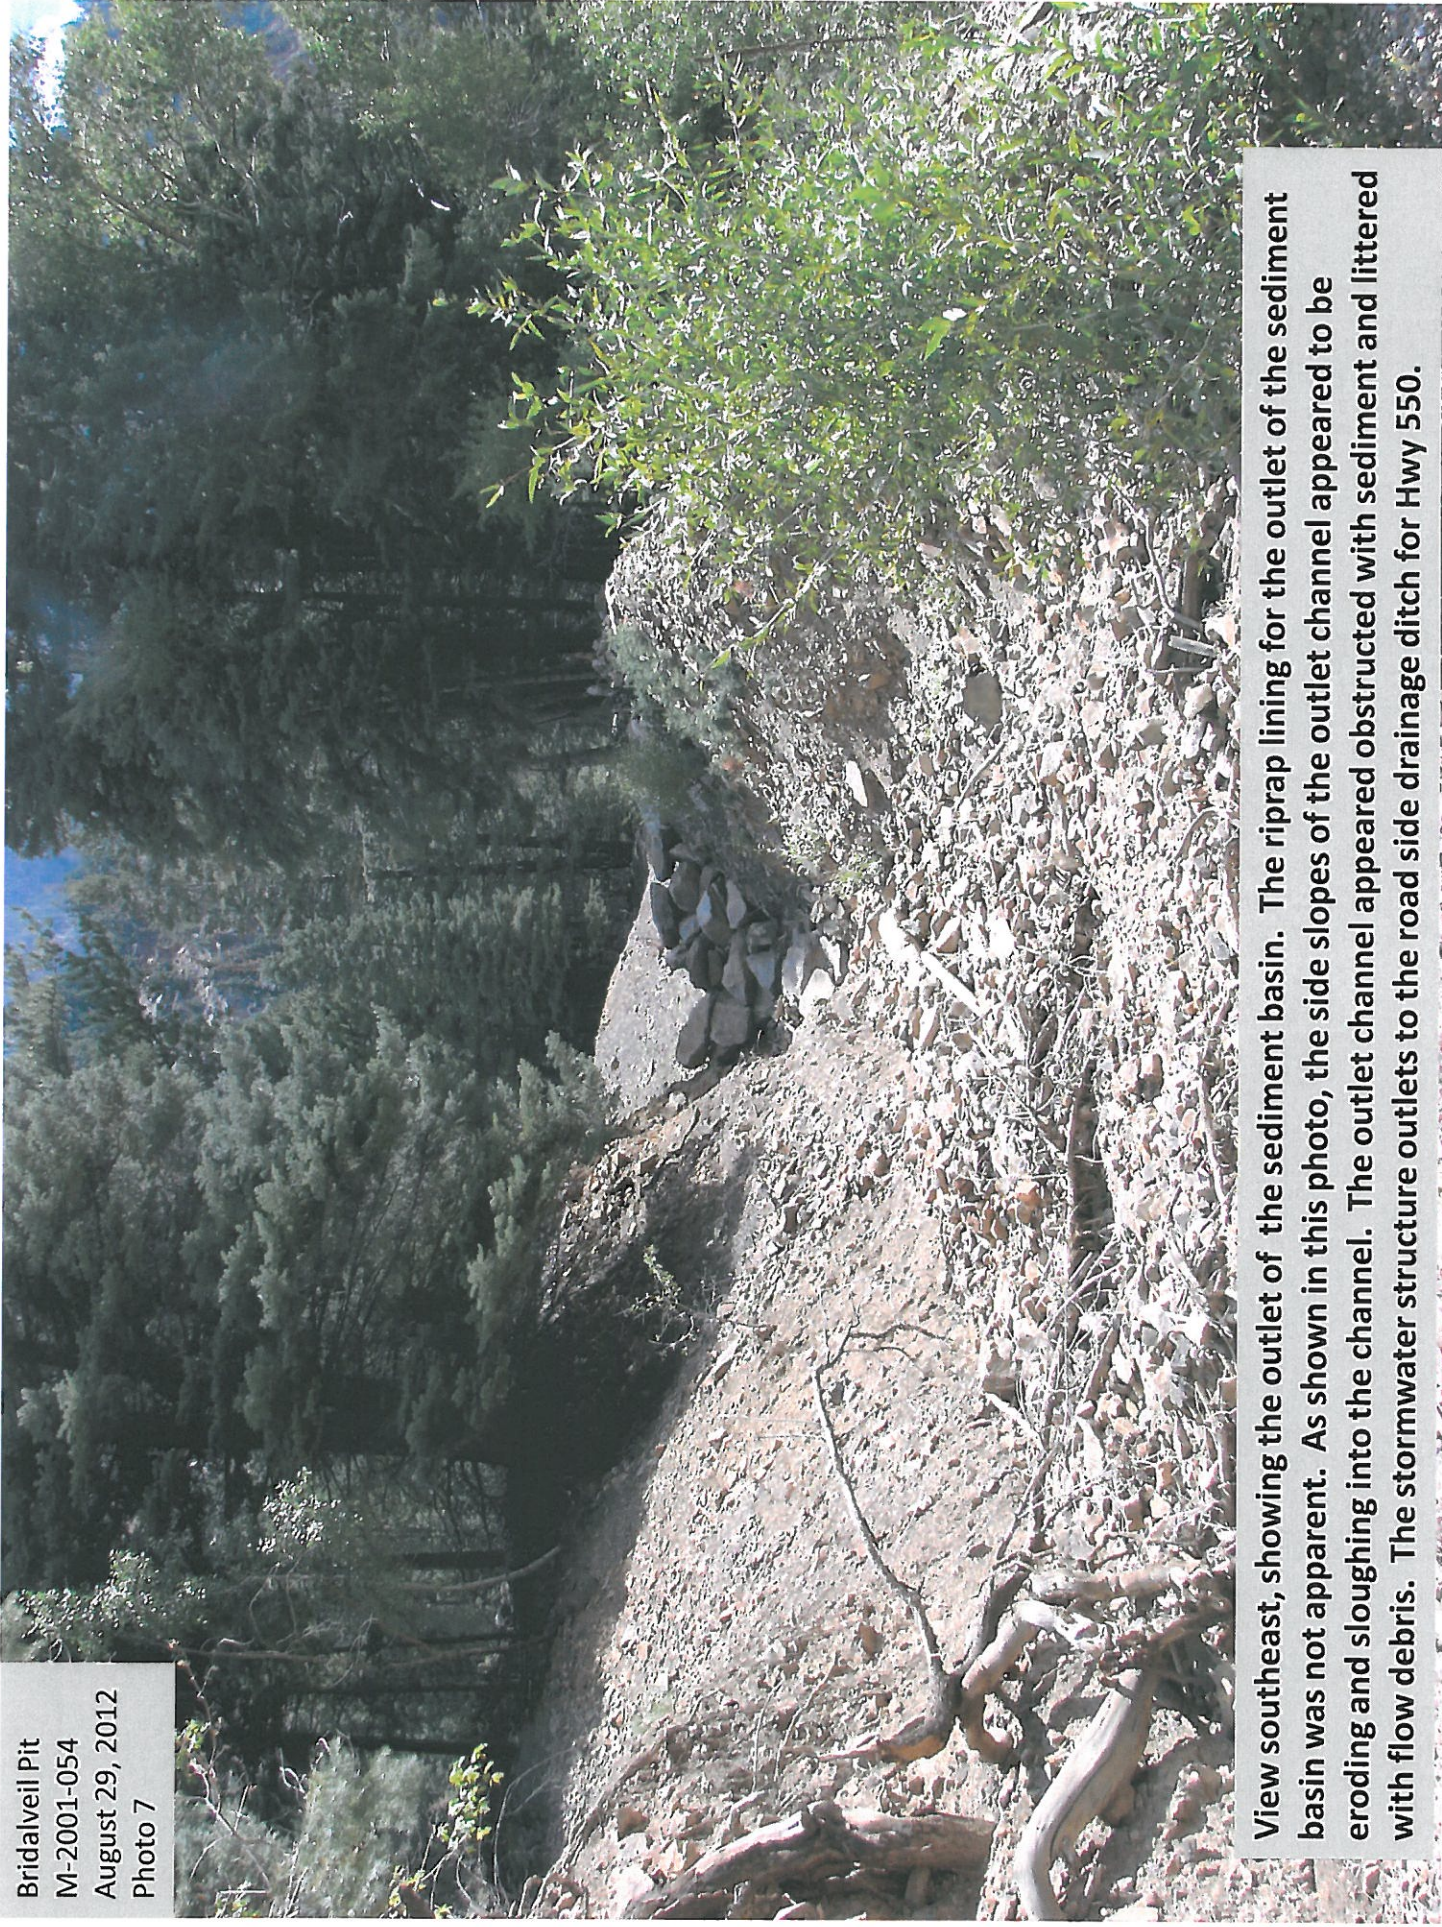
Bridalveil Pit  
M-2001-054  
August 29, 2012  
Photo 7

View southeast, showing the outlet of the sediment basin. The riprap lining for the outlet of the sediment basin was not apparent. As shown in this photo, the side slopes of the outlet channel appeared to be eroding and sloughing into the channel. The outlet channel appeared obstructed with sediment and littered with flow debris. The stormwater structure outlets to the road side drainage ditch for Hwy 550.
