**COLORADO DIVISION OF RECLAMATION, MINING AND SAFETY**  
**MINERALS PROGRAM INSPECTION REPORT**  
**PHONE: (303) 866-3567**

<b>MINE NAME:</b> Bridalveil Pit	<b>MINE/PROSPECTING ID#:</b> M-2001-054	<b>MINERAL:</b> Gravel	<b>COUNTY:</b> Ouray
<b>INSPECTION TYPE:</b> Multi Person Inspection	<b>INSPECTOR(S):</b> Wallace H. Erickson & G. Russell Means	<b>INSP. DATE:</b> August 29, 2012	<b>INSP. TIME:</b> 10:30
<b>OPERATOR:</b> Bridal Veil Construction	<b>OPERATOR REPRESENTATIVE:</b> Emery Lynn Olin	<b>TYPE OF OPERATION:</b> 110c - Construction Limited Impact	
<b>REASON FOR INSPECTION:</b> Normal I&E Program	<b>BOND CALCULATION TYPE:</b> Complete Bond	<b>BOND AMOUNT:</b> \$4,942.00	
<b>DATE OF COMPLAINT:</b> NA	<b>POST INSP. CONTACTS:</b> None	<b>JOINT INSP. AGENCY:</b> None	
<b>WEATHER:</b> Cloudy	<b>INSPECTOR'S SIGNATURE:</b> <i>Wallace H. Erickson</i>	<b>SIGNATURE DATE:</b> September 12, 2012

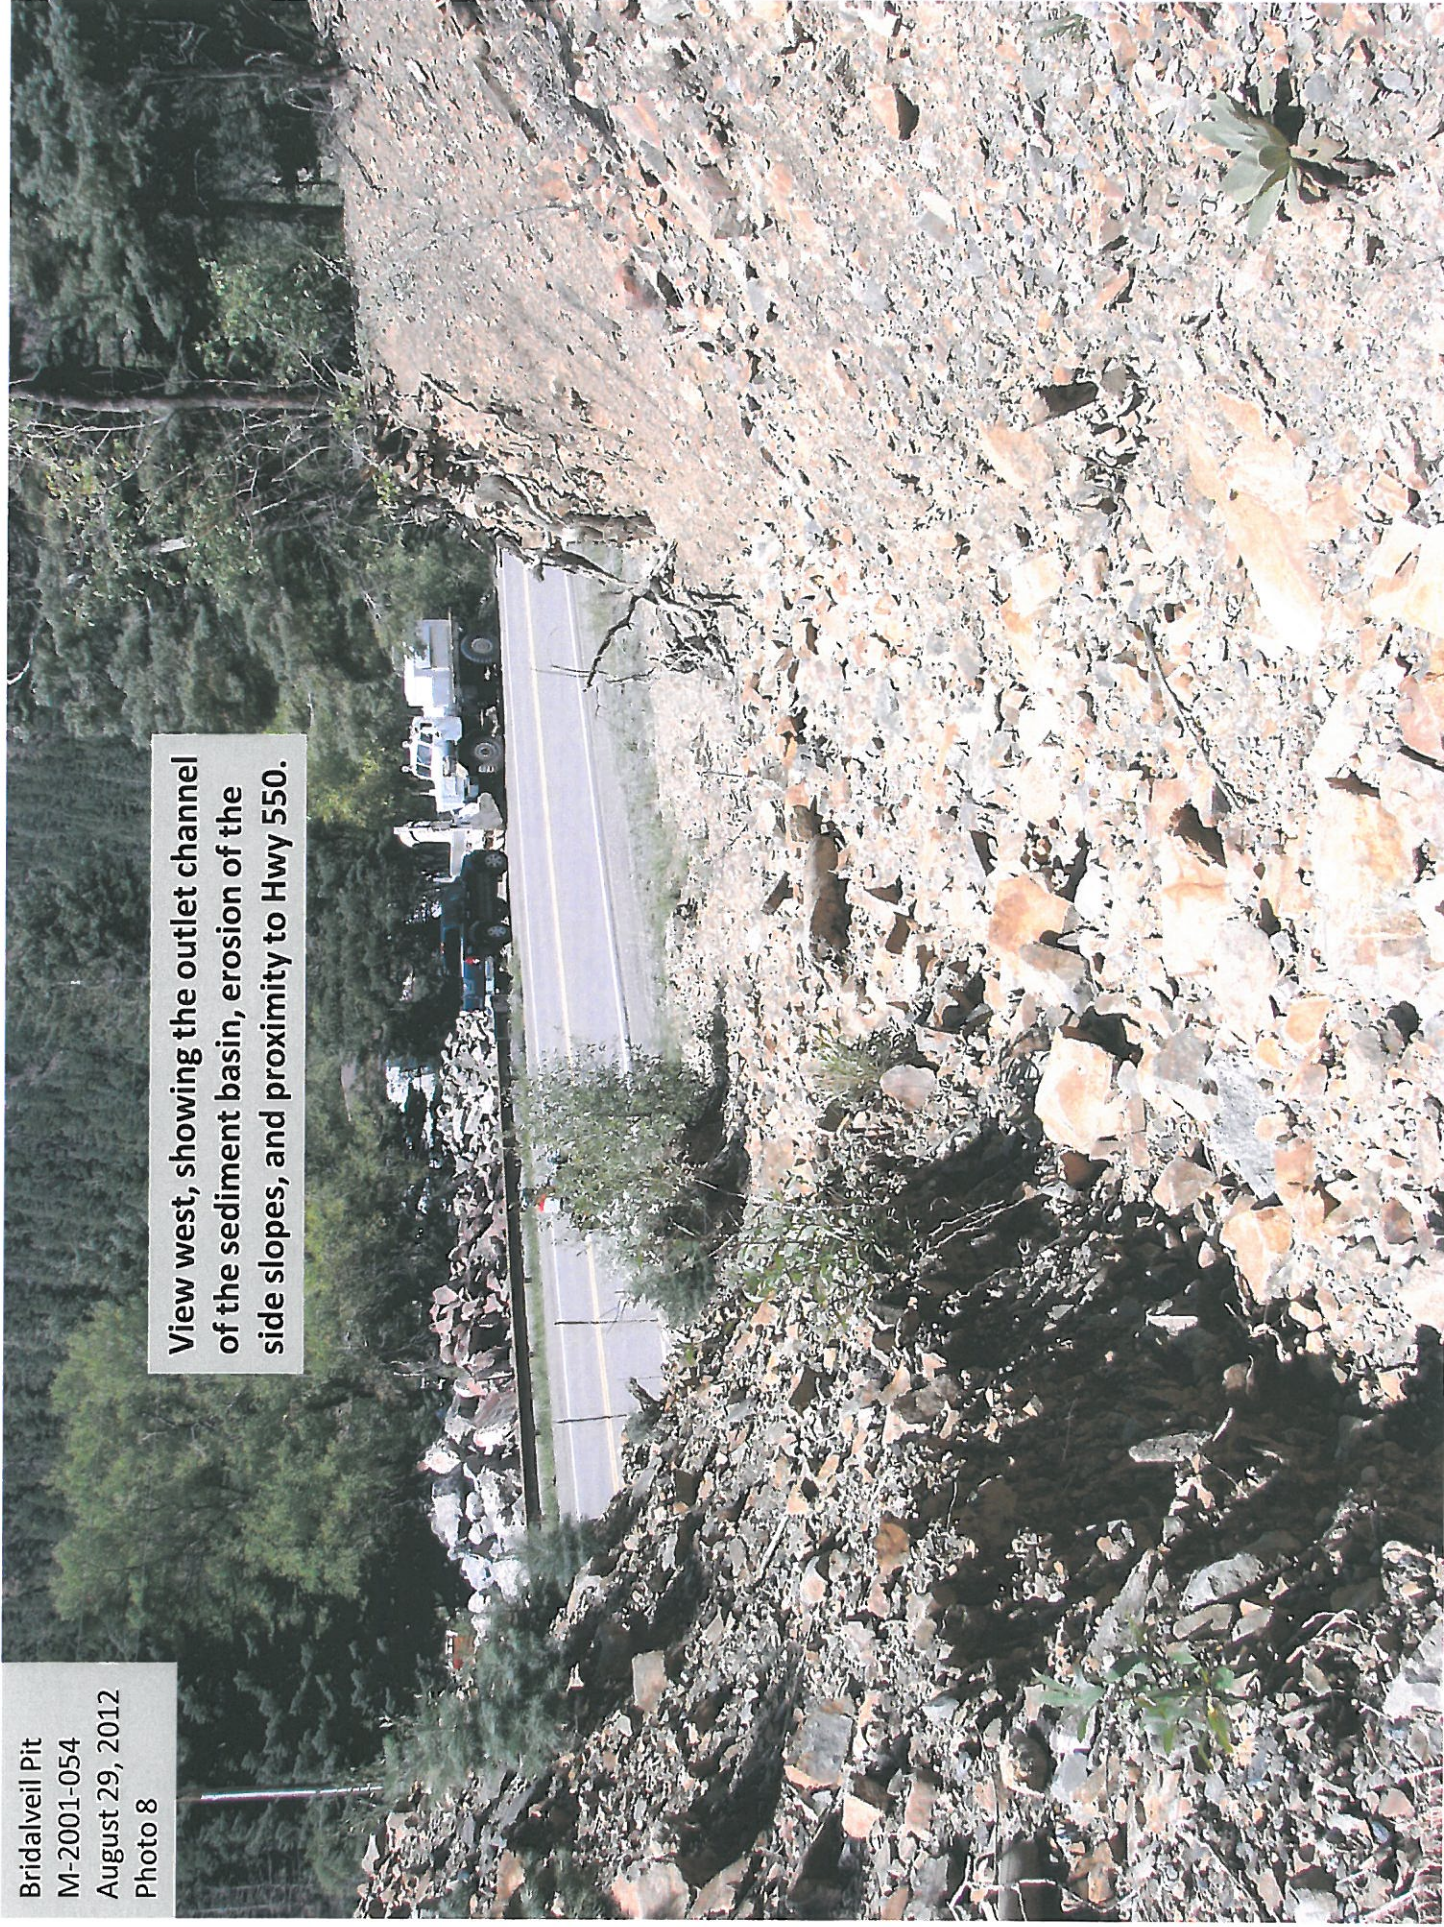
Bridalveil Pit  
M-2001-054  
August 29, 2012  
Photo 8

View west, showing the outlet channel  
of the sediment basin, erosion of the  
side slopes, and proximity to Hwy 550.

**CORRECTIVE ACTIONS:** Within 30 days, due October 12, 2012, the Operator shall repair the stormwater control channel and basin to fully comply with the approved plan, control erosion, and protect outside areas from damage. By October 12, 2012, the Operator shall provide photo documentation to the Division verifying the completion of repairs for all portions of the stormwater control structures.
