COLORADO DIVISION OF RECLAMATION, MINING AND SAFETY MINERALS PROGRAM INSPECTION REPORT

MINE NAME:	MINE/PROSPECTING ID#:	MINERAL:	COUNTY:
LZ Minerals Exploration Program	P-2008-044	Ag, Au, Cu, Zn, Pb	Mineral
INSPECTION TYPE:	INSPECTOR(S):	INSP. DATE:	INSP. TIME:
Mineral Prospect Inspection	Bob Oswald	August 14, 2012	16:30
OPERATOR:	OPERATOR REPRESENTATIVE:	TYPE OF OPERATION:	
NFI Ventures LLC	None	MP - Mineral Prospecting

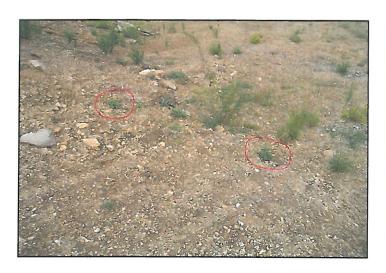
The operator has had a contractor spray the thistles numerous times in 2012, resulting in nearly 100% mortality of the weeds. Only ten (10) live thistle plants were found on the site, plus evidence of many dead ones. This is a great improvement from all other recent inspections, and is better than some adjacent undisturbed areas that contain Canada thistle (as noted in previous reports). This area should be checked during the remainder of this season to see if treatment has been fully effective.

The lower area of the project appeared to be stable and reclaimed. Some of the attached photos show the individual thistle plants circled. The upper (drill area) part of the project was not inspected at this time.

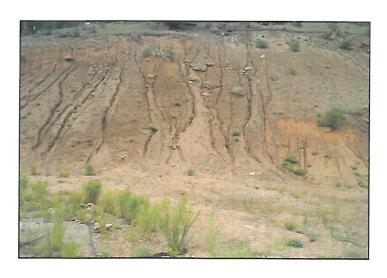
This inspection follows a brief period of heavy rain earlier in the week. The berm surrounding the portal-area disturbance was holding some rainwater, though it was only temporarily detained and appeared to be percolating into the pad. The historic cut slope above and around the face-up showed evidence of erosion, as the rills were deeper and the pad now contained the deposited sediment. This is a function of weathering of a surface that pre-existed on the site and was not redisturbed by the operator. The small portion of the cut slope where the "Big Six" portal was backfilled and recontoured was in better condition than the rest of the slope.
