COLORADO DIVISION OF RECLAMATION, MINING AND SAFETY MINERALS PROGRAM INSPECTION REPORT

MINE NAME: Topsoil Pit	MINE/PROSPECTING ID#: M-2012-027	MINERAL: Overburden	COUNTY: Chaffee
INSPECTION TYPE:	INSPECTOR(S):	INSP. DATE:	INSP. TIME:
Preoperation Inspection	Dustin M. Czapla	September 26, 2012	08:00
OPERATOR:	OPERATOR REPRESENTATIVE:	TYPE OF OPERATION:	
B & L Cogan LLC	None	112c - Construction Regular Operation

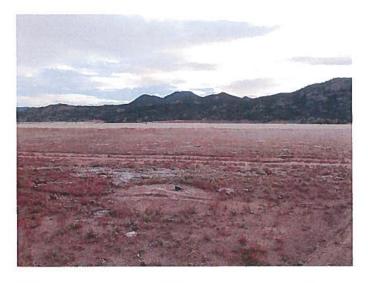
Figure 1: View from the southwest corner of the site, facing northeast.

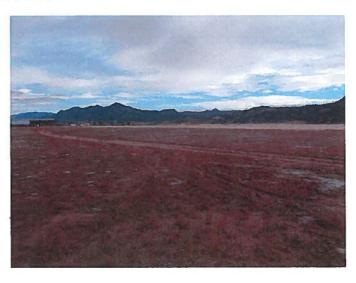
Figure 2: View from the southwest corner of the site, facing north.

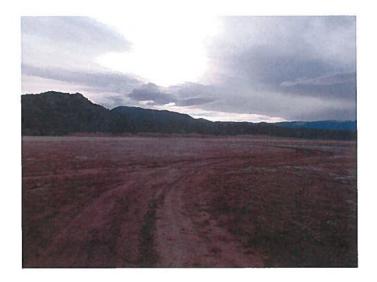
Figure 3: View from the southwest corner of the site, facing east.

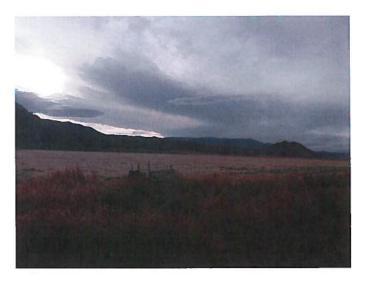
Figure 4: View from the west central part of the site, facing southeast.
