COLORADO DIVISION OF RECLAMATION, MINING AND SAFETY
MINERALS PROGRAM INSPECTION REPORT
PHONE: (303) 866-3567

MINE NAME: Upper Animas Sand and Gravel Pit	MINE/PROSPECTING ID#: M-2005-065	MINERAL: Sand and gravel	COUNTY: San Juan
INSPECTION TYPE: Monitoring	INSPECTOR(S): Wallace H. Erickson	INSP. DATE: September 25, 2012	INSP. TIME: 14:00
OPERATOR: Jack Clark Jr.	OPERATOR REPRESENTATIVE: Charles R. Ponchak	TYPE OF OPERATION: 112c - Construction Regular Operation

Upper Animas Sand
and Gravel Pit 1 & 2
M-2005-065
September 25, 2012

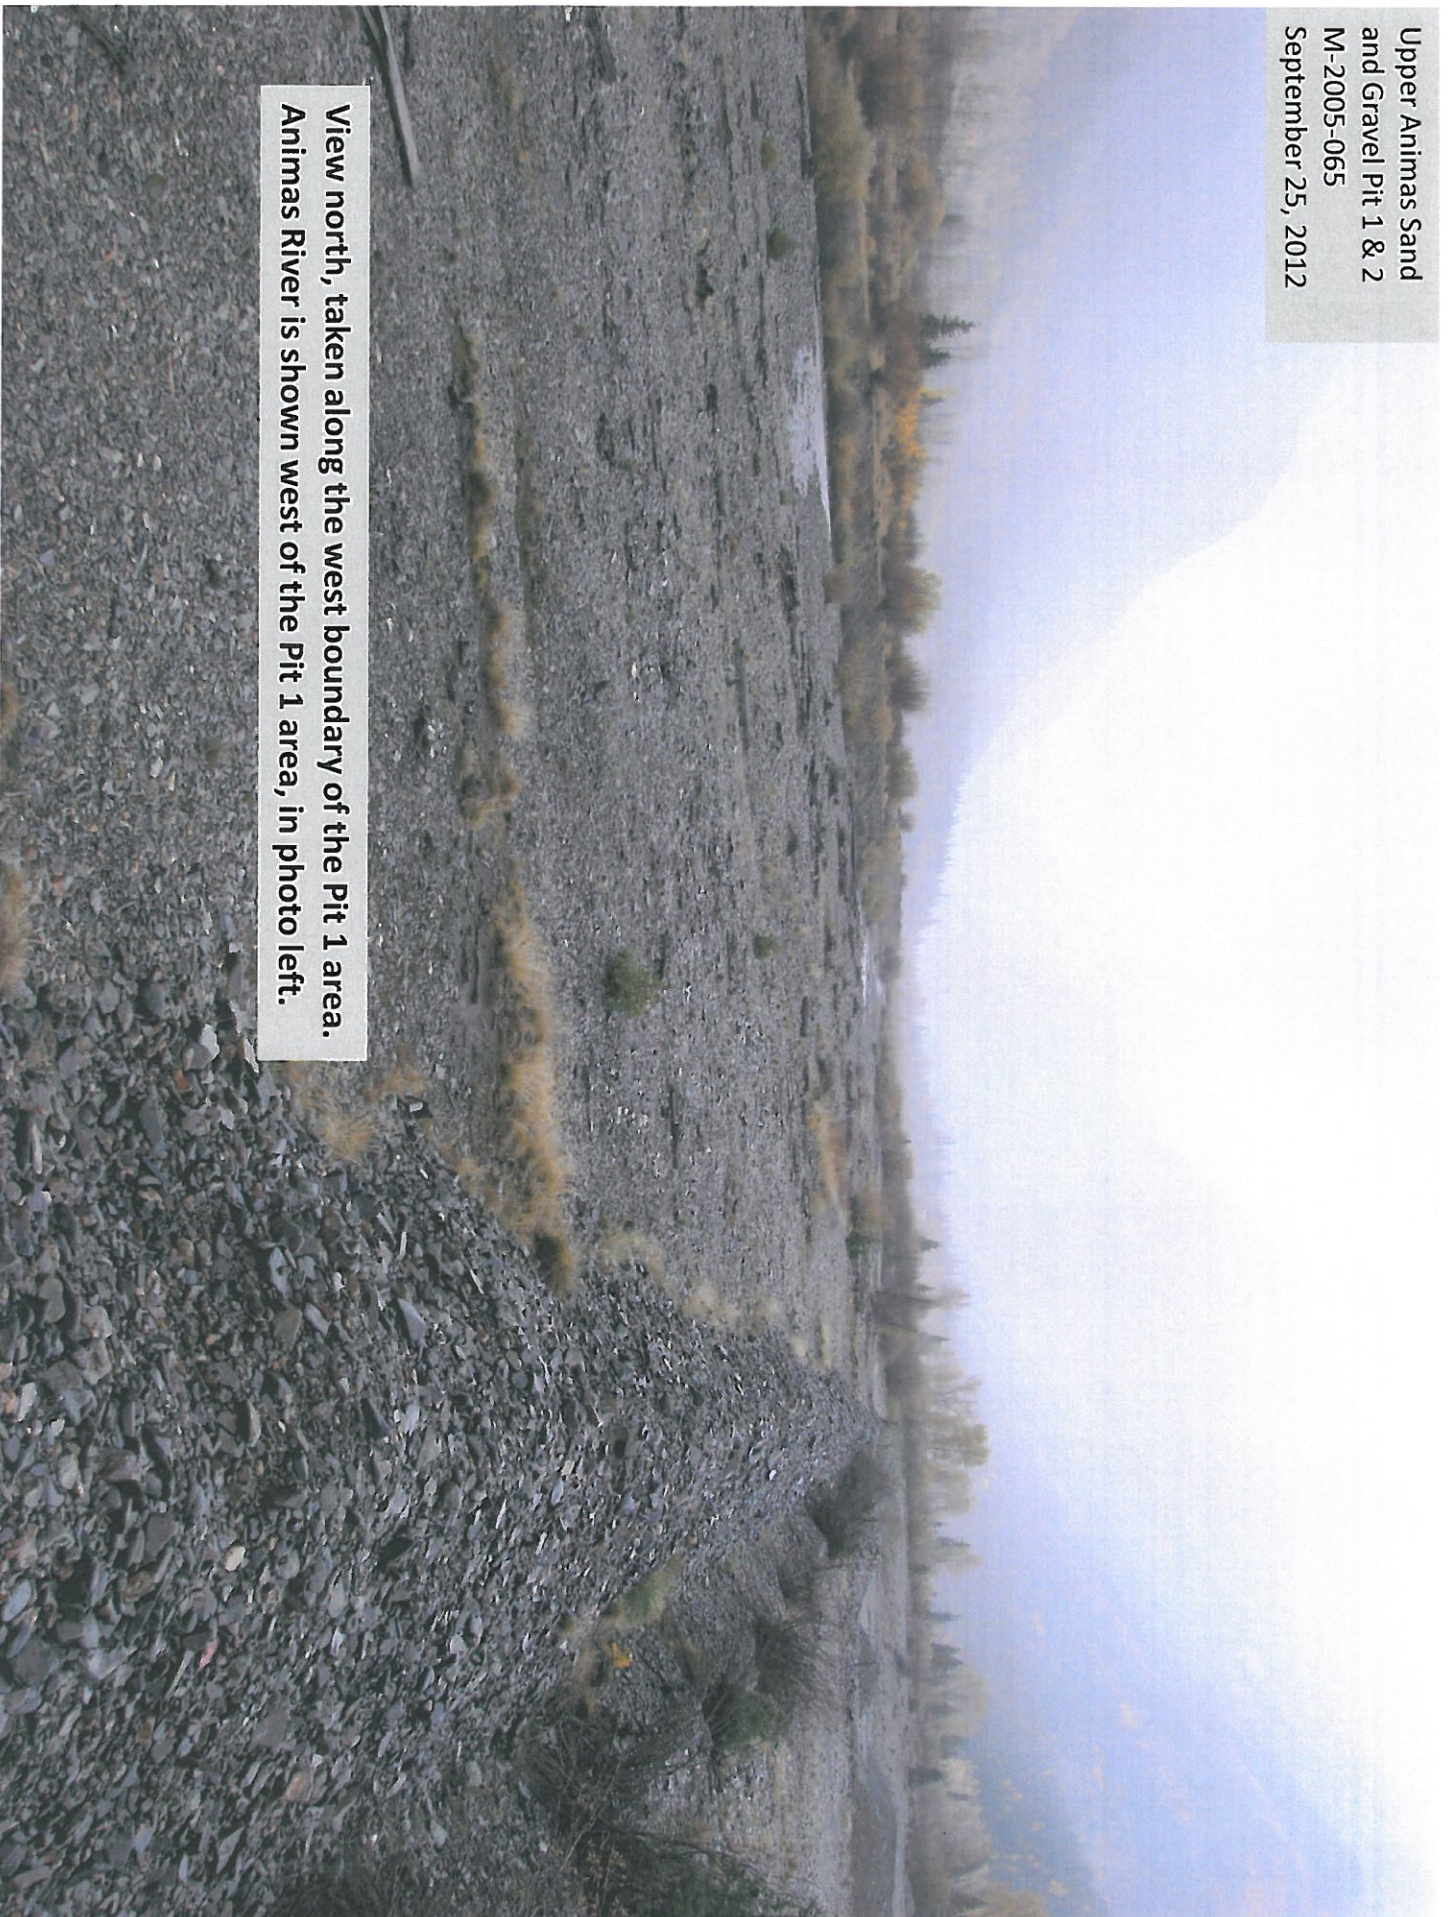
View north, taken along the west boundary of the Pit 1 area.
Animas River is shown west of the Pit 1 area, in photo left.

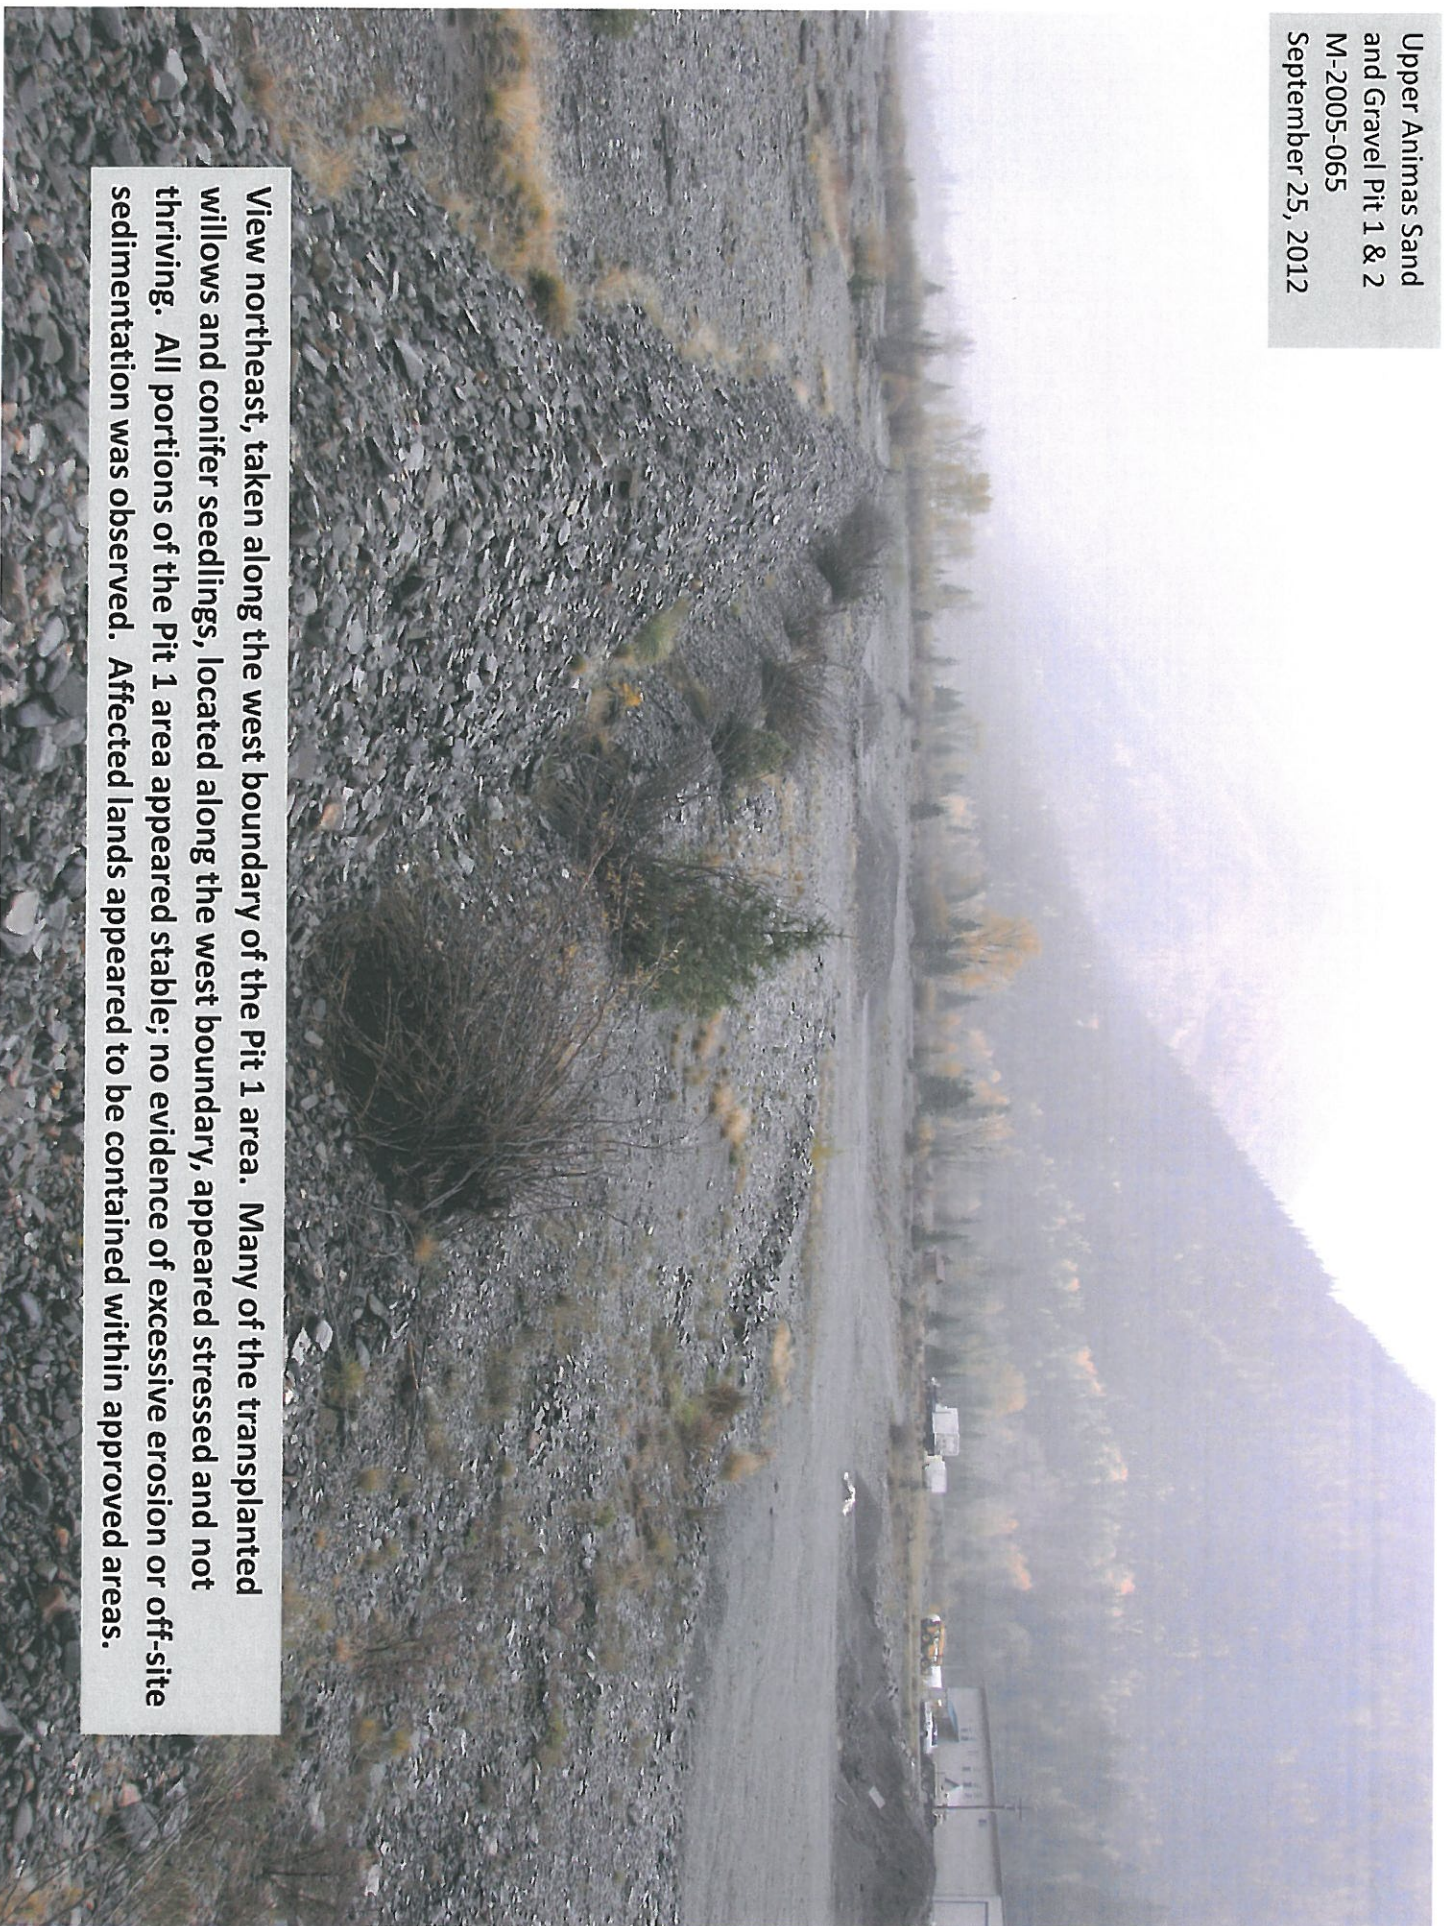
Upper Animas Sand
and Gravel Pit 1 & 2
M-2005-065
September 25, 2012

View northeast, taken along the west boundary of the Pit 1 area. Many of the transplanted willows and conifer seedlings, located along the west boundary, appeared stressed and not thriving. All portions of the Pit 1 area appeared stable; no evidence of excessive erosion or off-site sedimentation was observed. Affected lands appeared to be contained within approved areas.

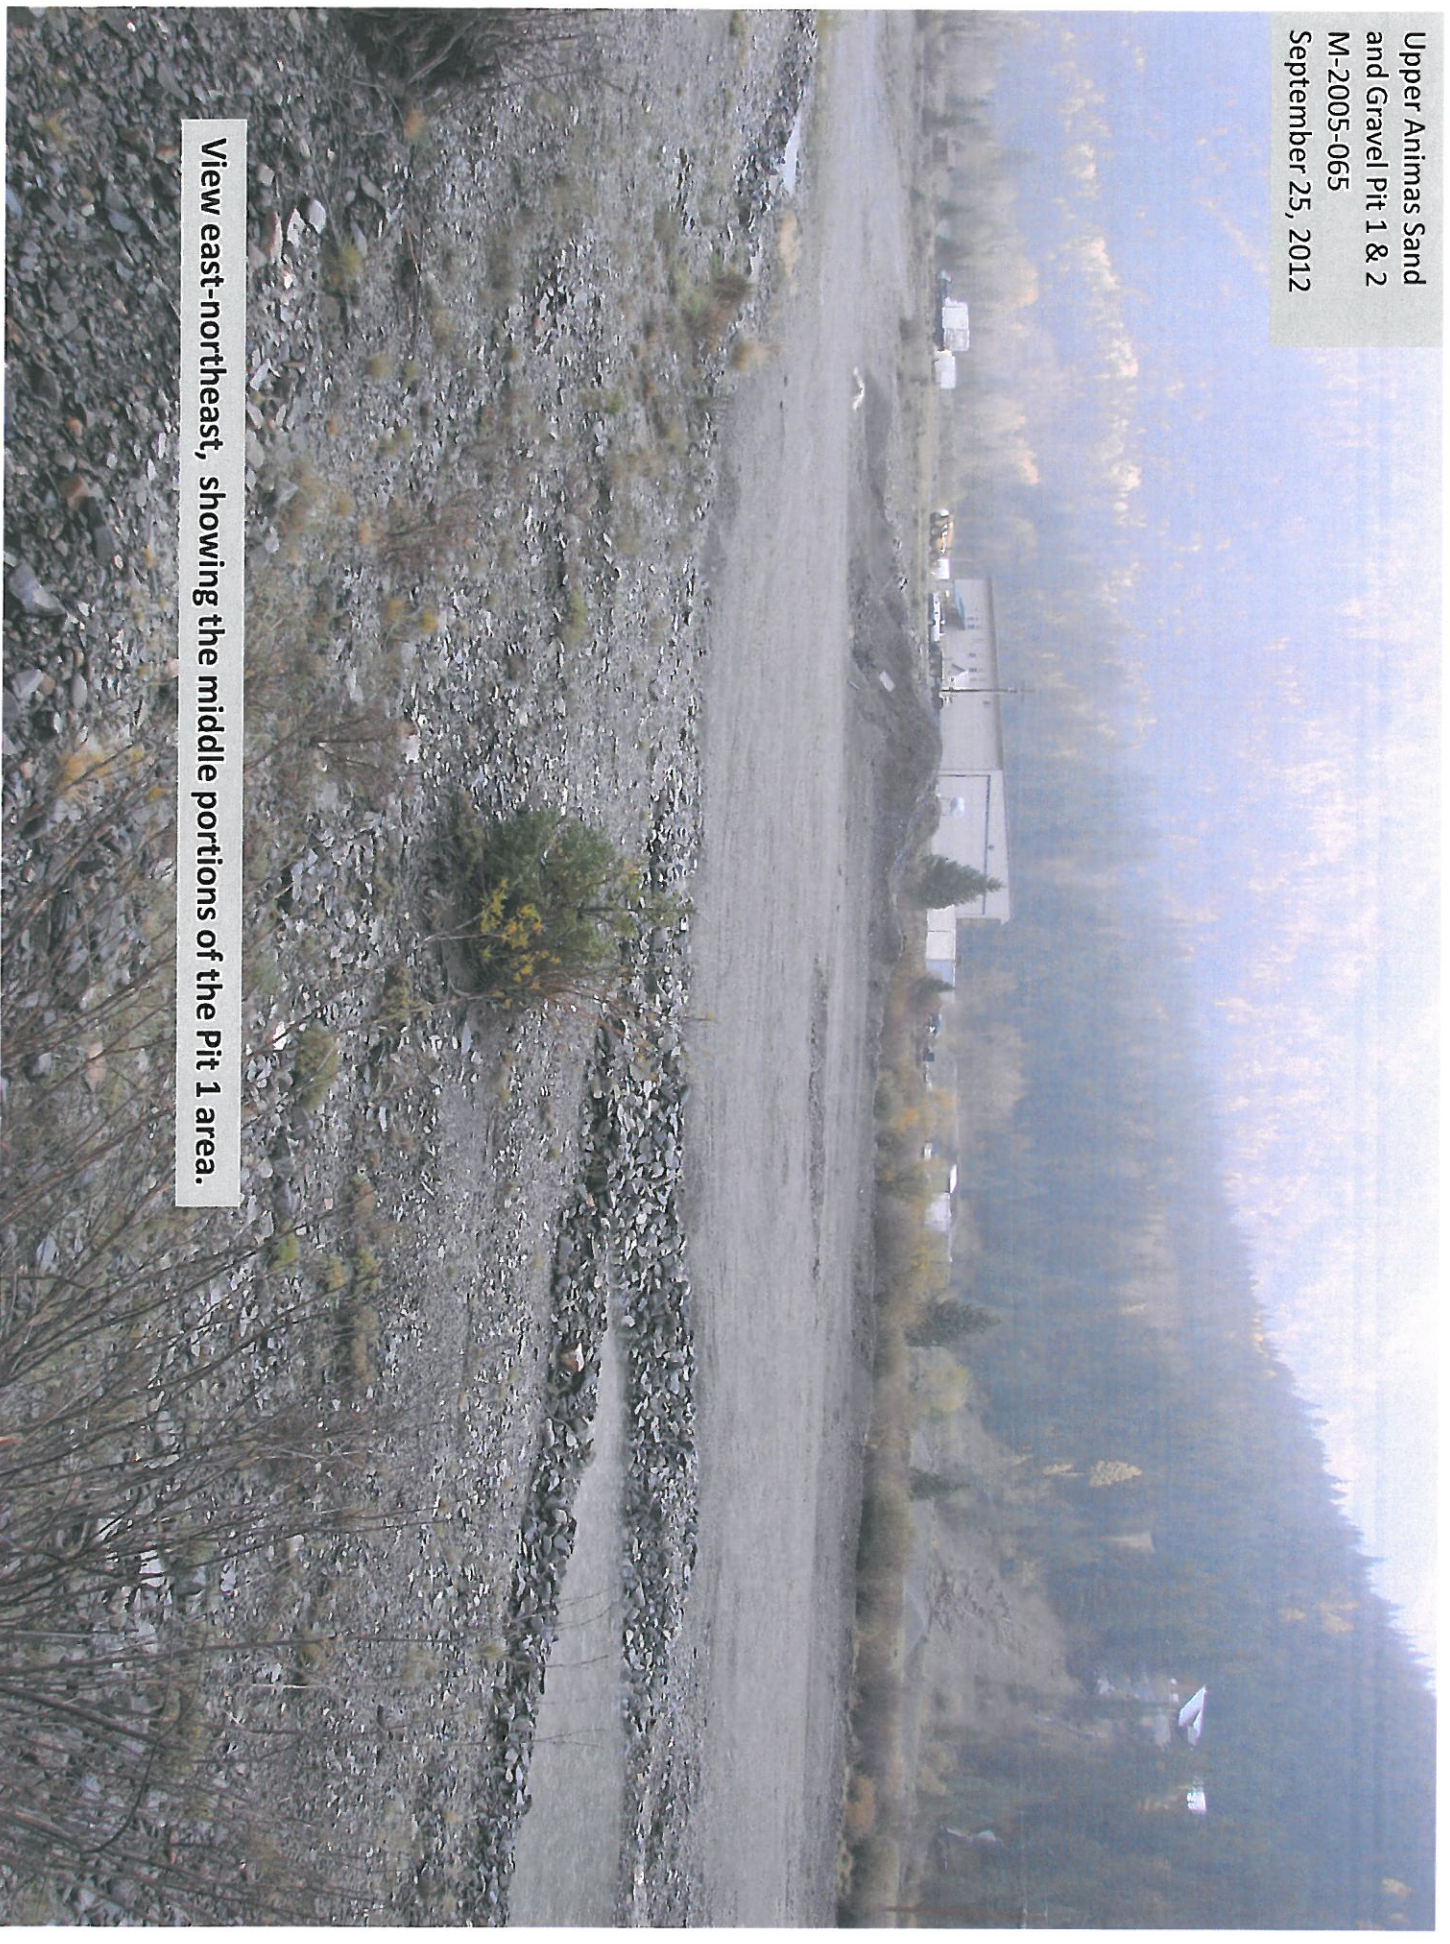
Upper Animas Sand
and Gravel Pit 1 & 2
M-2005-065
September 25, 2012

View east-northeast, showing the middle portions of the Pit 1 area.

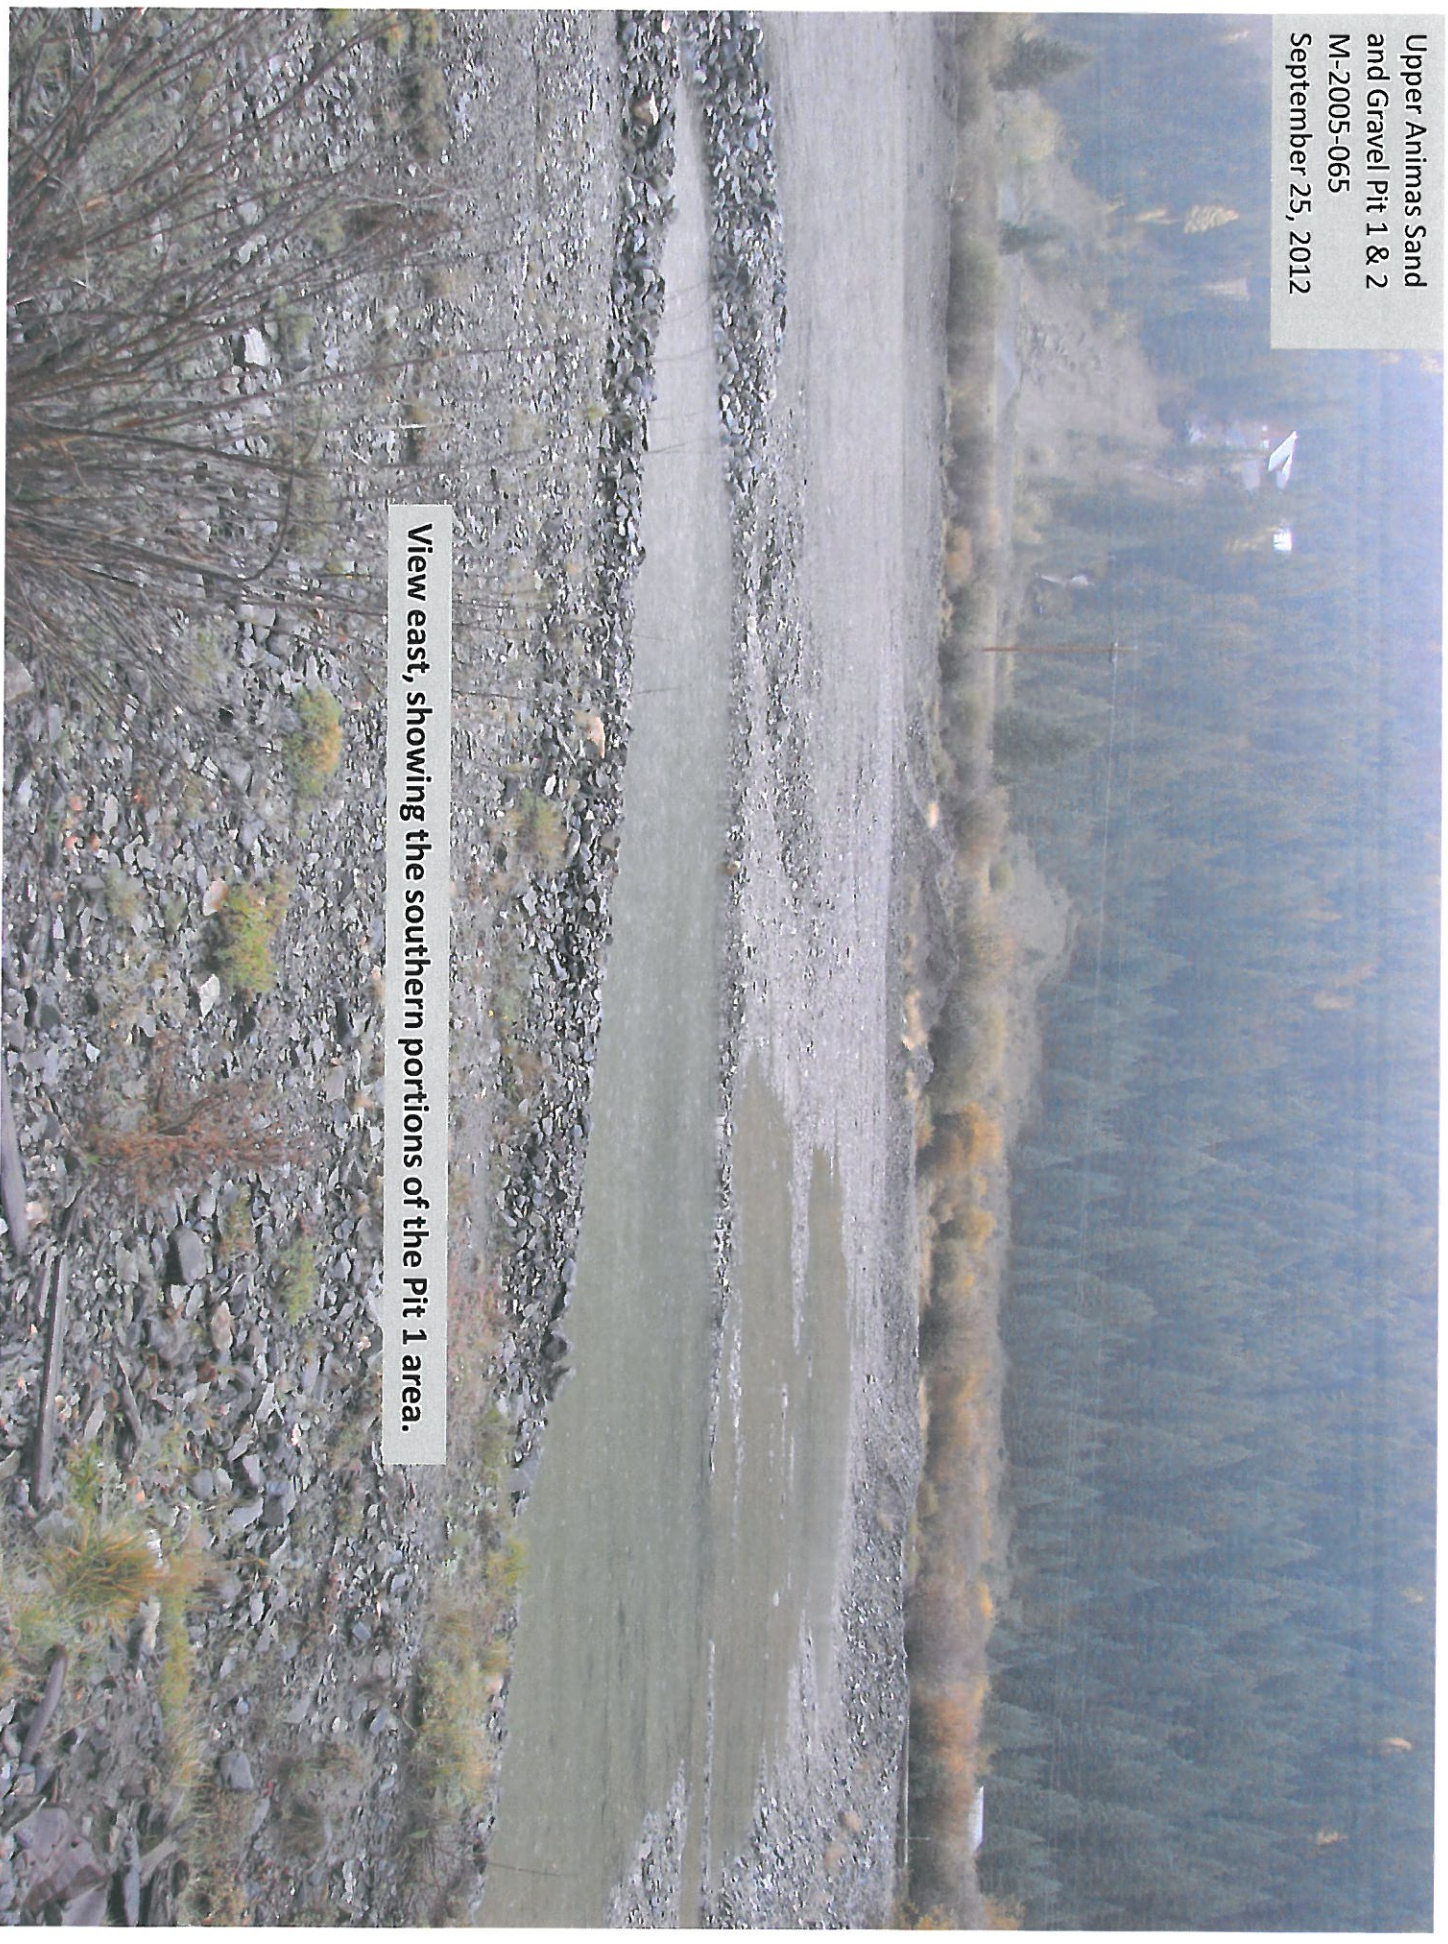
Upper Animas Sand
and Gravel Pit 1 & 2
M-2005-065
September 25, 2012

View east, showing the southern portions of the Pit 1 area.

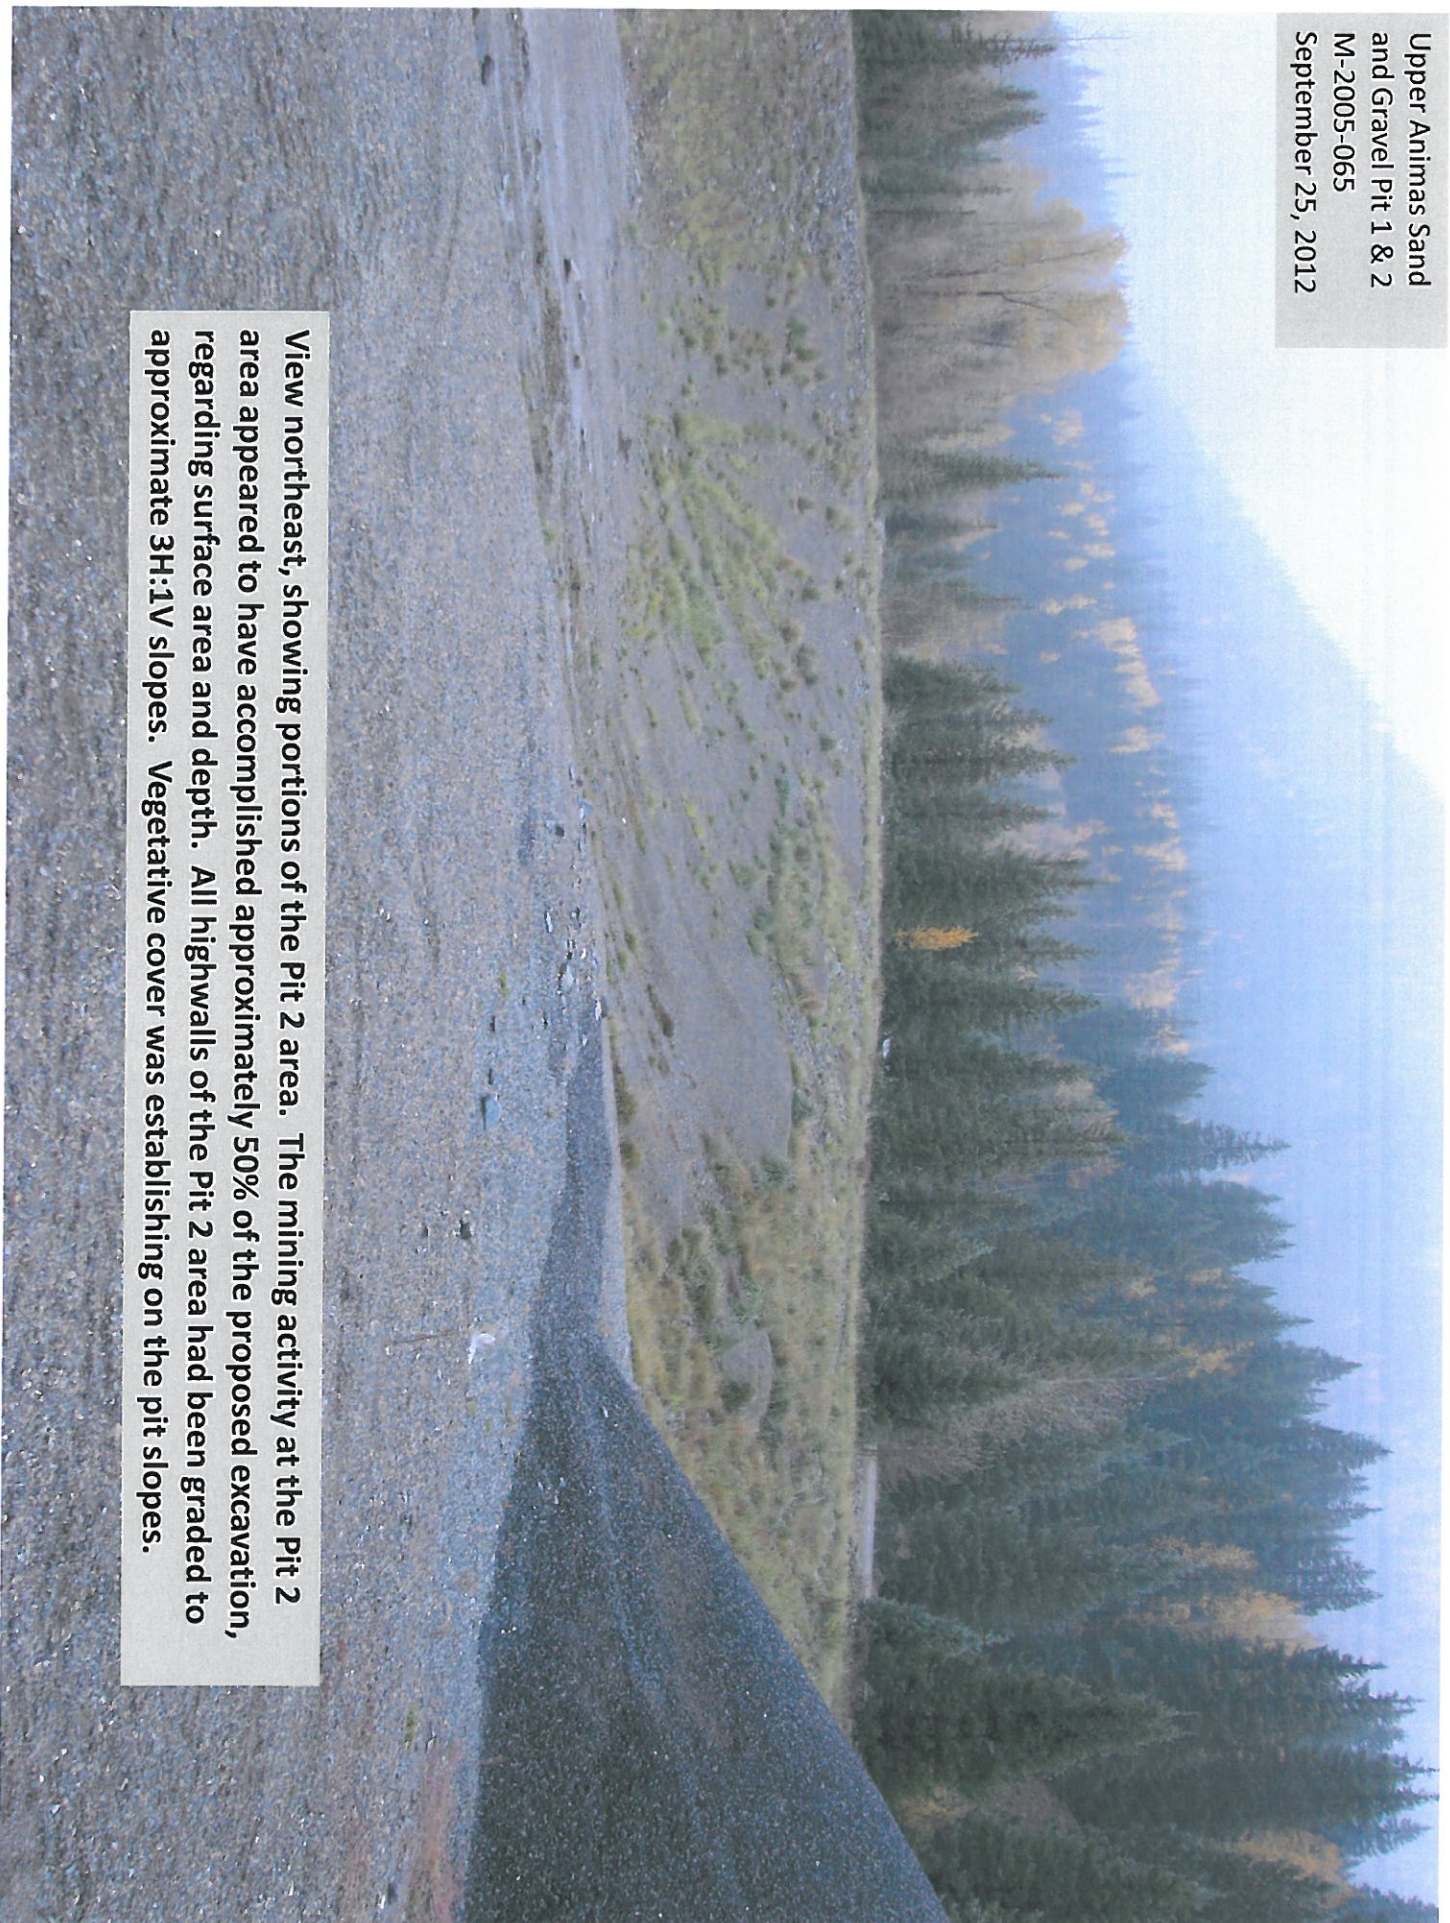
Upper Animas Sand
and Gravel Pit 1 & 2
M-2005-065
September 25, 2012

View northeast, showing portions of the Pit 2 area. The mining activity at the Pit 2 area appeared to have accomplished approximately 50% of the proposed excavation, regarding surface area and depth. All highwalls of the Pit 2 area had been graded to approximate 3H:1V slopes. Vegetative cover was establishing on the pit slopes.

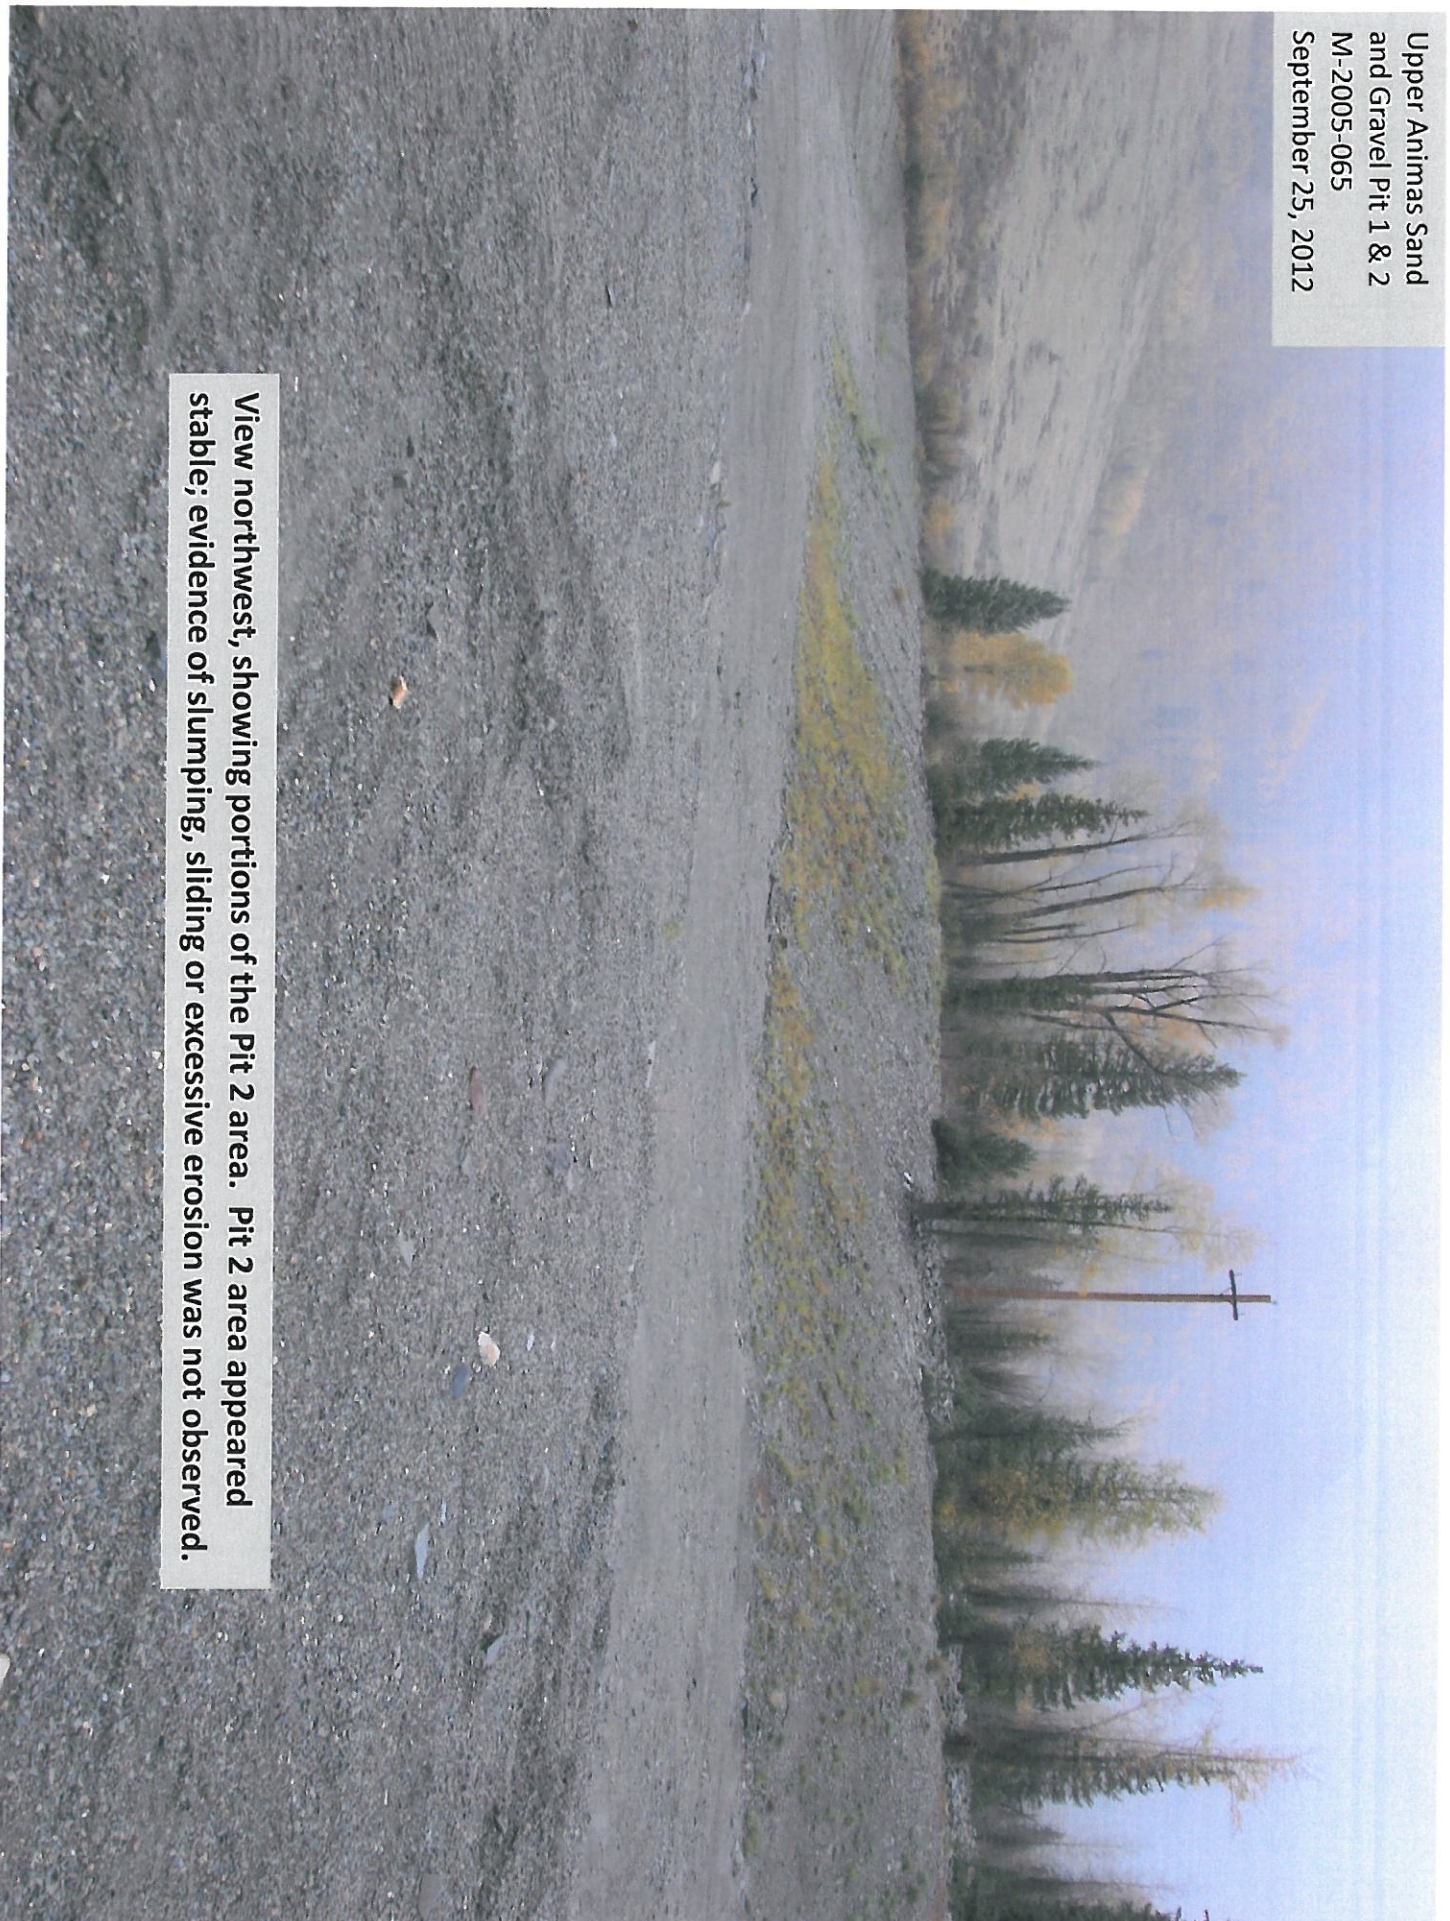
Upper Animas Sand
and Gravel Pit 1 & 2
M-2005-065
September 25, 2012

View northwest, showing portions of the Pit 2 area. Pit 2 area appeared stable; evidence of slumping, sliding or excessive erosion was not observed.

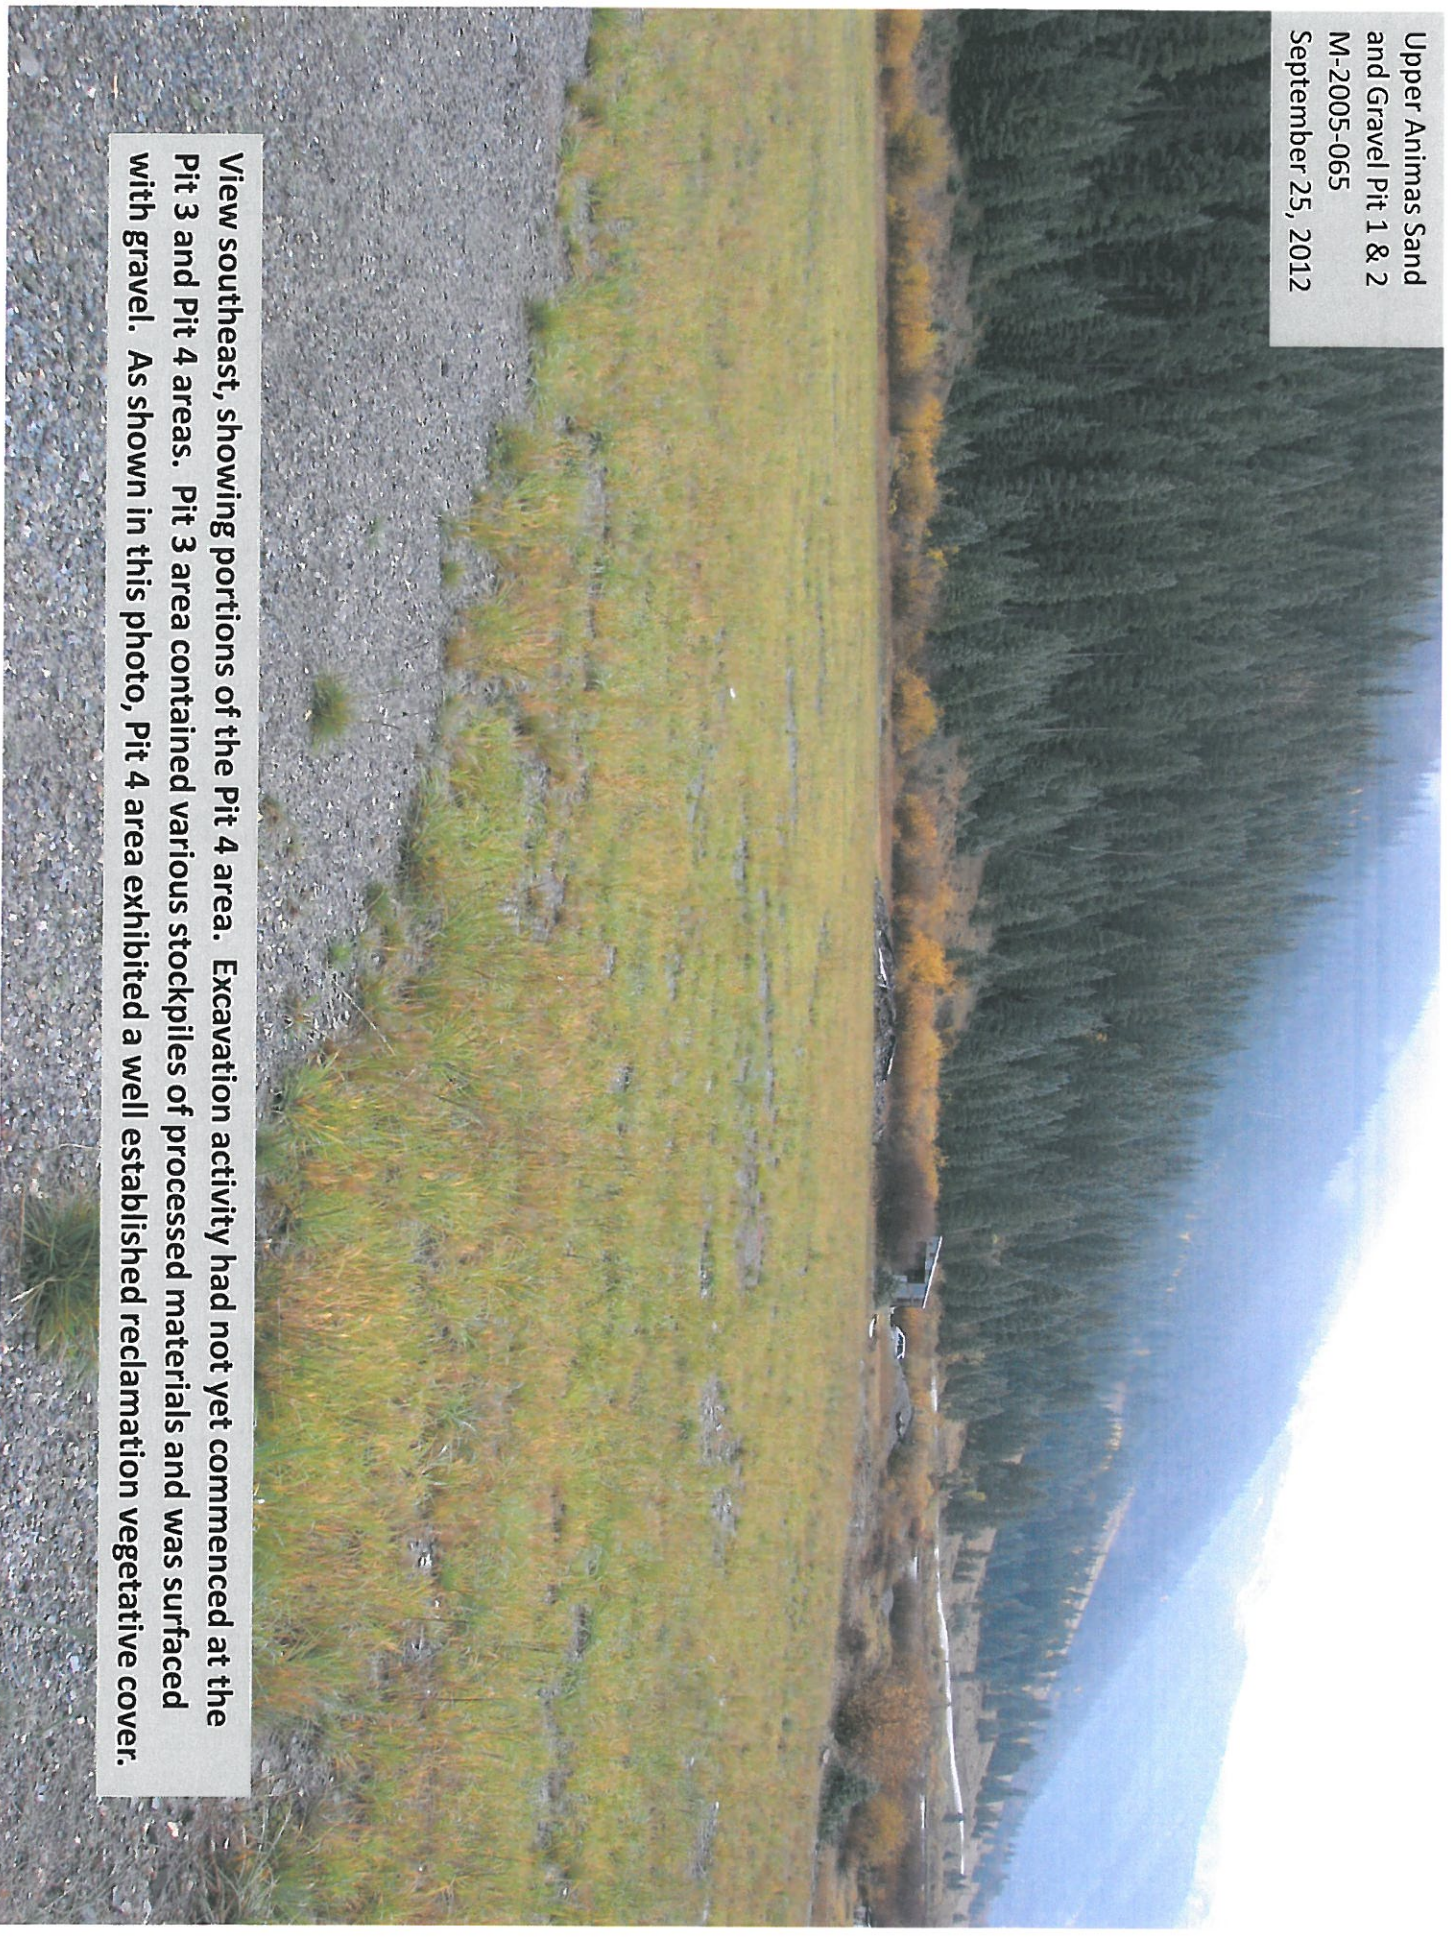
Upper Animas Sand
and Gravel Pit 1 & 2
M-2005-065
September 25, 2012

View southeast, showing portions of the Pit 4 area. Excavation activity had not yet commenced at the Pit 3 and Pit 4 areas. Pit 3 area contained various stockpiles of processed materials and was surfaced with gravel. As shown in this photo, Pit 4 area exhibited a well established reclamation vegetative cover.
