COLORADO DIVISION OF RECLAMATION, MINING AND SAFETY
MINERALS PROGRAM INSPECTION REPORT
PHONE: (303) 866-3567

MINE NAME: Jesse Lee	MINE/PROSPECTING ID#: M-1984-043	MINERAL: Sand and gravel	COUNTY: Chaffee
INSPECTION TYPE: Monitoring	INSPECTOR(S): Dustin M. Czapla	INSP. DATE: September 26, 2012	INSP. TIME: 08:30
OPERATOR: Pelino, Inc.	OPERATOR REPRESENTATIVE: Scott Pelino	TYPE OF OPERATION: 112c - Construction Regular Operation

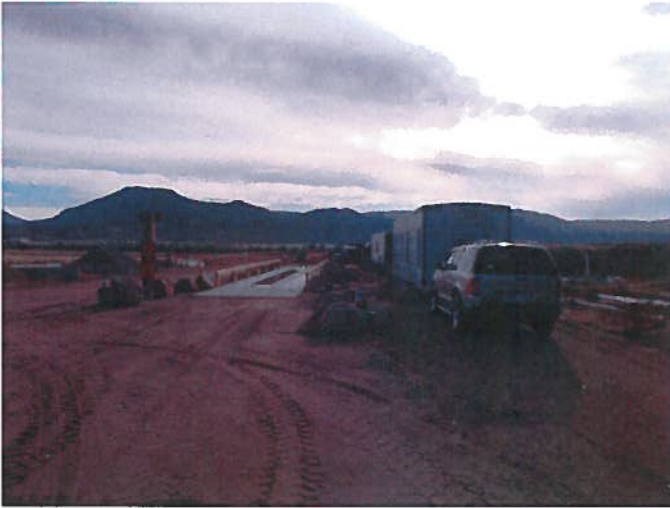
The west portion of the permit area contains the scale and scale house, various materials stockpiles, and miscellaneous debris. This area is a level bench located above the pit area. The active mining/operating area is located in the east portion of the permit area. Mining is progressing west. The pit floor is relatively level and is located beneath the static groundwater table. However, groundwater is not impounded in the pit due to a diversion ditch redirecting the water, that seeps through the highwall at several locations, into sediment ponds to the south, and ultimately into the Arkansas River. The south portion of the permitted area appeared to be reclaimed with vegetation well established.

Figure 1: Upper bench area located in the west portion of the permit area.

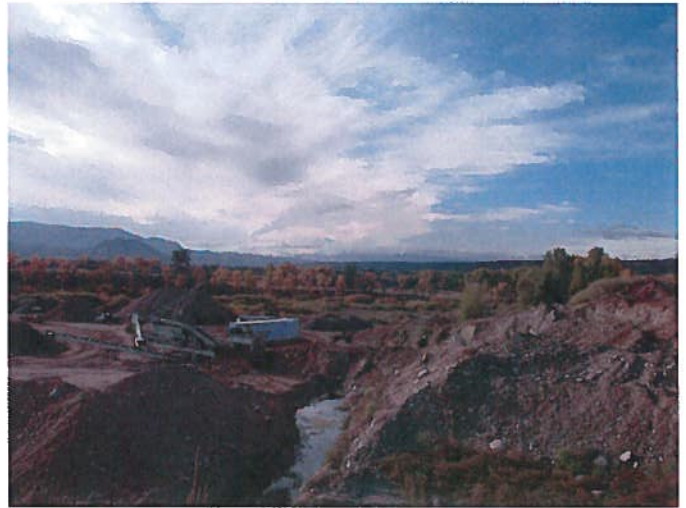
Figure 2: View from the bench area down toward the pit, facing south.

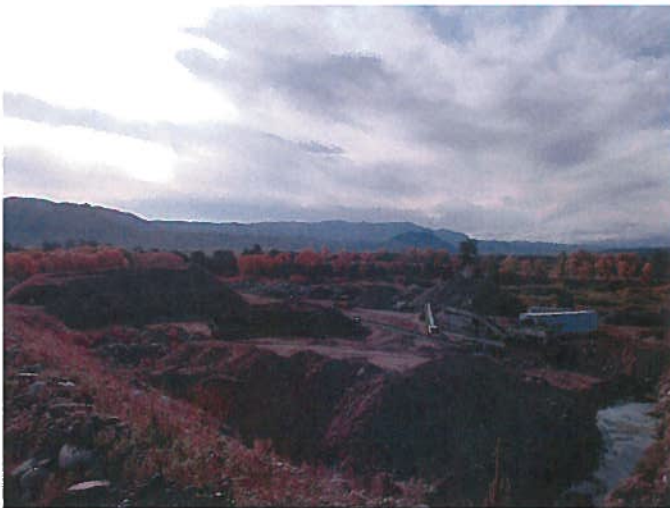
Figure 3: View from the bench area down toward the pit, facing southwest.

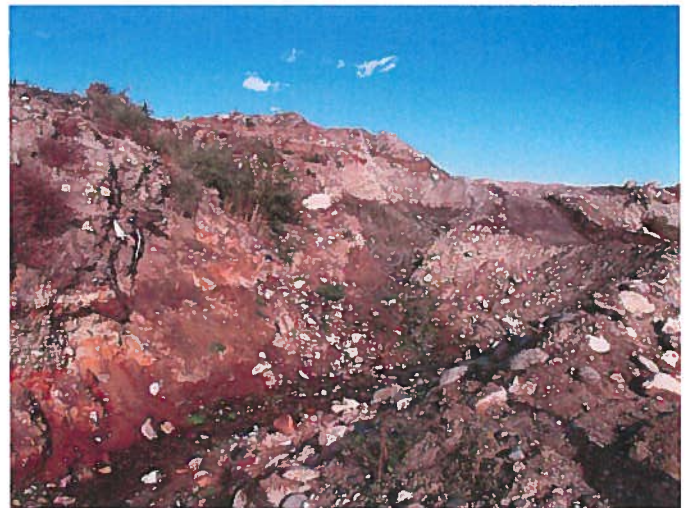
Figure 4: View toward the west highwall. The diversion ditch at the base of the highwall redirects water from the seeps off site.

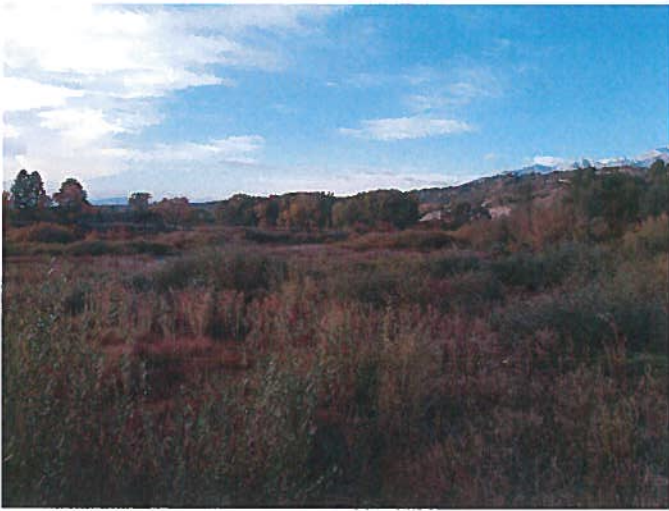
Figure 5: View of the reclaimed south portion of the permit area.

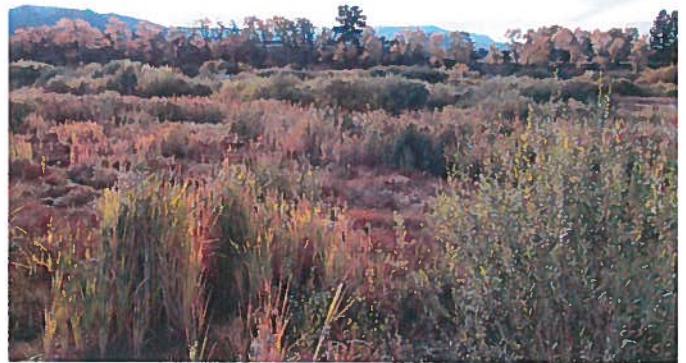
Figure 6: View of the reclaimed south portion of the permit area.
